Bridge #03118(Routine)
SH 135-04- LM 3.10 over 8 MILE CREEK
Location: 3.10 MI N CRAIGHEAD CO L
Team Lead: Tim Myrick Inspection Date: April 12, 2021

IDENTIFICATION	
(1) State Names	Arkansas
(8) Structure Number	03118
(5) Inventory Route	135
(2) Highway Agency District	10
(3) County Code	55-Greene County, Arkansas

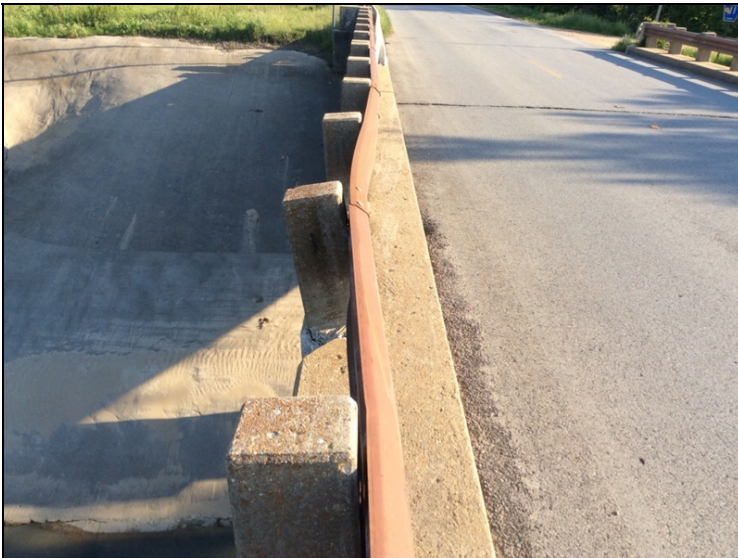
Lt rail at span 2

Lt bridge rail at span 2 has impact damage to 3 posts. Posts are leaning away from bridge and have cracks/spalls at bottom of posts and overhang.

Metal bridge rails have minor corrosion.
Left bridge rail has 24 ft. of collision damage on span 2 with 3 broken posts.
Asphalt wearing surface has cracks & delaminated areas over joints and in gutters.
Soffit has a few minor cracks with some efflorescence.
Overhangs have a few patched areas at bridge rail posts.
Span 2 drains each have some minor exposed rebar.

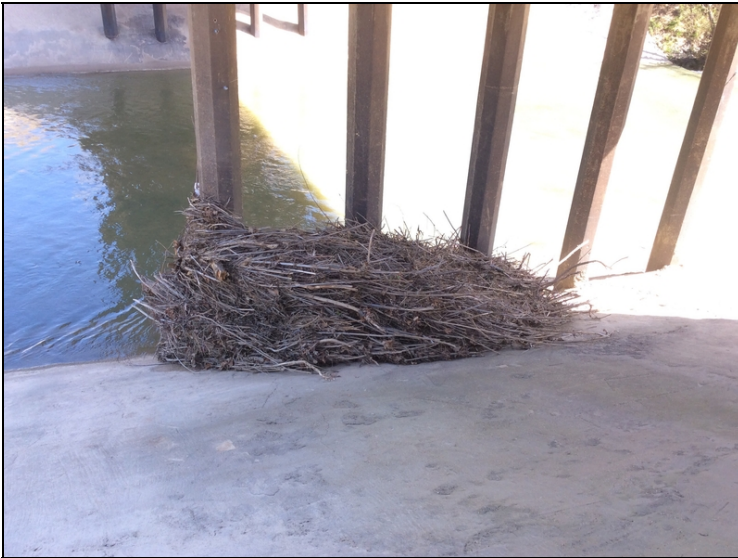
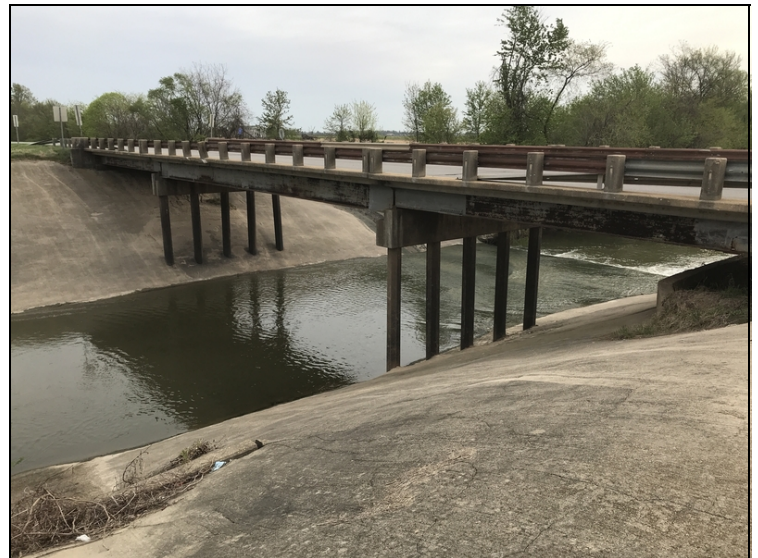
Side

Drift buildup at bent 2.

Drift has been removed or washed out as of this inspection, JFA/CWS

To Greene Co for repair KAW 5/15/18
