Bridge #06831(Routine, Underwater type 2)
US 412-09- LM 8.09 over SAINT FRANCIS RIVER

Location: MO. State Line

Team Lead: James Adams **Inspection Date:** August 06, 2020

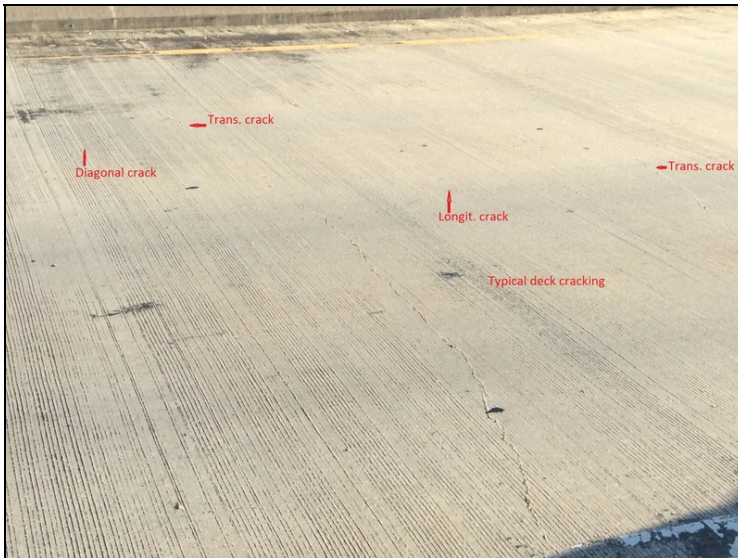
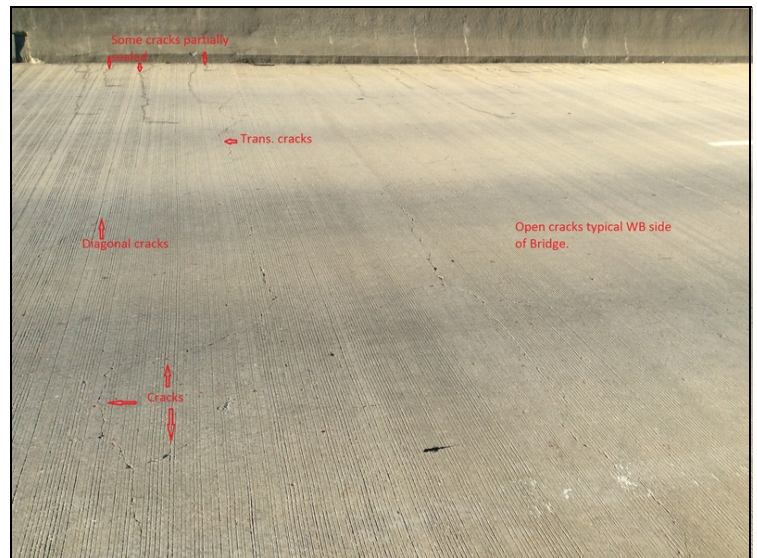
Deck has numerous transverse, longitudinal, and diagonal unsealed cracks.
End units have transverse cracks on approximately 4 ft. spacing. Interior units have transverse cracks on approximately 4 ft. – 6 ft. spacing. Several cracks are up to .07" wide.

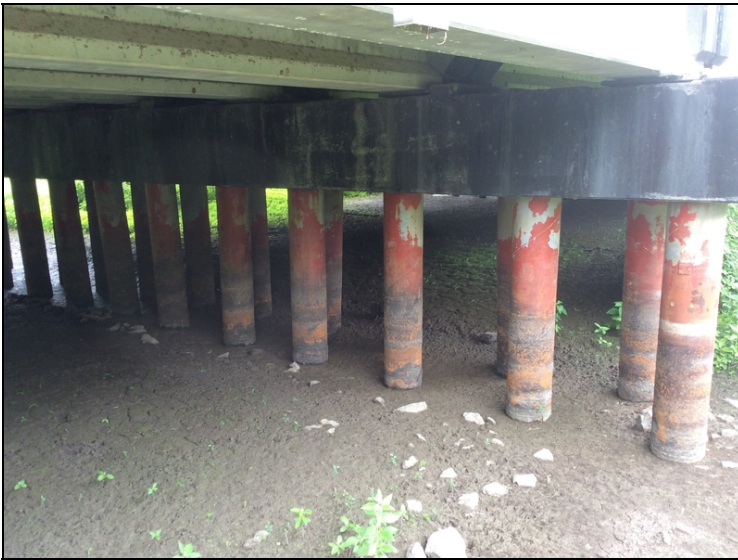
Steel shell piles have moderate corrosion and flaking rust near water level/ground line.

Steel shell piles have moderate corrosion and flaking rust near water level.

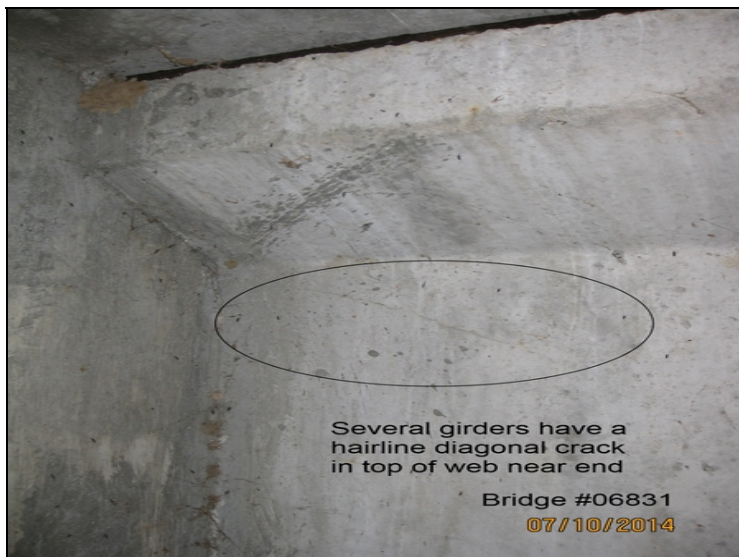
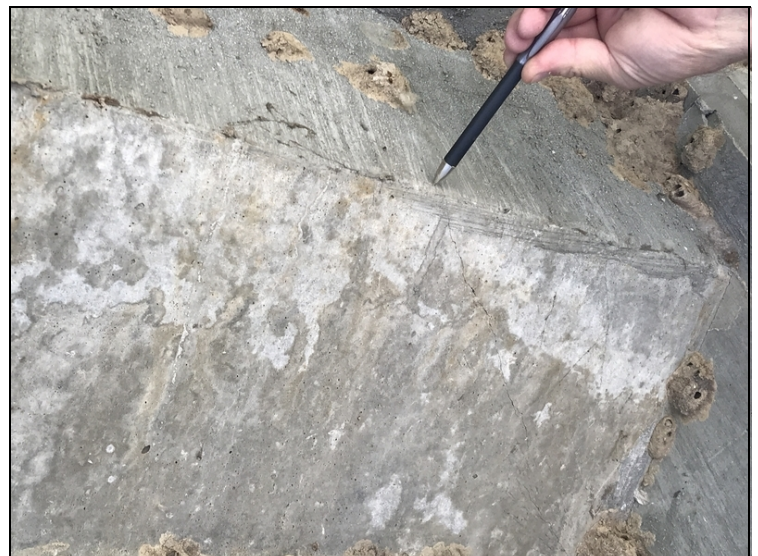
A few pre-stressed concrete girders have hairline cracks in top flange & web approximately 1 ft. long, starting at top end of girder running down at a 45 degree angle:

Span 8 bent 9 girder 9 2020 photo.

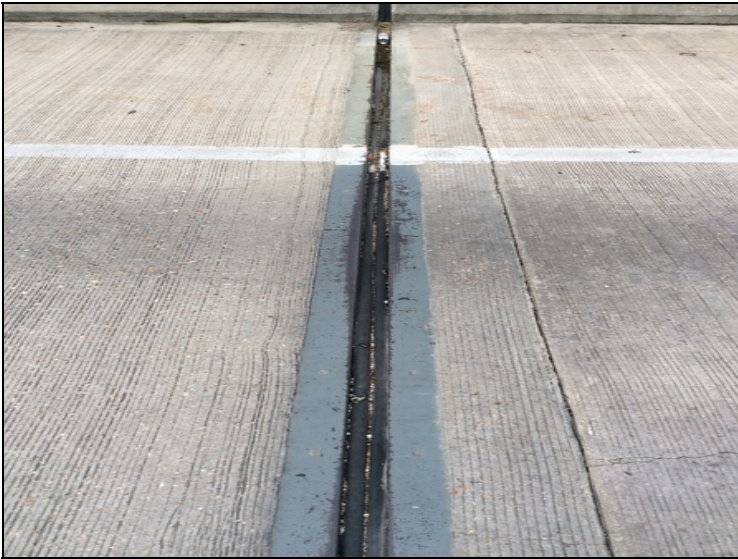
Compression seals at end bents have a few areas beginning to lose adhesion.
Bent 1 right end has 12 ft. dropped out.

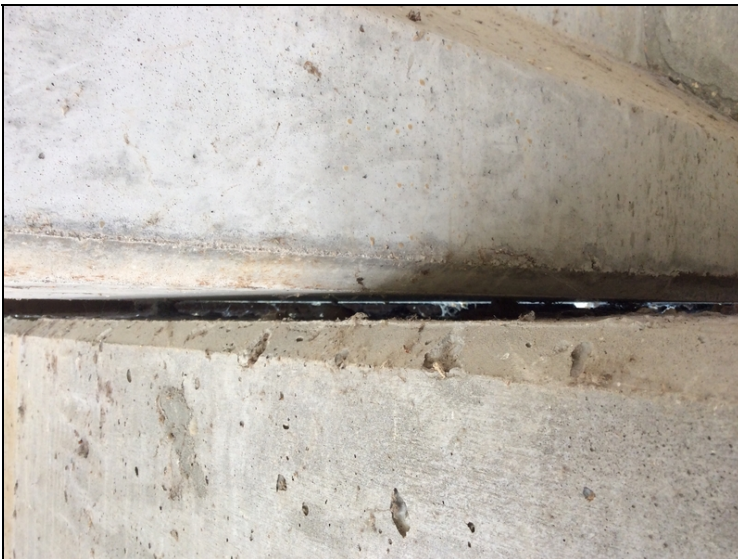
Several girders at fixed bents have up to a 1" gap between bottom flange of girder and top of cap. A few neoprene pads have shifted under girders.

Span 2 bent 2 girders 1 – 5 are missing neoprene pads.
