Bridge #07038(Routine, Underwater type 2)

US 412-09-LM 4.96 over JOHNSON CREEK

Location: 3.29 M W OF MISSOURI LINE

Team Lead: James Adams **Inspection Date:** June 24, 2020

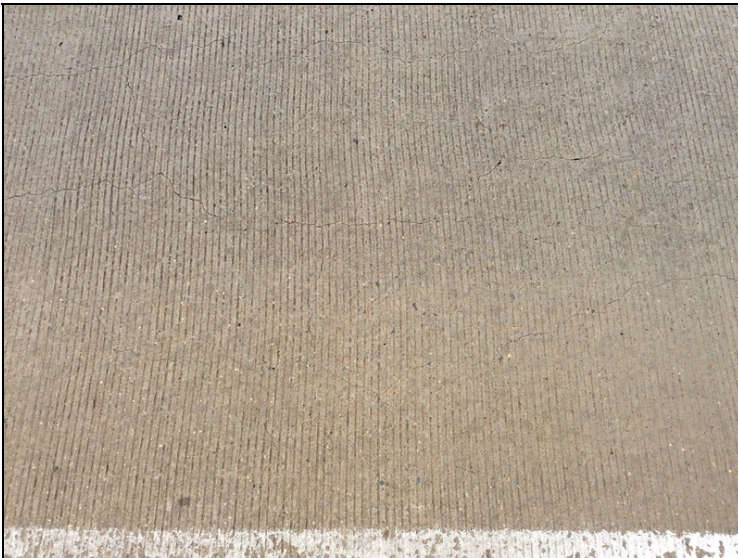
Deck has numerous unsealed transverse and longitudinal cracks, and has areas of map cracking in wheel paths, especially at span 2.

Deck has numerous unsealed transverse and longitudinal cracks, and has areas of map cracking in wheel paths, especially at span 2. Spans 1 & 3 have diagonal cracks at corners of deck over bents 1 & 4.
