Bridge #07040(Routine)
US 412-09- LM 5.71 over LOCUST CREEK
Location: 2.53 MI W of MO STATE LN
Team Lead: Tim Myrick Inspection Date: August 23, 2021

IDENTIFICATION	
(1) State Names	Arkansas
(8) Structure Number	07040
(5) Inventory Route	412
(2) Highway Agency District	10
(3) County Code	55-Greene County, Arkansas

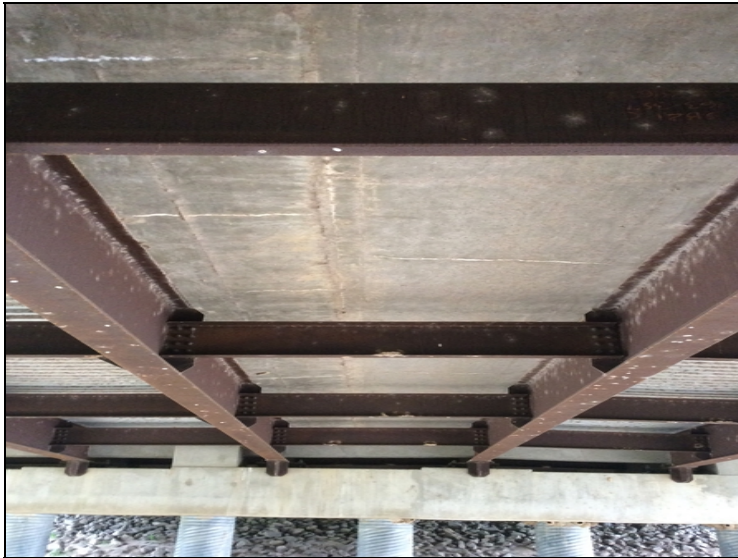
Bottom of Deck Bay 4 near centerline has insignificant size and density cracks with efflorescence, (Bay has no SIP Decking).
Exposed Soffit has some cracks with efflorescence.
