Bridge #05642(Routine, Underwater type 2)
SH 135-03- LM 3.32 over THOMPSON CREEK

Team Lead: Richard Jones **Inspection Date:** October 13, 2020

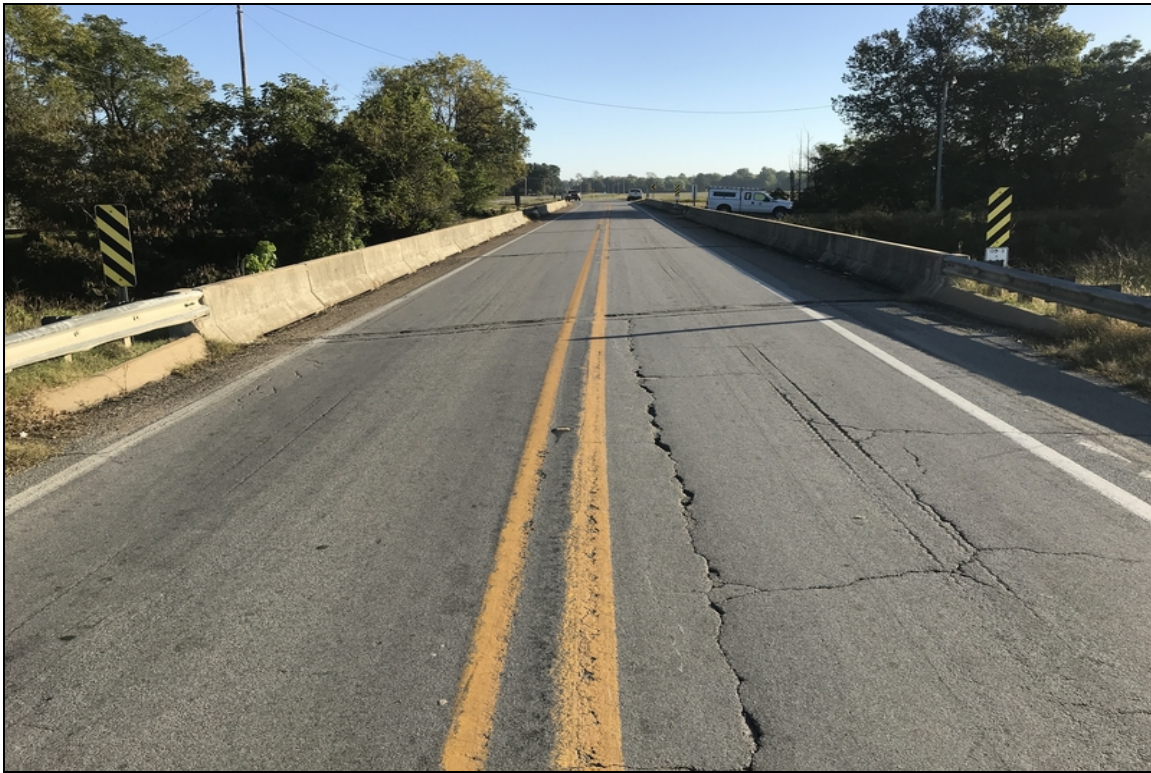
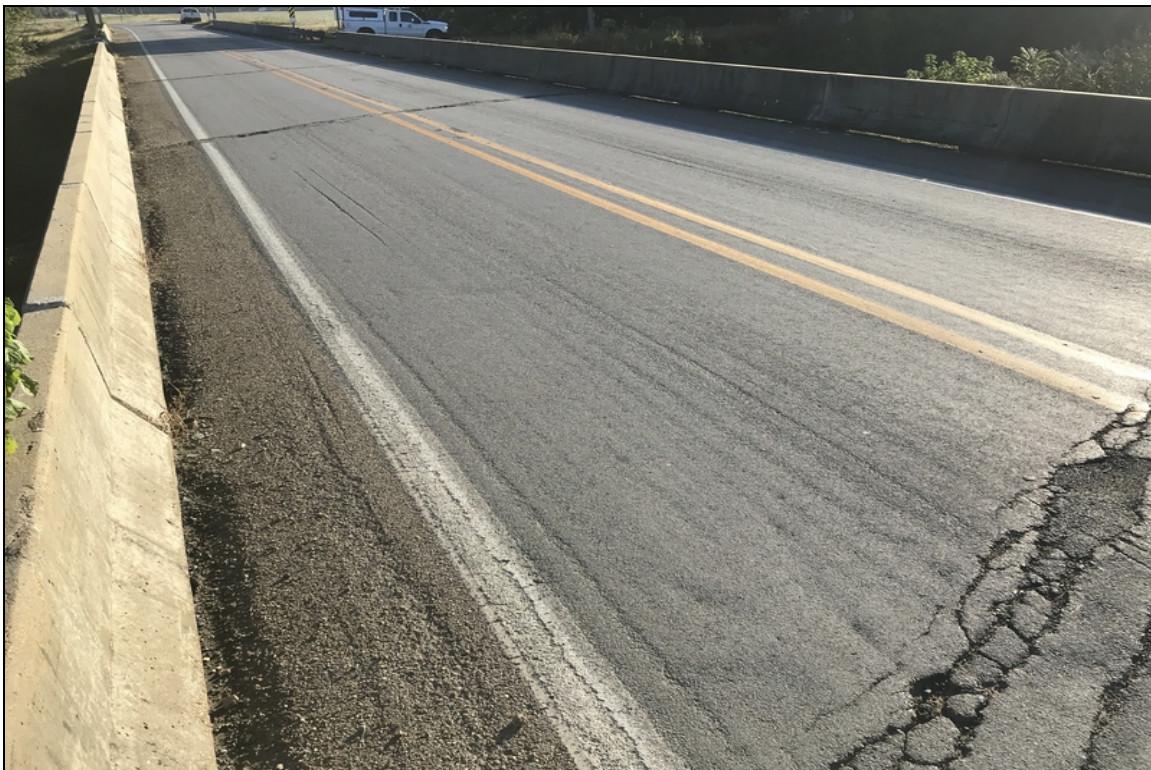
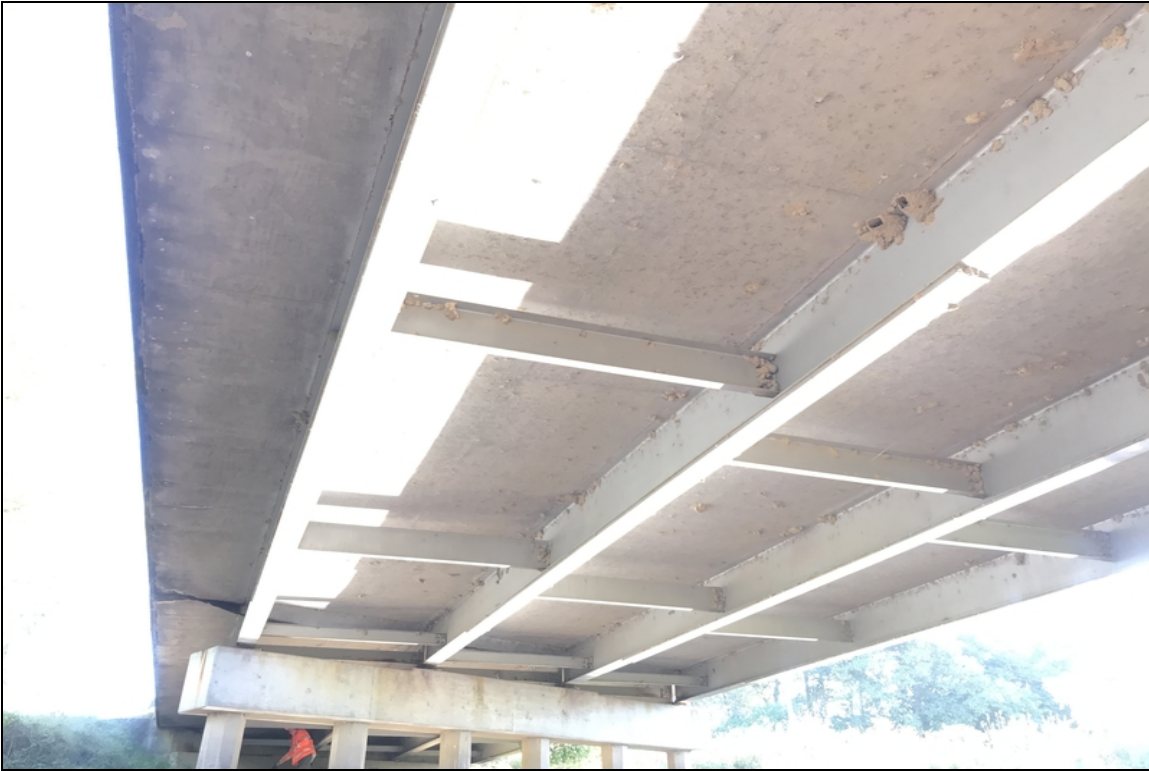
Wearing surface

Asphalt wearing surface has a few longitudinal cracks. Asphalt is raveling out over bents and along gutters.

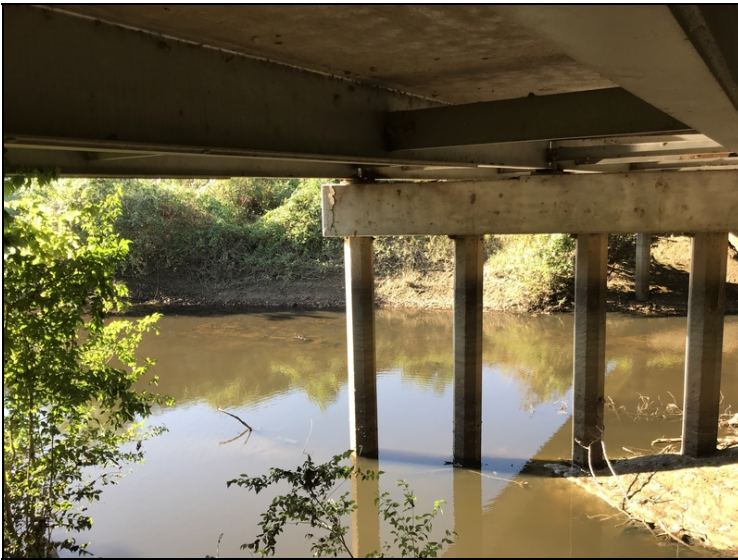
Bents 2 and 3 caps have a few delaminated areas and spalls with exposed rebar, mostly from lack of coverage.

S3 b3 cap delamination and spall

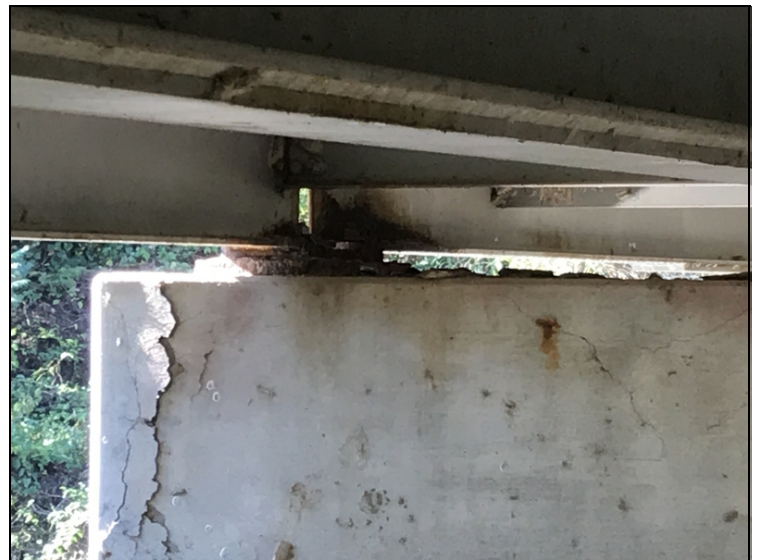
S2 b3 g5 rust for 2'

Ends of steel girders over bents 2 & 3 have areas of flaking rust with some section loss along bottom of web and bottom flange.
