Bridge #05643(Routine, Underwater type 2)

SH 135-03- LM 3.36 over BIG BAY DITCH

Team Lead: Richard Jones Inspection Date: October 13, 2020

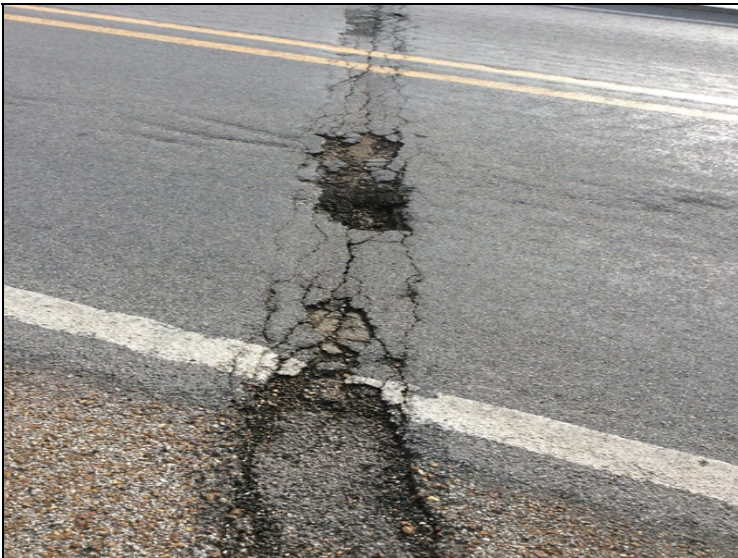
Asphalt wearing surface has a few longitudinal cracks. Asphalt is raveling out over bents and along gutters.
