Bridge #06461 (Routine)  
SH 158-01-LM 11.56 over KOCHTITKI DITCH

Location: 2.7 MI W JCT SH 181

Team Lead: Tim Myrick Inspection Date: February 25, 2021

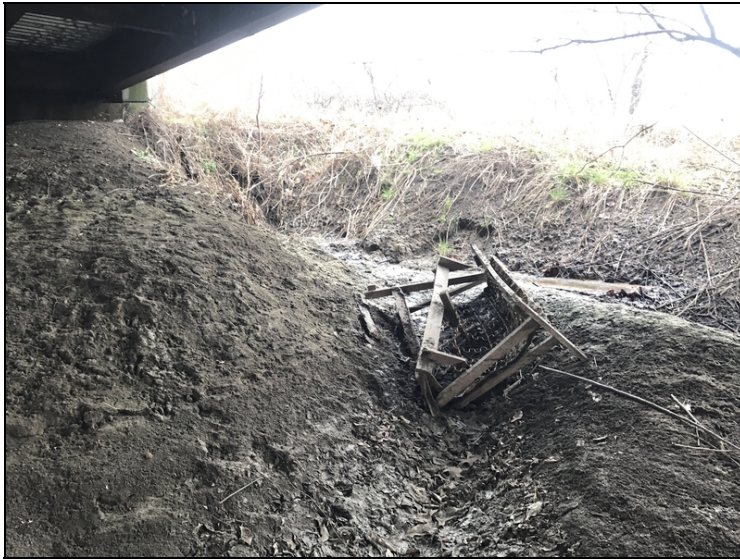
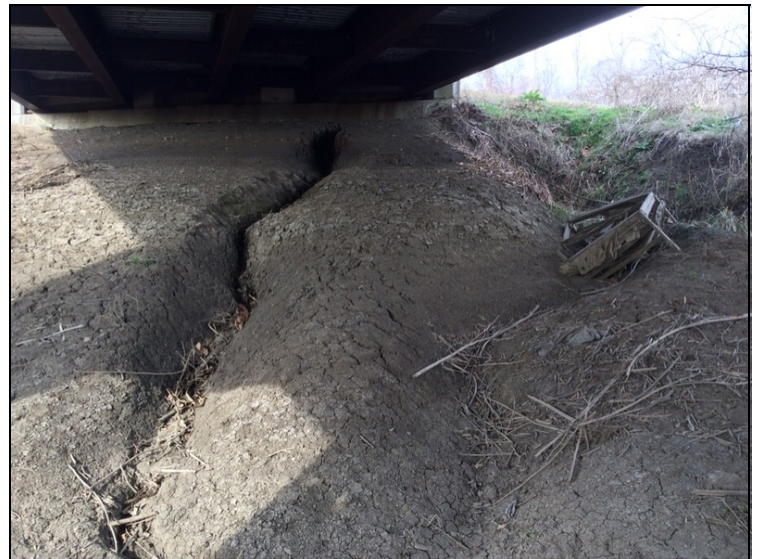
Span 3 RT Side

Erosion under Spans 1&3 due to roadway runoff see 2017 photo of Span 3.  
Moderate erosion beside bridge north side of span 3, see 2019 photo.

Minor Erosion under Spans 1&3 due to roadway runoff, see 2017 photo of Span 3.

Moderate erosion beside bridge north side of span 3, see 2019 photo.

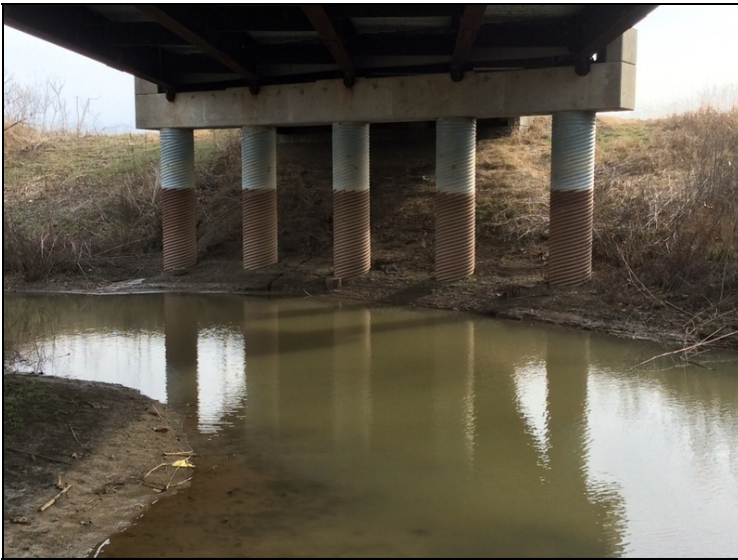
Bents 2&3 Piles Encasements have the bottom 5ft. rusted, see 2017 photo of Bent 2 for typical.

Bents 2&3 Pile Encasements have the bottom 5ft. rusted, see 2017 photo of Bent 2.
