Bridge #06833(Routine)

SH 158-01-LM 12.48 over L. H. Chute of Little R.

Team Lead: Tim Myrick Inspection Date: June 15, 2021

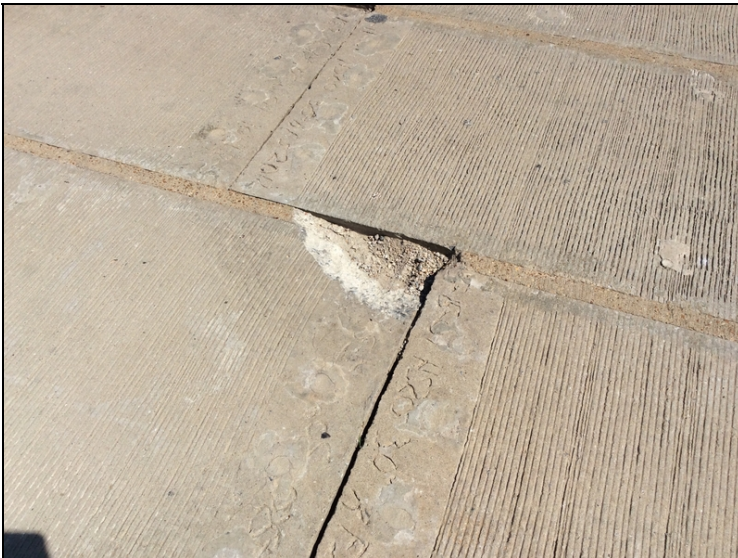
Span 4 unit 4 over bent 4.

Top of deck units, mostly on ends over bents.
Several small popouts and/or shelled out areas

Top of Deck Units has several spalled or delaminated areas and a few areas of grout missing, mostly on ends over bents, some have been repaired with asphalt. Back wall portion of abutments exposed to traffic have spalls with no exposed rebar.

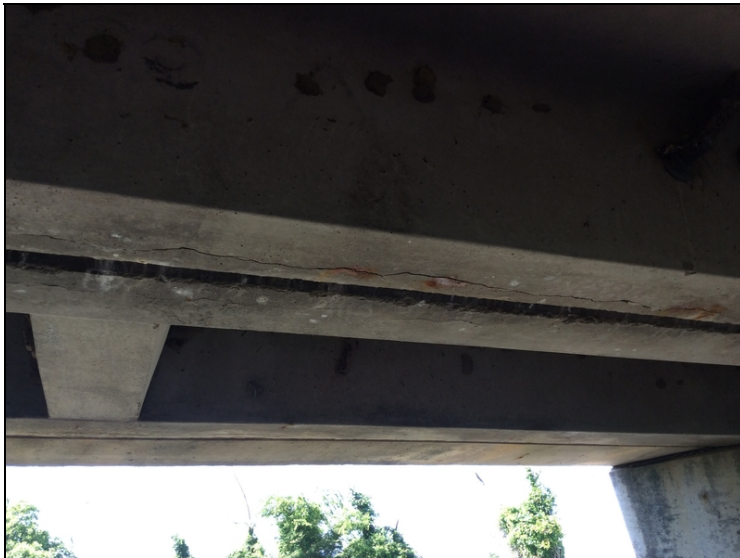
Span 1 unit 2.

Span 1 units 1, 2, 3, 7, 8, & 9 have longitudinal cracks with rust stains.

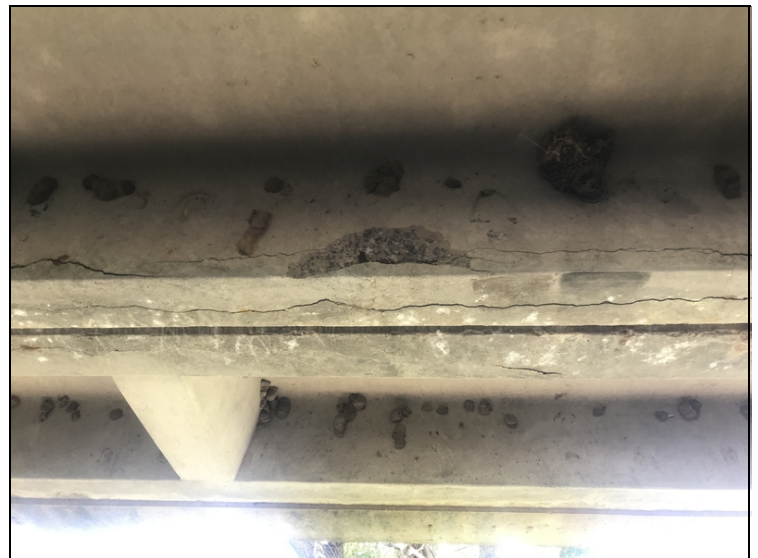
S4 unit 2

Span 4 unit 2 1' x 1' shell out with exposed rebar

Span 4 unit 1, 2, 3, 7, 8, & 9 have longitudinal crack with rust stains.

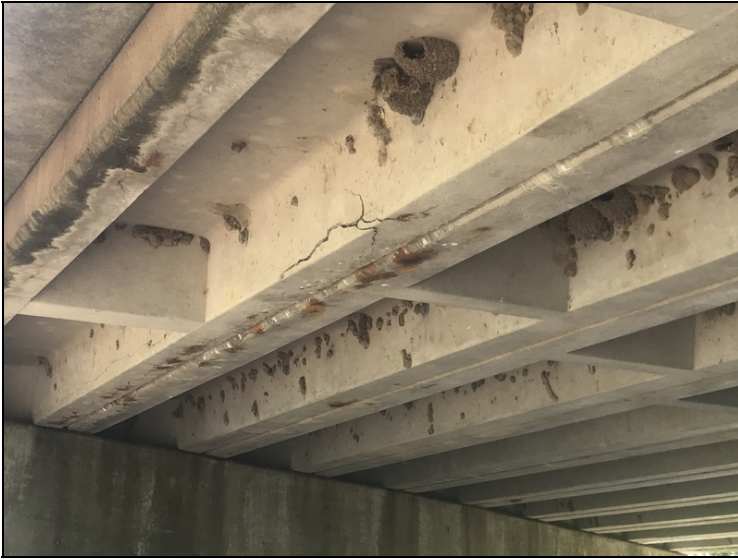
S3 unit 9

Span 3 units 1, 2, 3, 7, 8, & 9 have longitudinal cracks with rust stains.

Span 3 unit 9 large crack mid span.

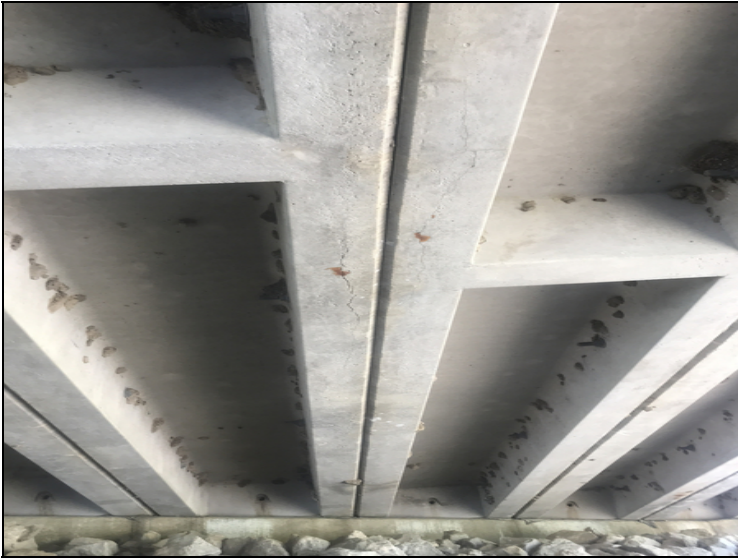
S1 unit 3 @ 4

Span 1 units 4, 5, & 6 have longitudinal cracks.

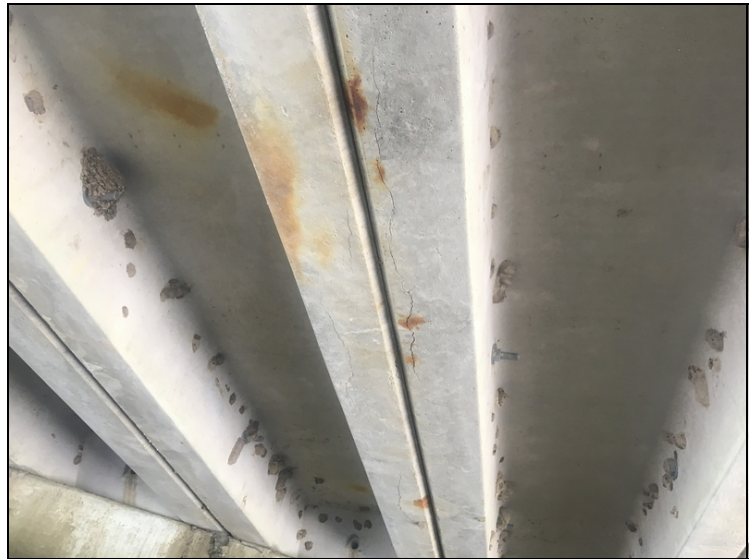
S1 units 6 @ 7

Span 1 unit 7 has a few vertical cracks with efflorescence stains.

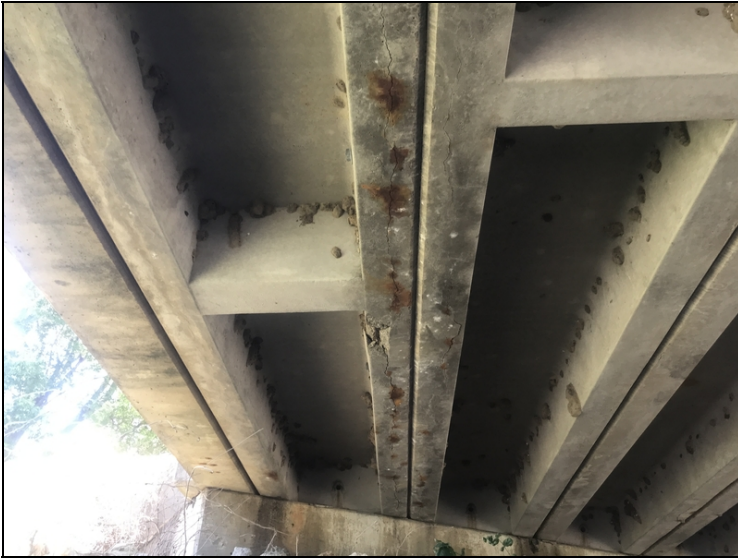
S1 unit 9

Span 1 unit 9 has 1' of exposed rebar.

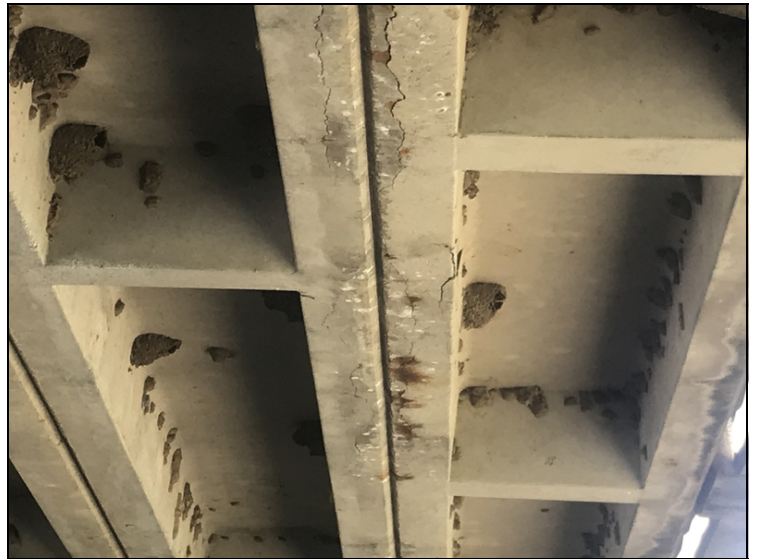
S2 units 8 @ 9

Span 2 units 1, 2, 3, 7, 8, & 9 have longitudinal cracks with rust stains.

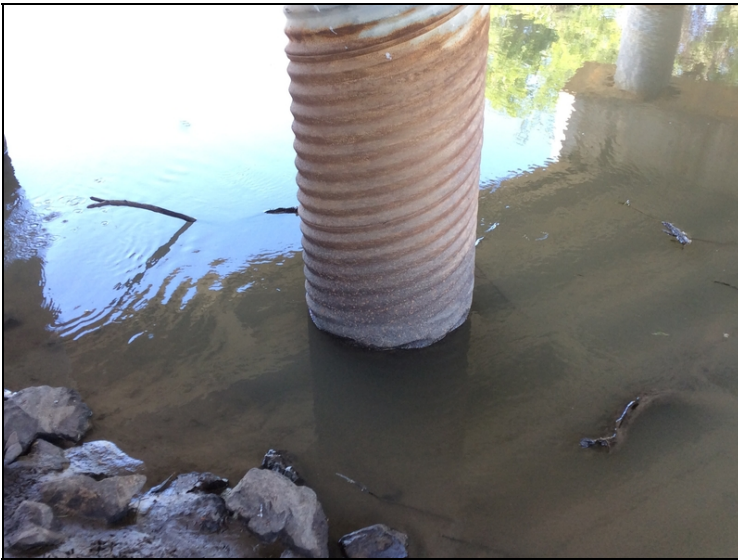
Bent 2 pile 2 pile encasement.

Steel Shell Pile Encasements have some rust forming near ground line.

Steel shell pile encasements have some rust forming near ground line.

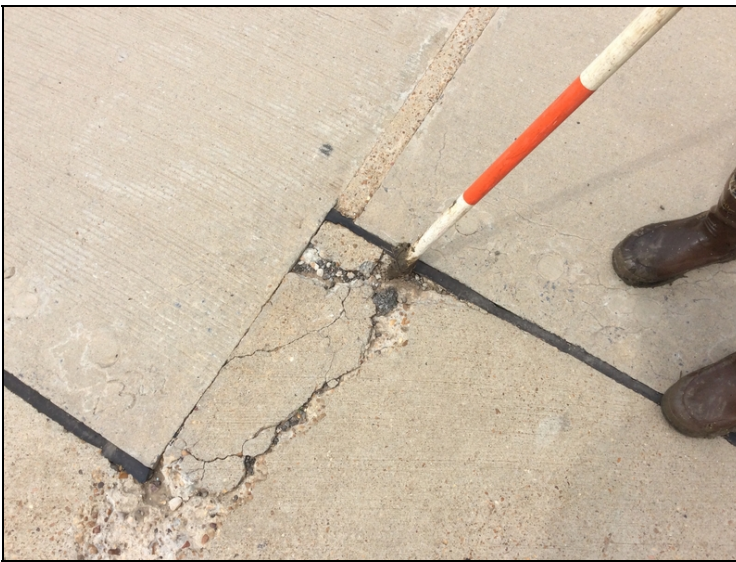
Back wall portion of abutments exposed to traffic have spalls with no exposed rebar (see photo).
