**Bridge #M4039(Routine)**  
**SH 158-01-LM 10.35 over NATIONAL DITCH**

**Location: 2 MI W VICTORIA ARK.**

**Team Lead: Richard Jones Inspection Date: March 01, 2022**

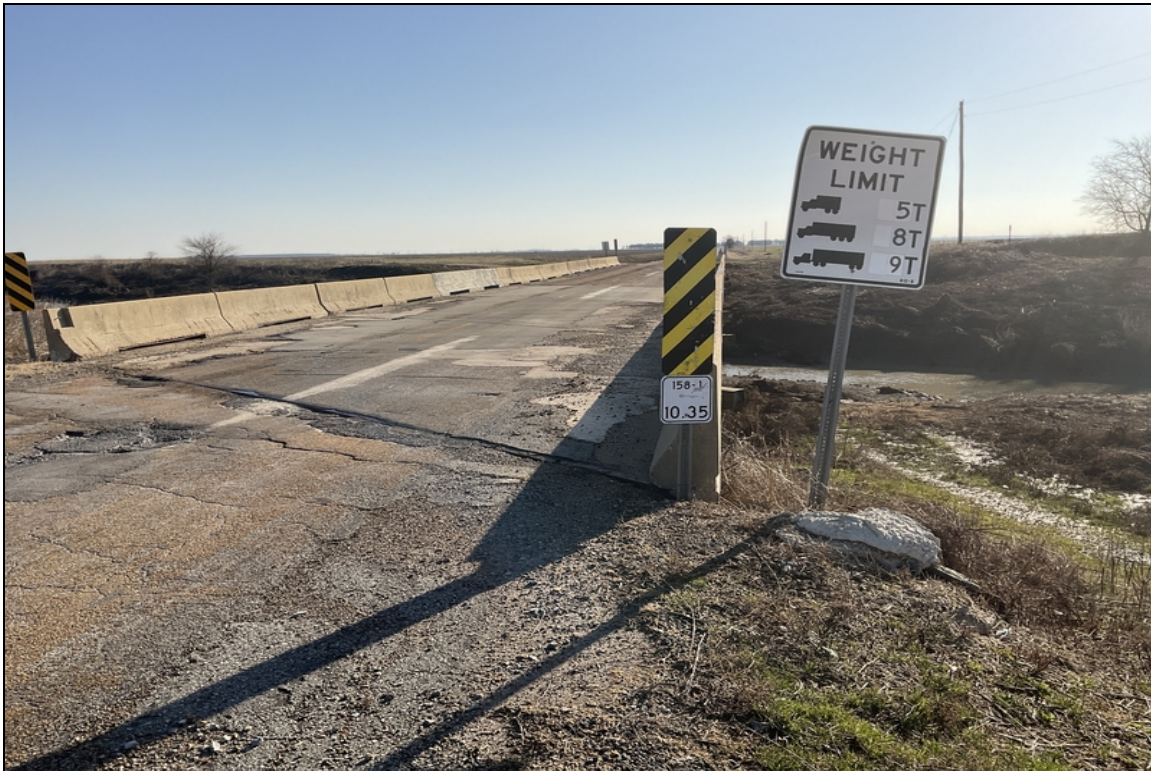
Load posting at beginning

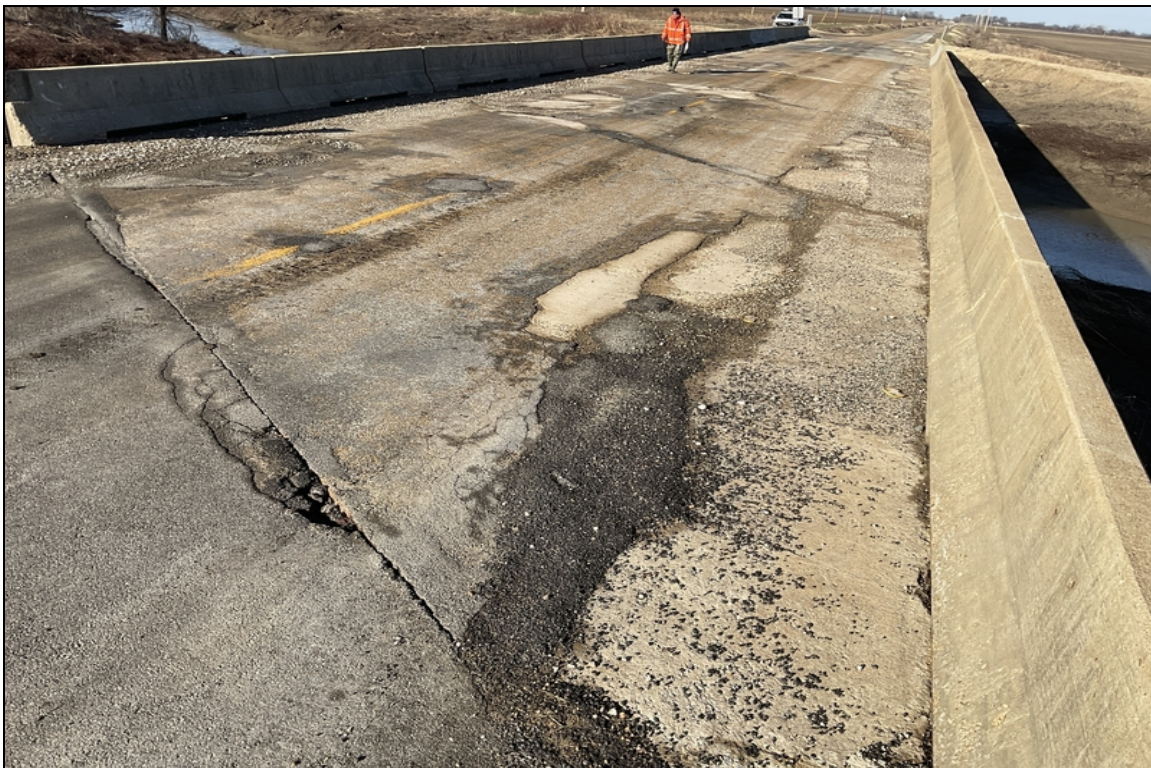
Load posting at end

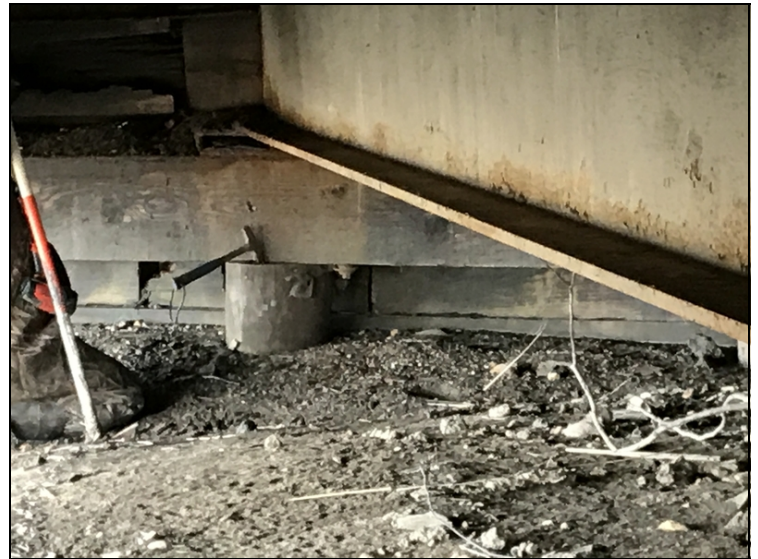
Bent 4 pile 8 has 1" outside decayed with some section loss. (Possible past fire damage.)

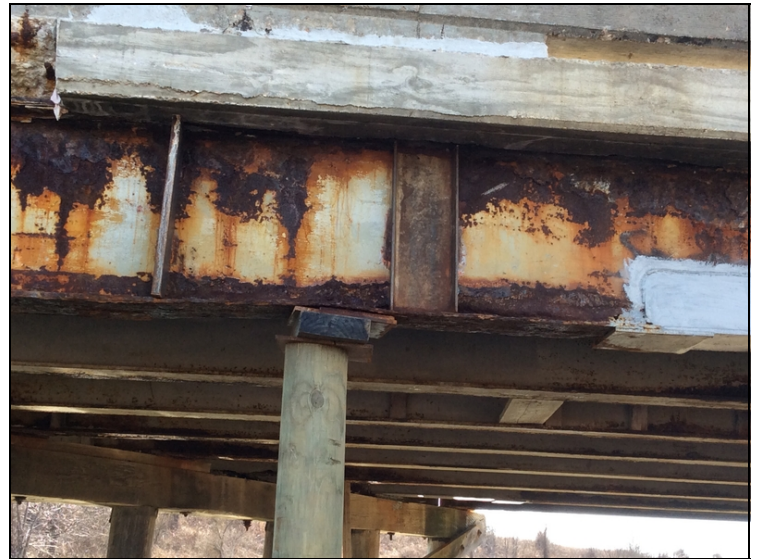
Span 5 girder 8.

Span 5 girders have been spliced & t- spliced. Girder 8 has been replaced. observed during inspection .01-24-2018

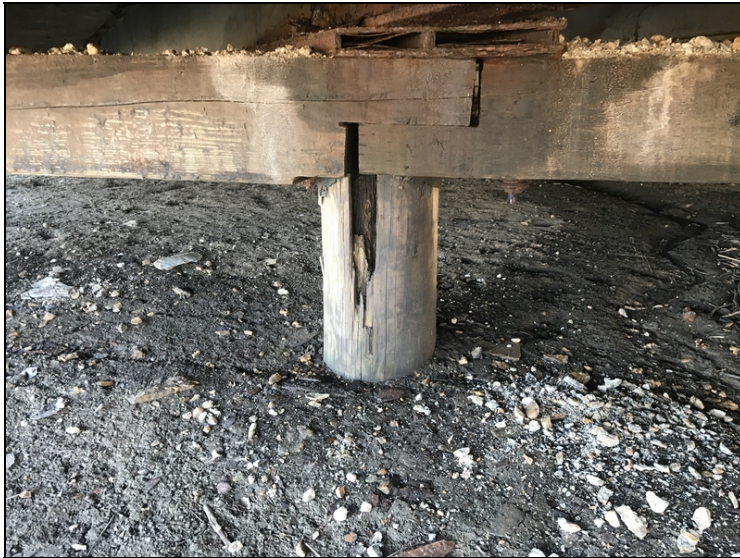
B2 p6

Bent 2 pile 6 has 3" deep outside decay on ahead side. Pile is partially hollow.

to Dist Bridge Crew for repair as priorities allow. 1/30/19 KAW  
10/19/2021 dlvr load rating performed, posting recommended. Signs not updated to date.  
Posting signs are in place. Bridge is under contract to be replaced (100955) RRJ 3/1/22

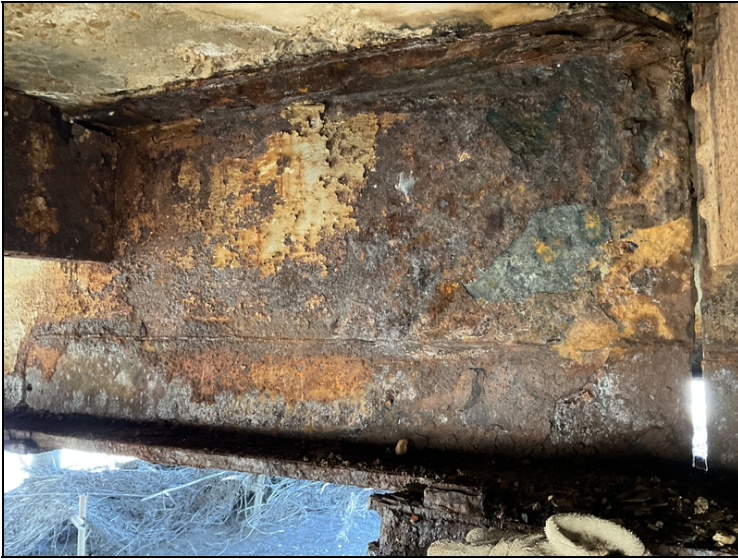
Span 1 bent 1 girder 1 has 2' of heavy section loss. Rt bottom flange is knife edged.  
Span 1 bent 1 girder 5 has heavy section loss along bottom of web. Lt bottom flange is knife edged.  
Span 1 bent 1 girder 7 has an 8" x 3" area of heavy section loss with holes rusted through bottom of web starting 8" from end. Bottom flange is knife edged.  
Span 1 bent 1 girder 8 has heavy section loss at end with holes rusted through web near top flange 9" from end.

Span 1 bent 1 girder 1

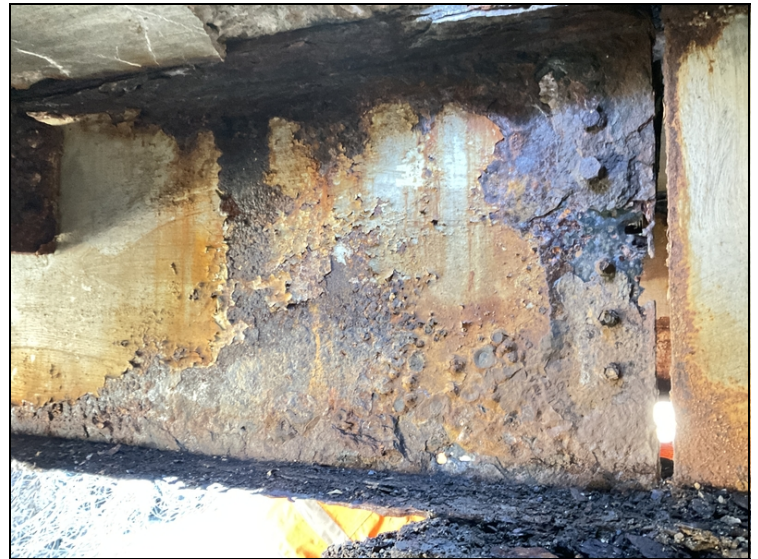
2022 - Span 2 bent 2 girder 5

Span 2 bent 2 girder 5 has 3' of heavy loss with holes rusted through at end of web, diaphragm connection, a 2" x 1" in bottom of web 8.5" from end. Lt bottom flange is knife edged with several holes rusted through.

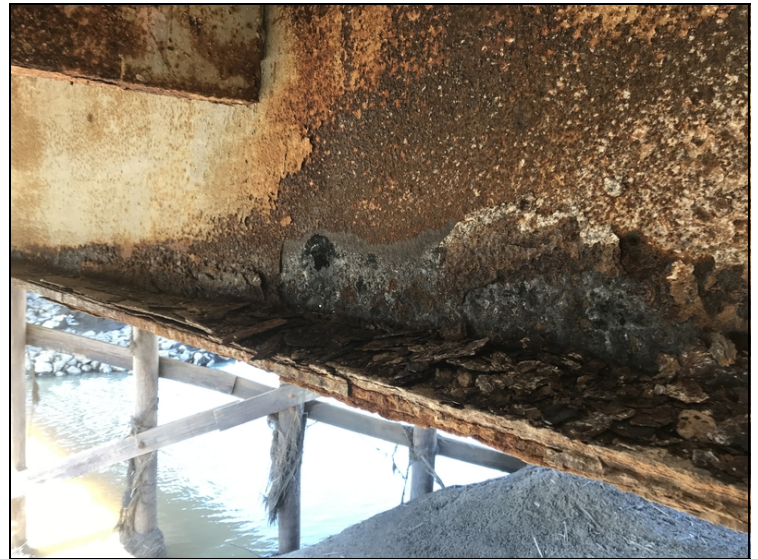
S3 b3 g2

Span 3 bent 3 girder 2 has 34" x up to 5" area of heavy section loss along bottom of web with several holes rusted through.

This bridge scheduled for replacement with numerous others in this area in next year or so. Will keep monitoring as bridge repair schedule is overwhelmed. KAW 4/10/20  
Bridge is under contract 100955 to be replaced. RRJ

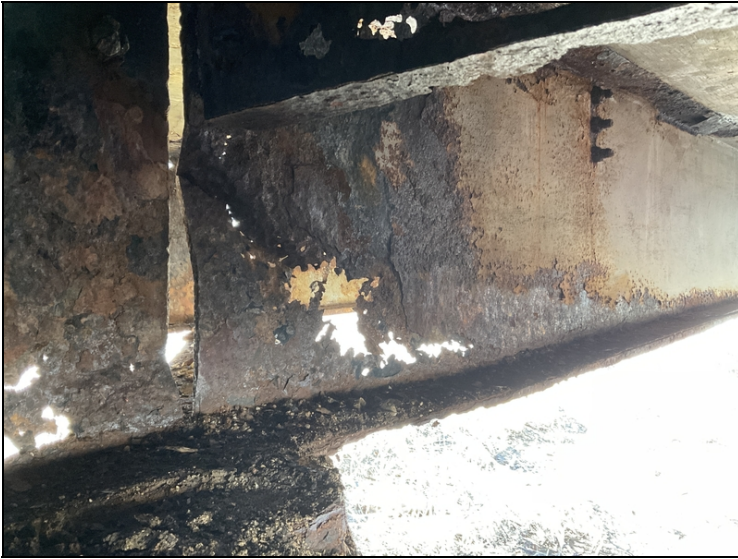
2022 - Span 2 bent 2 girder 2

Span 2 bent 2 girder 2 has a 21" x 5" area of holes, cracked, and crushing at end.
