**Bridge #M1653(Routine)**  
**SH 91-01- LM 3.55 over LINDSEYS CREEK**

**Location: 3.55 MI S JCT US412/91**

**Team Lead: Tim Myrick Inspection Date: November 03, 2021**

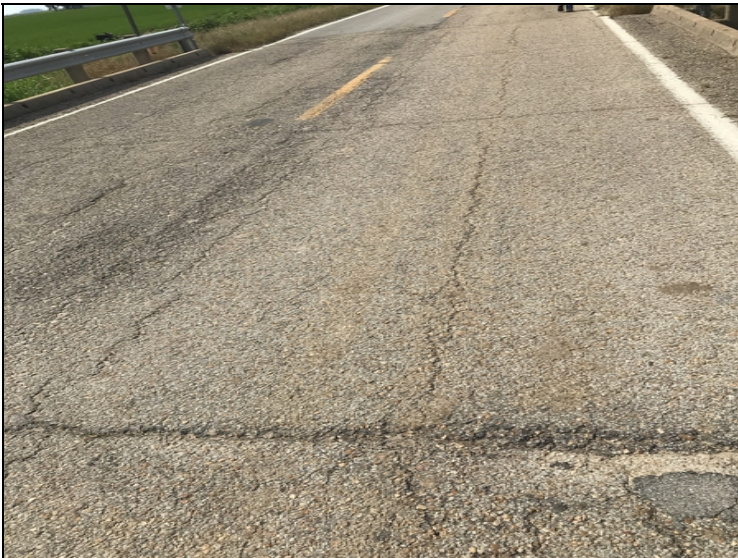
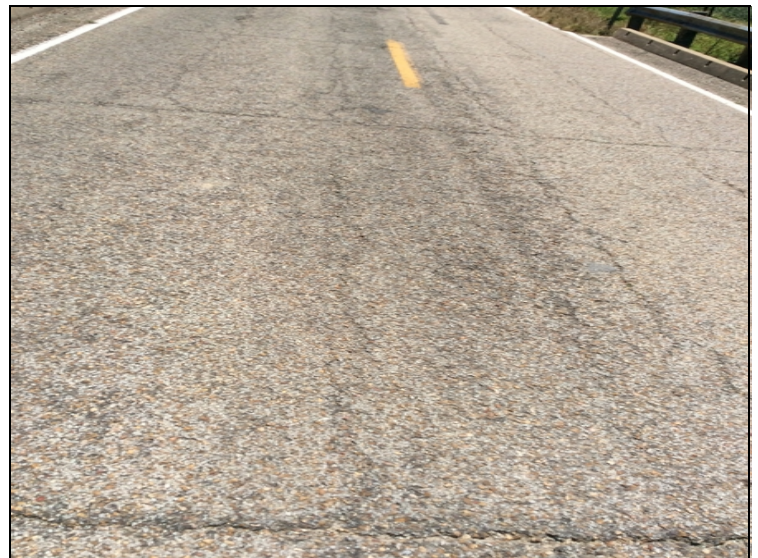
Top of Deck Asphalt Overlay has several open cracks especially over joints and between units, remainder of wearing surface has moderate abrasion.

Bridge is posted correctly.  
Northeast & southwest flareboards are missing.  
Steel Bridge Rail has rust with some pitting.  
Top of Deck Asphalt Overlay has several open cracks especially over joints and between units, remainder of wearing surface has moderate abrasion.

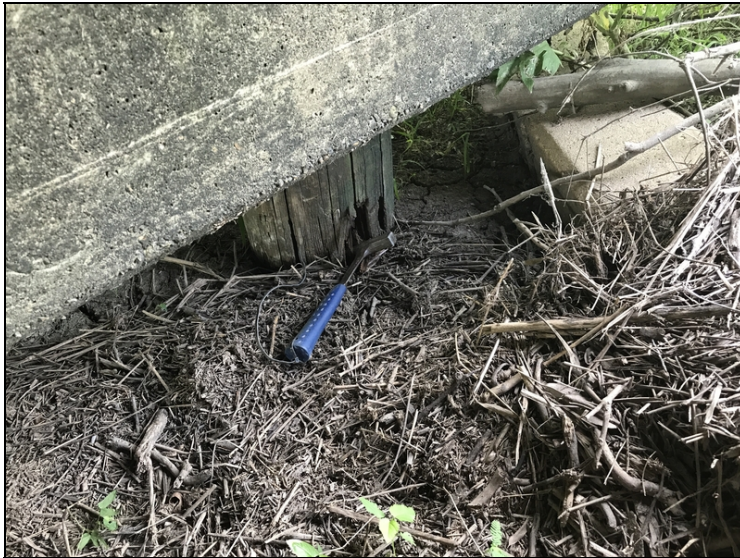
Bent 2 pile 5

Majority of Piles have some decay with checks and shakes. Some Piles have 1 to 2in. outside decay with some section loss.

Majority of Piles have some decay with checks and shakes. Some Piles have 1 to 2 in. outside decay with some section loss.

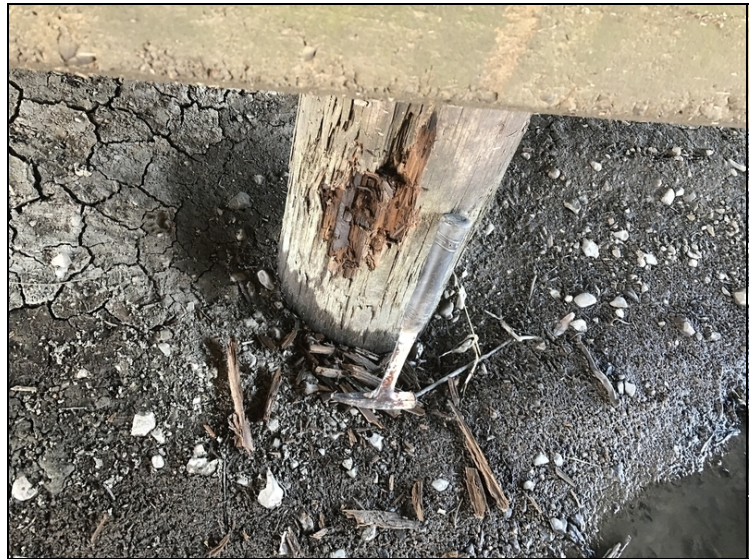
Bent 3 pile 3 2020

Bent 3 piles 3,4 & 5 have up to 2 in. outside decay.

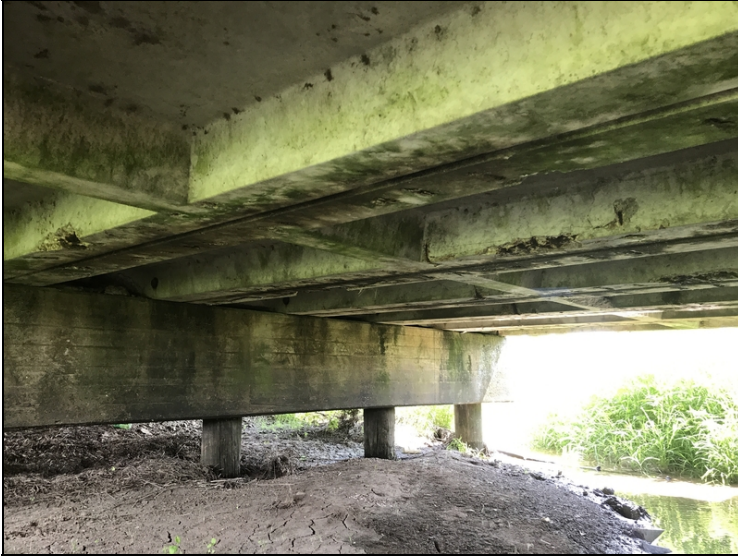
Span 2 soffit

Girder portion of Deck Units have a few small shelled out areas with exposed rebar due to inadequate coverage from steel replacement.

Span 2 Unit 1 has 15LF exposed rebar.  
Span 2 Unit 2 has 15LF exposed rebar.  
Span 2 Unit 3 has 15LF exposed rebar.  
Span 2 Unit 4 has 15LF exposed rebar.  
Span 2 Unit 5 has 13LF exposed rebar.  
Span 2 Unit 6 has 12LF exposed rebar.  
Span 2 Unit 7 has 15LF exposed rebar.

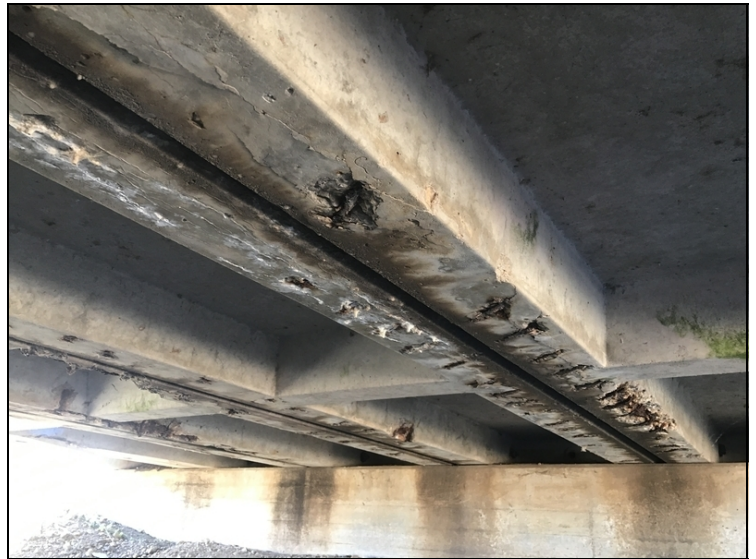
Span 3 soffit 2020

Span 3 Unit 1 has 10LF exposed rebar and 2LF of delamination.  
Span 3 Unit 2 has 4LF of cracks and 10LF exposed rebar.  
Span 3 Unit 3 has 3LF of cracks and 10LF exposed rebar.  
Span 3 Unit 4 has 12LF exposed rebar, and 2ft of efflorescence.  
Span 3 Unit 5 has 14LF exposed rebar.  
Span 3 Unit 6 has 14LF exposed rebar.  
Span 3 Unit 7 has 14LF exposed rebar.
