Route:34 Section:03 Log:11.1

Bridge #M0774(Routine)
SH 34-03- LM 11.10 over CREEK
Location: 1.5 MI E OF BEECH GROVE

Team Lead: Tim Myrick Inspection Date: February 01, 2022

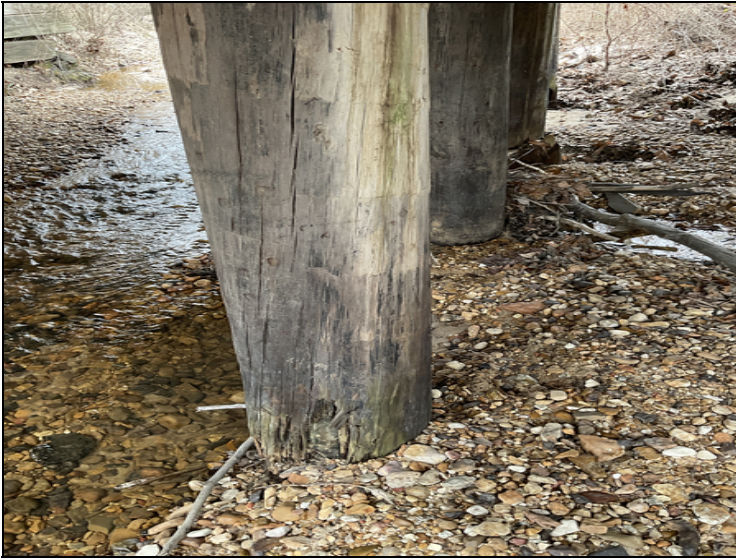
B2 p2

Bent 2 pile 2 has 2" outside decay near groundline.
Bent 3 pile 4 is decayed and partially hollow.

Bent 1 is undermined up to 1.5 ft. below cap and 3 ft. back under on left end. Rip rap is in place on slope.
Timber piles have several checks.
Bent 2 pile 2 has 2 in. outside decay near ground line.
Bent 2 pile 4 has 1" outside decay bottom 1' at ground line.
Bent 2 pile 5 is decayed and hollow with solid 2" core.
Bent 3 cap has a few horizontal cracks and honeycombed areas near bottom of cap with a 2' x 2' delamination area at old patch over pile 3.
Bent 3 cap is undermined 4 ft. below cap.
Bent 3 Timber back wall in place holding back fill. Backwall has some decay throughout , especially top to timber boards..
Bent 3 pile 4 is decayed & partially hollow.
Trees & brush in channel.

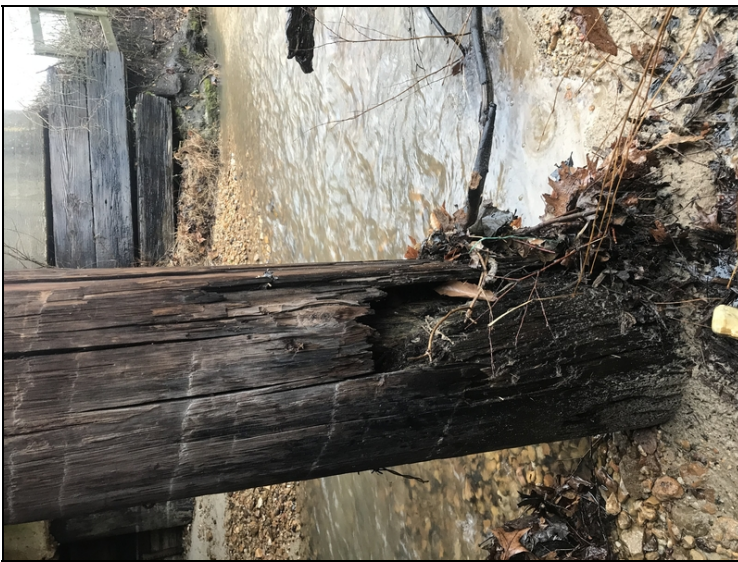
Bent 2 pile 5 is decayed and hollow with solid core.

to Dist bridge crew for repair when work schedule allows KAW 2/12/2020

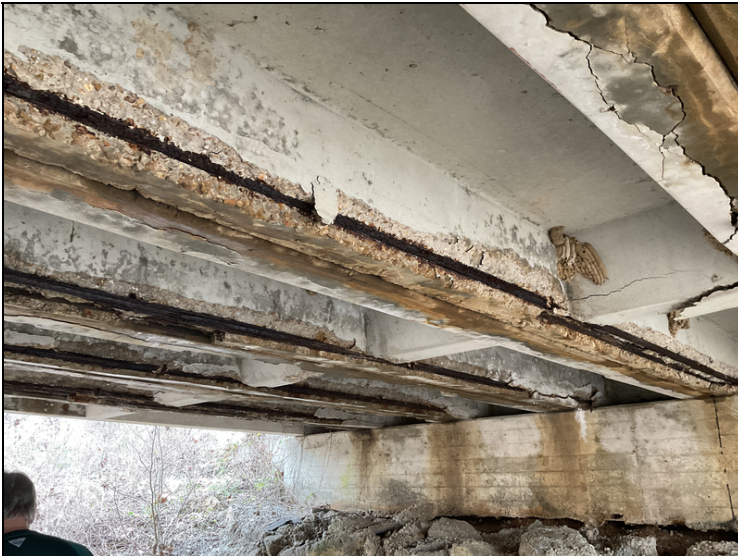
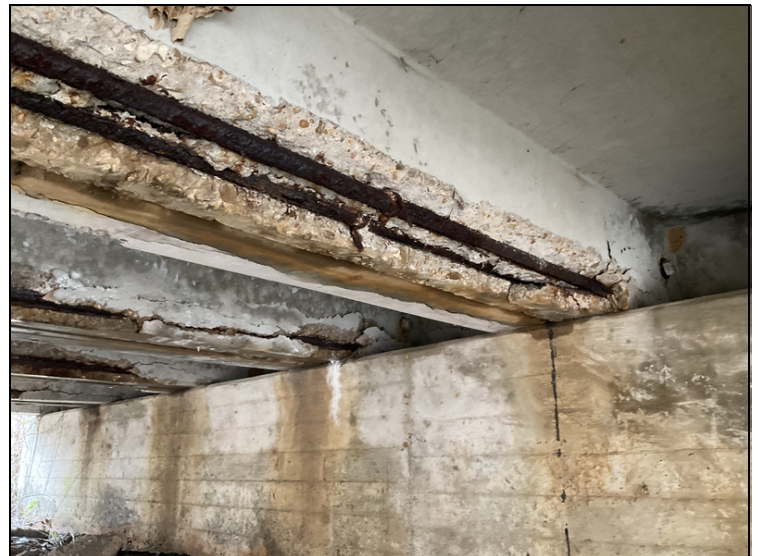
S1 B1 u3

Span 1 units 4 and 6 have some minor hairline cracks. Some rebar has up to 50% section loss.
Some rebar has 2' - 8' completely lost of bond with concrete.
Span 1 unit 3 has 15 ft. of exposed rebar. Approx. 9 ft. of rebar has lost bond with concrete. Remainder of unit has cracked and delaminated areas.
Span 1 unit 4 has 19 ft. of exposed rebar. Approx. 7 ft. of rebar has lost bond with concrete.
Span 1 unit 5 has 17 ft. of exposed rebar. Approx. 5 ft. of rebar has lost bond with concrete. Remainder of unit has cracked and delaminated areas.
Span 1 unit 6 has 19 ft. of exposed rebar. Approx. 18 ft. of rebar has lost bond with concrete.
Span 2 unit 3 has 19 ft. of exposed rebar. Approx. 9 ft. of rebar has lost bond with concrete.
Span 2 unit 6 has 19 ft. of exposed rebar. Approx. 8 ft. of rebar has lost bond with concrete. Remainder of unit has cracked and delaminated areas.
Span 2 unit 7 has 13 ft. of exposed rebar, 6 ft. cracked and delaminated. 3 ft. of rebar has lost bond from concrete.

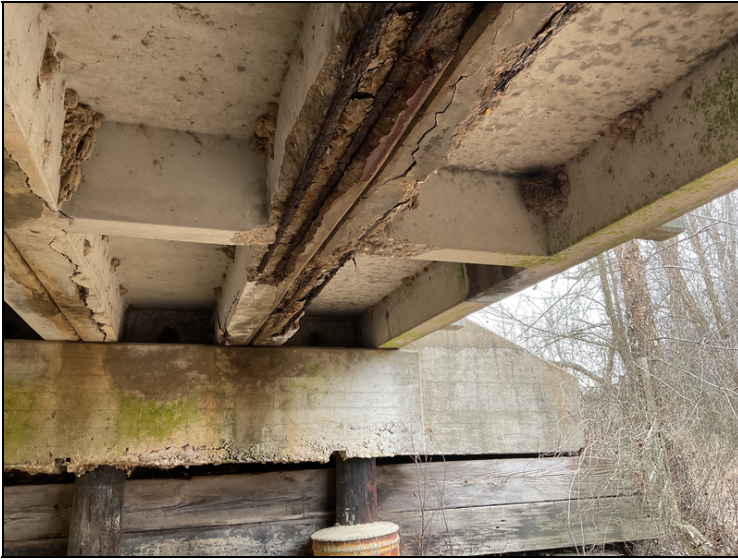
S2 b3 u6&7

Span 2 unit 2 has 7 ft. of exposed rebar, 12 ft. cracked and delaminated.
Span 2 unit 3 has 19 ft. of exposed rebar. Approx. 9 ft. of rebar has lost bond with concrete.
Span 2 unit 4 has 5 ft. of exposed rebar, 14 ft. cracked and delaminated.
Span 2 unit 5 has 4 ft. of exposed rebar, 15 ft. of cracking.
Span 2 unit 6 has 19 ft. of exposed rebar. Approx. 8 ft. of rebar has lost bond with concrete. Remainder of unit has cracked and delaminated areas.
Span 2 unit 7 has 13 ft. of exposed rebar, 6 ft. cracked and delaminated. 3 ft. of rebar has lost bond from concrete.

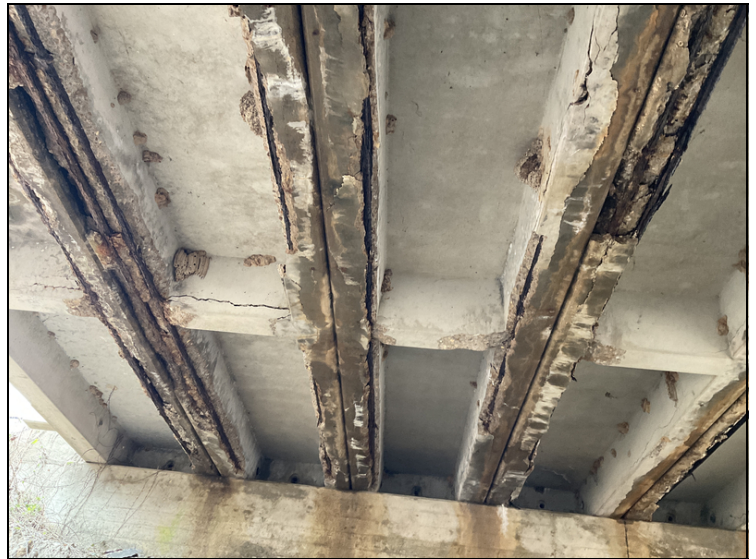
S1 b1 u7-4

Span 1 unit 2 has 10 ft. of rebar exposed, and 9 ft. cracked and delaminated.
Span 1 unit 7 has 19 ft. of exposed rebar.
Span 2 unit 2 has 7 ft. of exposed rebar, 12 ft. cracked and delaminated.
Span 2 unit 4 has 5 ft. of exposed rebar, 14 ft. cracked and delaminated.
Span 2 unit 5 has 4 ft. of exposed rebar, 15 ft. of cracking.
