Bridge #M0775(Routine)
SH 34-03- LM 14.99 over LOCUST CREEK
Location: 1.65 MI W JCT SH 135 & 34

Team Lead: James Adams Inspection Date: December 07, 2020

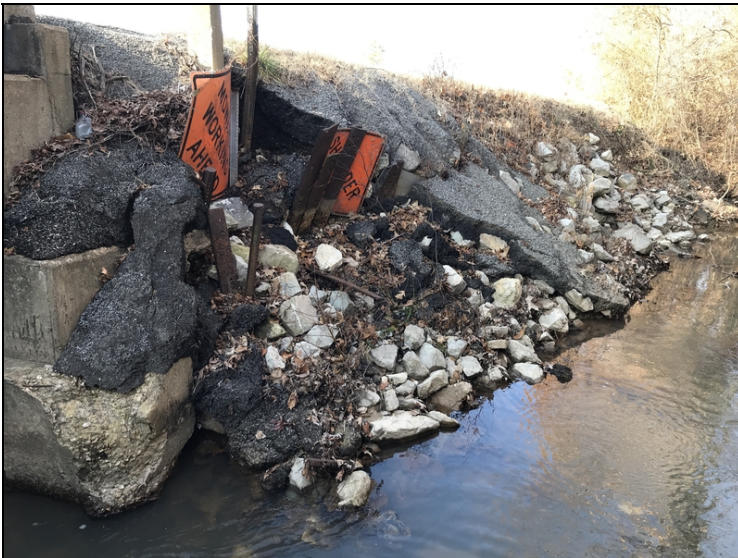
Bent 1 abutment is undermined for 7' on Lt end up to 1.5' below and 2' back under. Abutment 1 near centerline has 9' undermined up to 1' below and 2' back under.

Concrete abutments have a few vertical cracks under girders and a few honeycombed areas.
Bent 1 abutment is undermined for 7 ft. on left end up to 1.5 ft. below and 2 ft. back under.
Asphalt and rip rap have been placed on slope behind abutment at Bent 1 left end, repair has some minor undermining.
Abutment 1 near centerline has 9 ft. undermined up to 1 ft. below and 2 ft. back under.
Bent 2 abutment is undermined up to 2 ft. below abutment for entire length, but has riprap in place on slope in front of abutment.
Bent 2 exposed timber piles have minor checks.

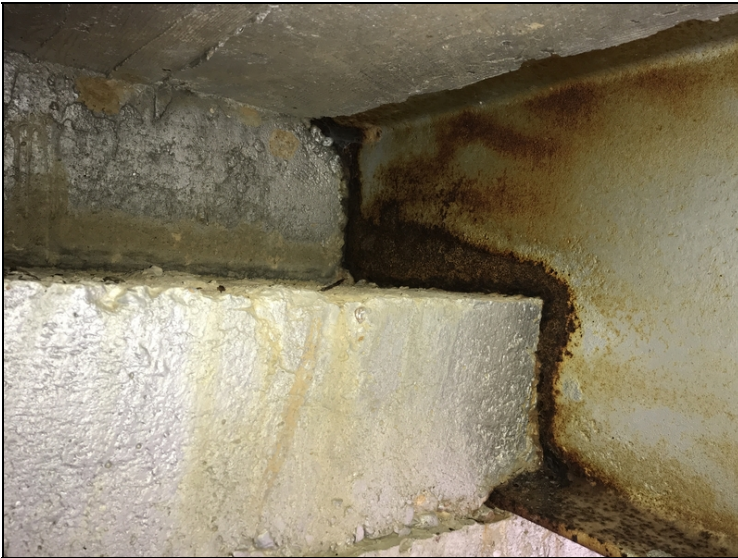
Bent 2 Girder 12

Girders have areas of section loss along edge of concrete diaphragm/encasement over bents 1 and 2.
Bent 1 girders 1, 2, 4, 5, 12, and 13 have up to 1/8" section loss.
Bent 2 girders 9 – 13 have up to 1/8" section loss.
