Bridge #06501 (Routine)
US 49-02- LM 20.39 over VILLAGE CREEK
Location: 3.61 M N OF CRAIGHEAD CO

Team Lead: Tim Myrick **Inspection Date:** August 16, 2021

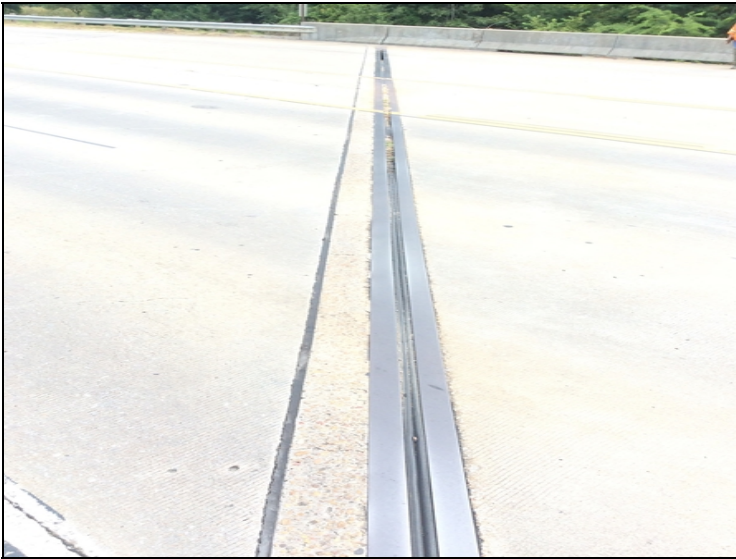
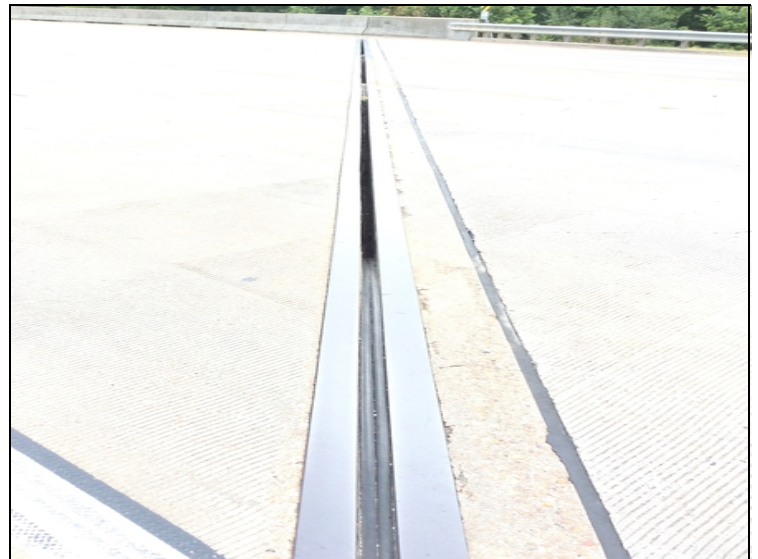
Date Reported: 08/15/2011
Priority: C - Important
Type of Work: Repair
Status: Monitor
Component: 302 - Compression Joint Seal

Compression seals at bents 1 and 4 are losing adhesion, and falling out of joint, steel armor plate is rusted with measurable section loss where joint has dropped.

Approach slabs have several wide unsealed cracks.
Approach slab on bent 1 end has a minor spall.
Approach slab on bent 4 end has a 10' by up to 1" wide crack with spalling .
Deck has several minor unsealed cracks.
Compression seals at bents 1 and 4 are losing adhesion, and falling out of joint.
Steel armor plates where seals have dropped are rusted with measurable section loss.
