Bridge #00830(Routine, Underwater type 2)

SH 90-04-LM 5.33 over POST OAK DITCH

Location: 2.0 Mi. SW Delaplaine

Team Lead: James Adams **Inspection Date:** September 15, 2020

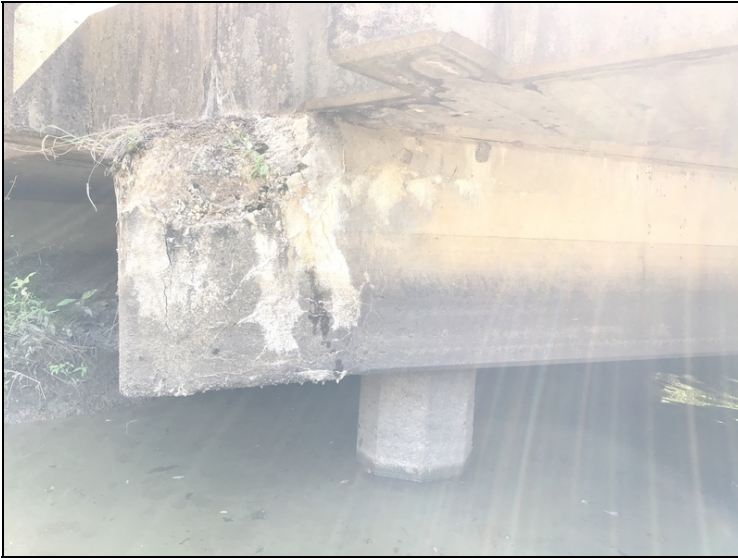
Bent 2 Rt

Caps have heavy deterioration on Rt end with efflorescent cracks and some concrete disintegration.

Caps have heavy deterioration on right ends with efflorescent cracks and some concrete disintegration.
