Bridge #03008(Routine, Underwater type 2)

SH 163-04- LM 5.56 over BIG CREEK

Location: 5.56 N JCT OF SH 14

Team Lead: James Adams **Inspection Date:** February 11, 2020

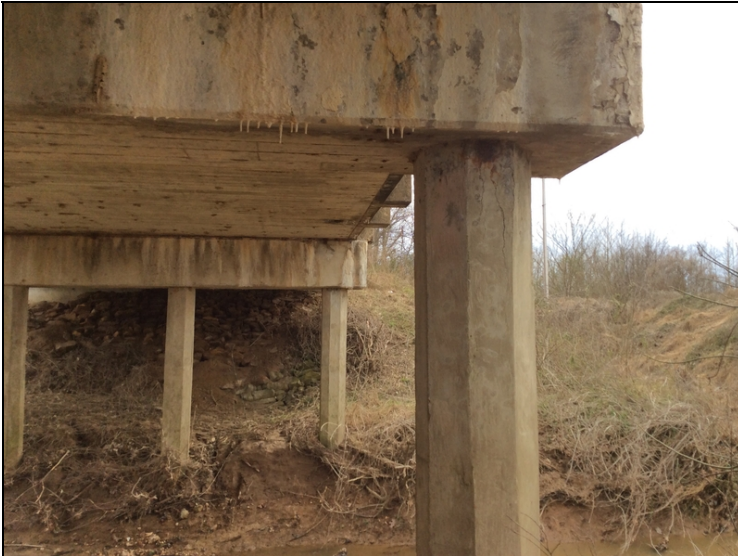
Caps have a few cracks with efflorescence and some rust stains. Caps have a few small spalls/delaminated areas.

Bent 2 pile 1 has 2' of cracks and delamination near top.

Bent 3 pile 1 has 2' of rust stained cracks near top.

Caps have a few cracks with efflorescence and some rust stains with a few spalls & delaminated areas. Bent 3 cap span 3 side has a 10 ft. horizontal crack with efflorescence & rust stains near top of cap. Bent 2 pile 1 has 2 ft. of cracks and delamination near top. Bent 3 pile 1 has 2 ft. of rust stained cracks near top.

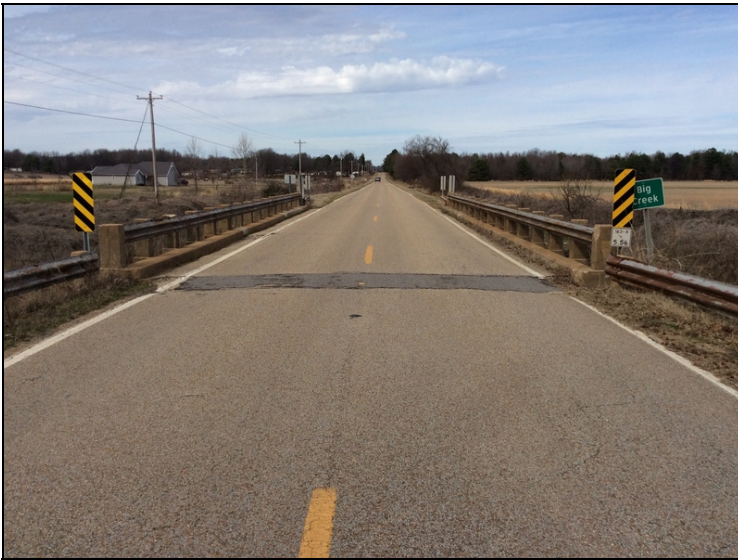
Approach roadways have up to 1.5" of settlement at each end of bridge.
