Asset #03180(Routine)

SH 181-00- LM 2.19 over I 55-SEC 12

Location: 2 MI E OF BASSETT

Team Lead: Richard Jones, Inspection Date: 08/18/2022

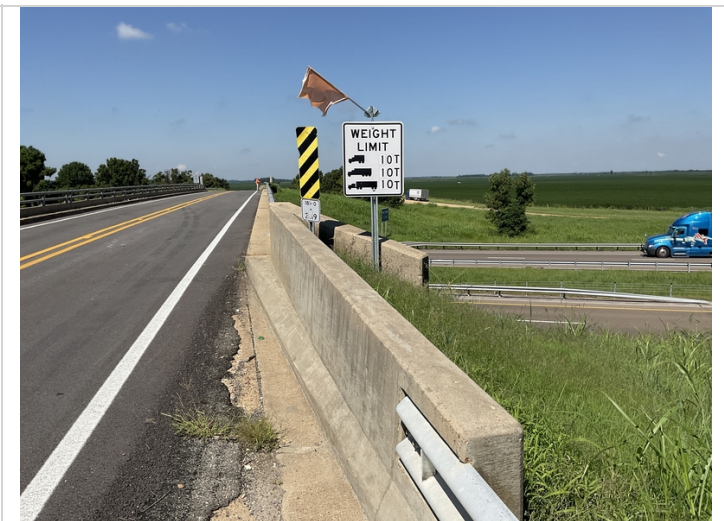
Load posting at beginning

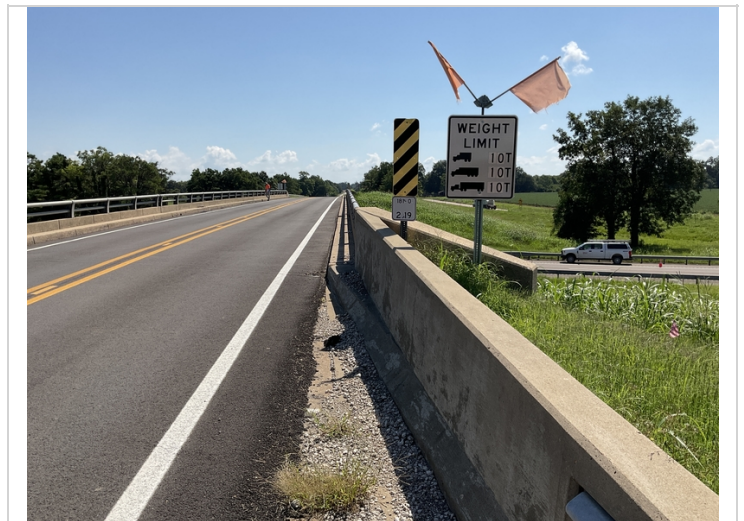
Load posting at end

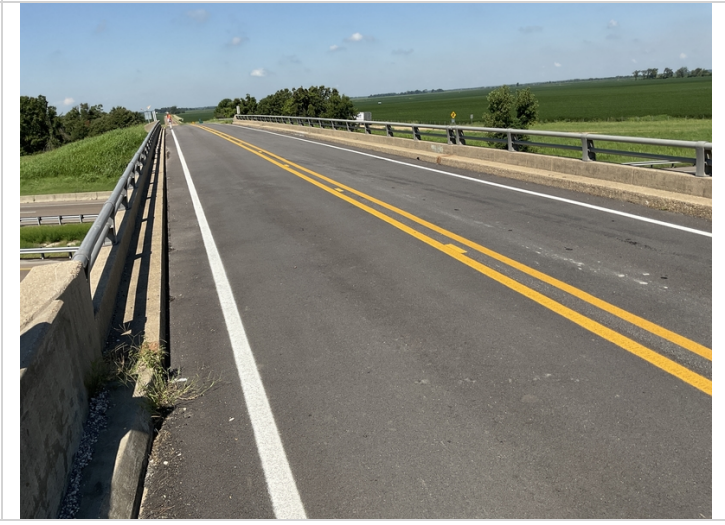
Wearing surface is cracked over bent 2 joint.

Wearing surface

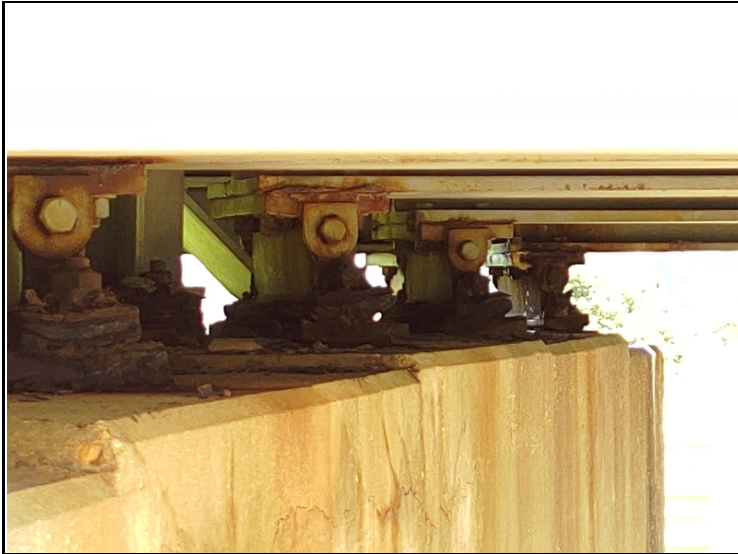
Span 3 bent 4 rockers

Span 3 bent 4 bearing 4 sole plate "ears" are bowed from pack rust at cap screw connection.

Bearings have pack rust and section loss.
Span 1 bent 2 bearing 3 is missing 1 anchor bolt.
Span 2 bent 2 bearings 3 and 4 are each missing 1 anchor bolt.
Span 3 bent 4 bearing 4 sole plate "ears" are bowed from pack rust at cap screw connection.
Span 3 bent 4 bearing 5 is missing a cap screw on Lt side.
Span 4 bent 4 bearings 2 and 3 have a 1/4" gap between bearing and masonry plate.

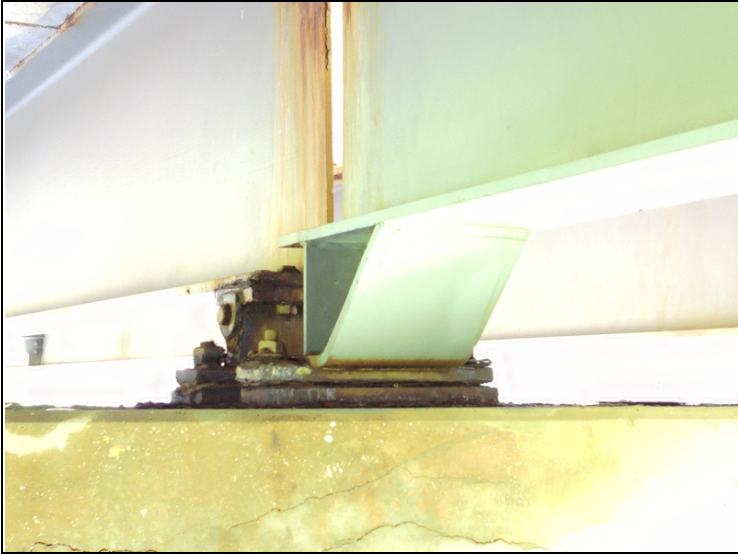
Bent 4 bearing 2

Span 4 bent 4 bearings 2 and 3 have a 1/4" gap between bearing and masonry plate.

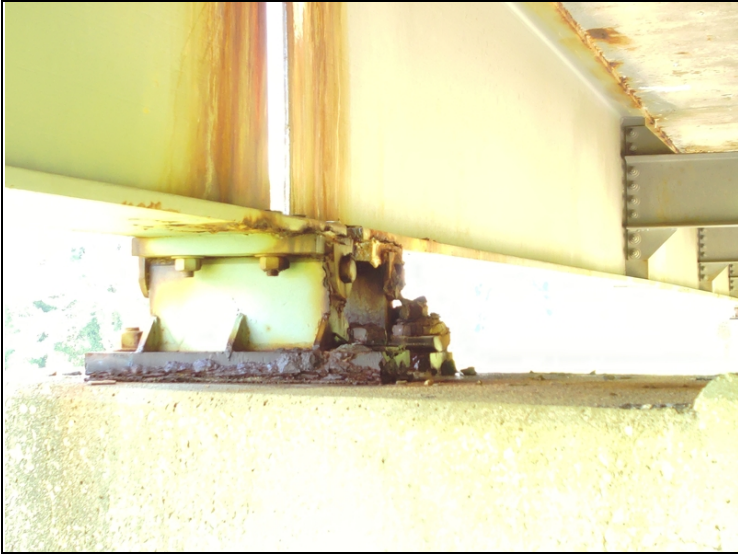
Bent 4 bearing 5

Span 3 bent 4 bearing 5 is missing a cap screw on Lt side.

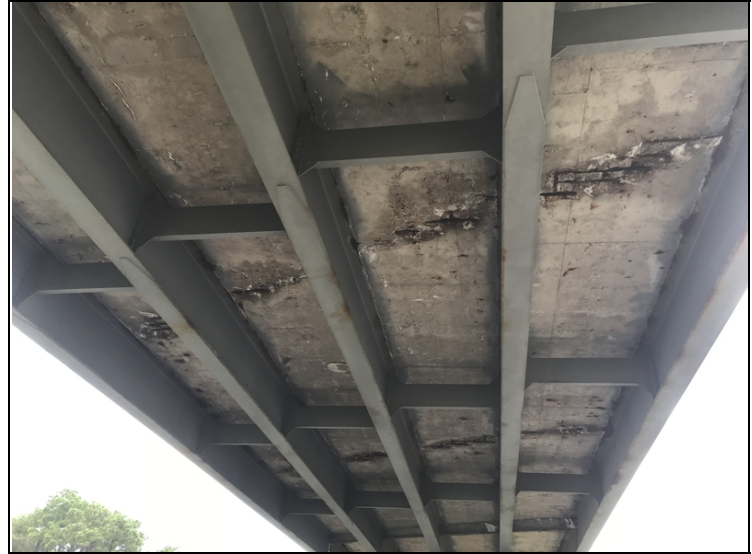
S2

Soffit has several areas of map cracking. Some areas have efflorescence or rust stains.
Soffit at spans 2 and 3 have 2 spalls with rebar exposed that run from exterior girder to exterior girder along the skew.
Spans 2 and 3 have considerable leakage with some efflorescent staining on under structure routes. North bound and South bound exterior lanes each have stains.

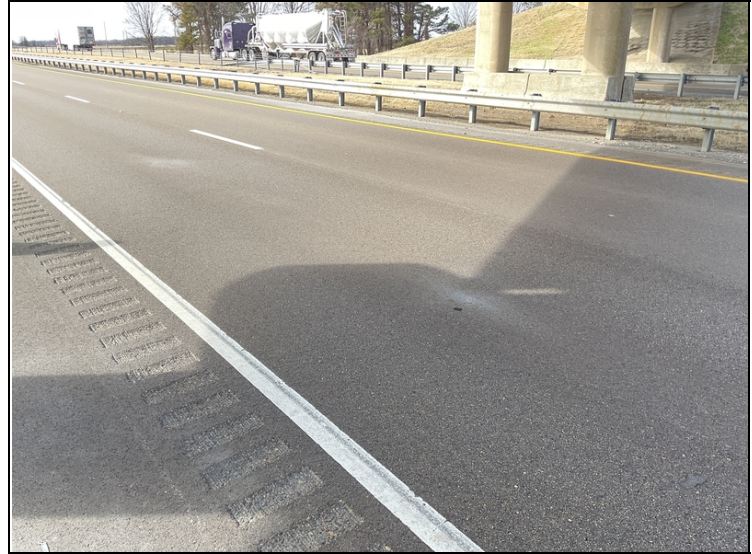
1/28/22 - Span 2 under route (North bound)

Spans 2 and 3 have considerable leakage with some efflorescent staining on under structure routes. North bound and South bound exterior lanes each have stains.

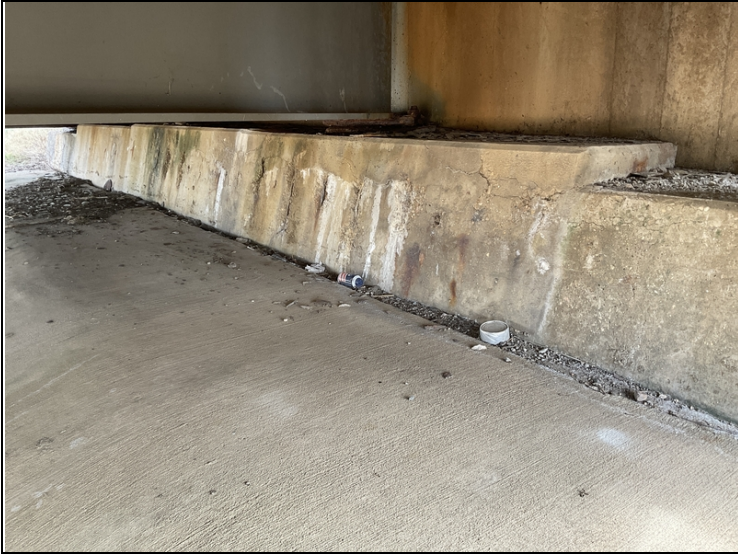
Bent 1 abutment has horizontal cracks with some efflorescence and rust stains along front face of cap. Front face has spalls with rebar exposed from lack of coverage.

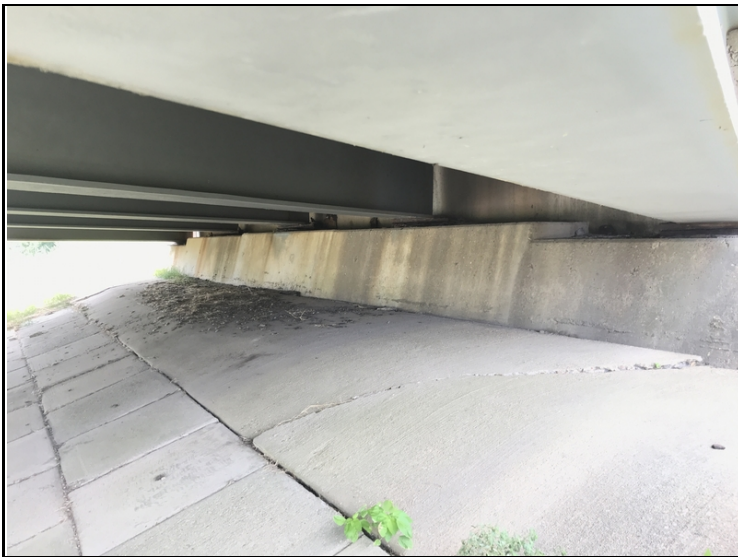
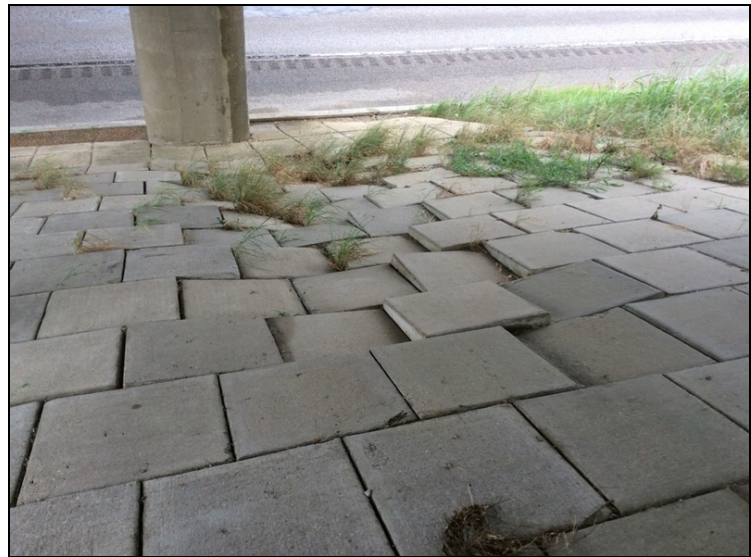
Slope protection has some undermining near end bents. Slope protection has some settlement.

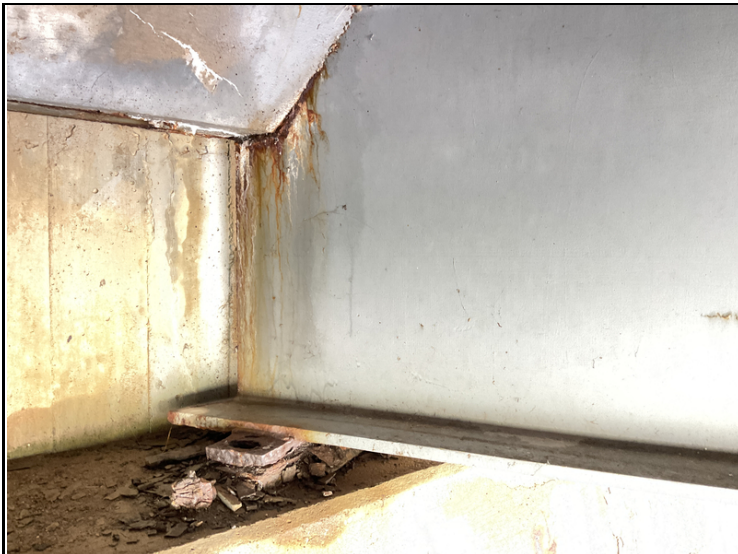
Span 1 bent 1 girder 4

Ends of girders have rust with some section loss at web below haunch.

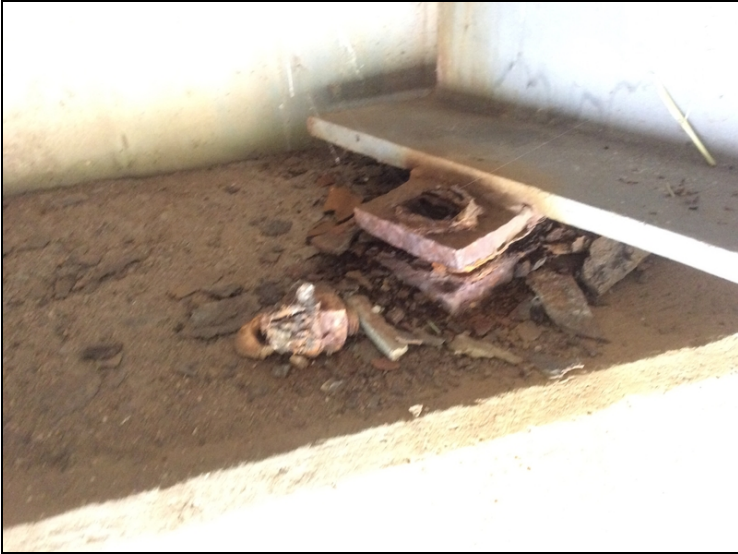
Span 1 bent 1 bearing 4

Span 1 bent 1 bearings 2 - 5 are each missing 1 anchor bolt.

Bearings at end bents have heavy pack rust and section loss. Most anchor bolts are missing.

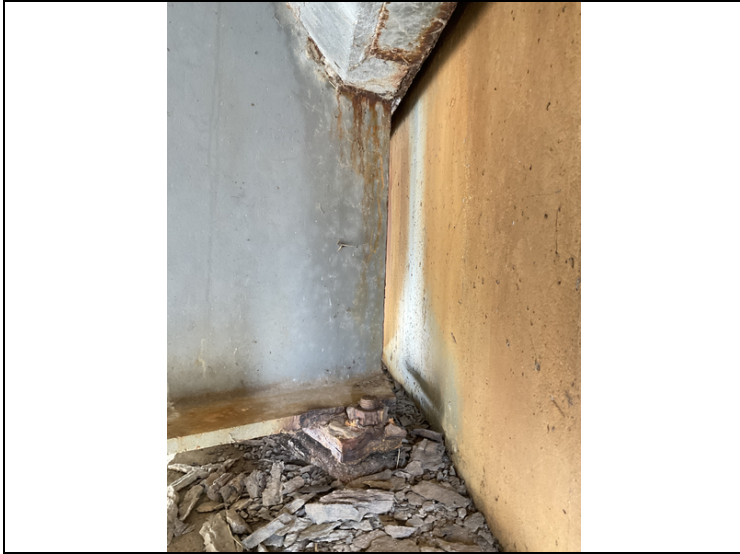
typ bearing at end bents
