Asset #00582(Routine)

SH 14-13- LM 13.53 over LANGUILLE RELIEF

Location: 4.2 MI W JCT SH 1

Team Lead: James Adams, Inspection Date: 01/16/2020

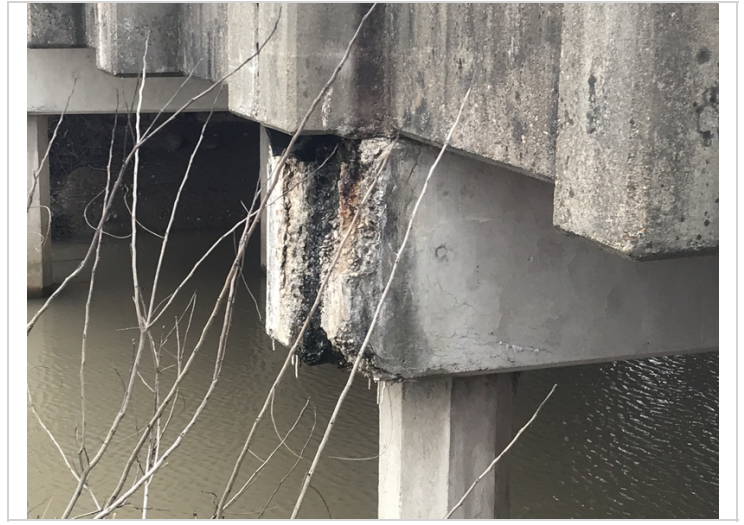
Bent 2 left side

Comment: Bents 2 and 3 caps have some deterioration on left end, and a few minor spalls with exposed rebar.

Bent 2 cap span 2 side has 6 ft. of cracking & delamination on face of cap.

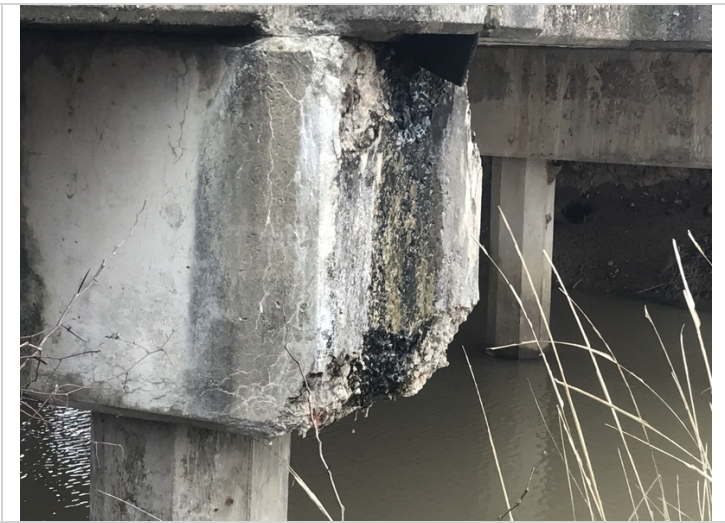
Bent 3 left side

Bent 3 cap span 3 side has 12 ft. of horizontal cracking 8 in. from top of cap. Cap has a 3 ft. area of cracking & delamination.

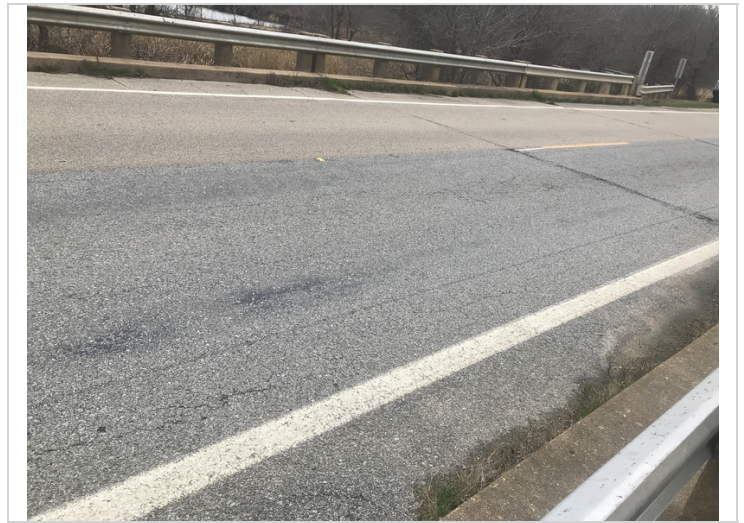
Deck

Asphalt wearing surface has transverse cracks &amp; spalls over joints.

Wearing surface has delamination in gutter line detected by sounding.

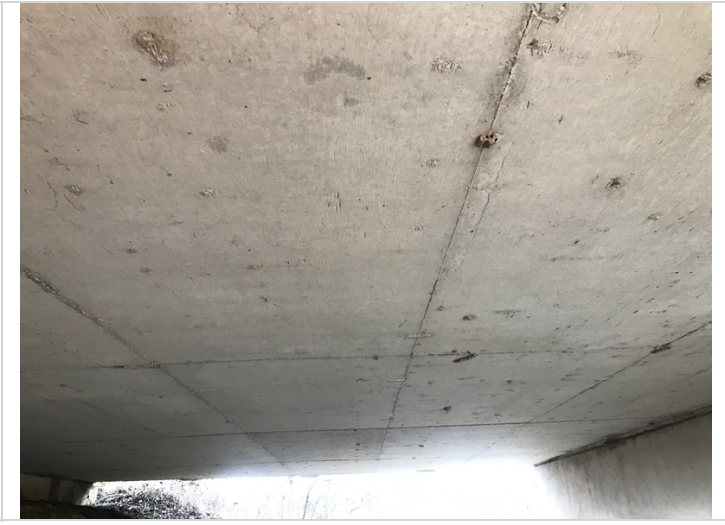
Span 1 soffit

Comment: Soffit has a few cracks with some efflorescence.

Span 1 slab has 4 ft. of diagonal cracking with efflorescence at right corner near bent 1.

Soffit has a few small delaminated areas along edges.

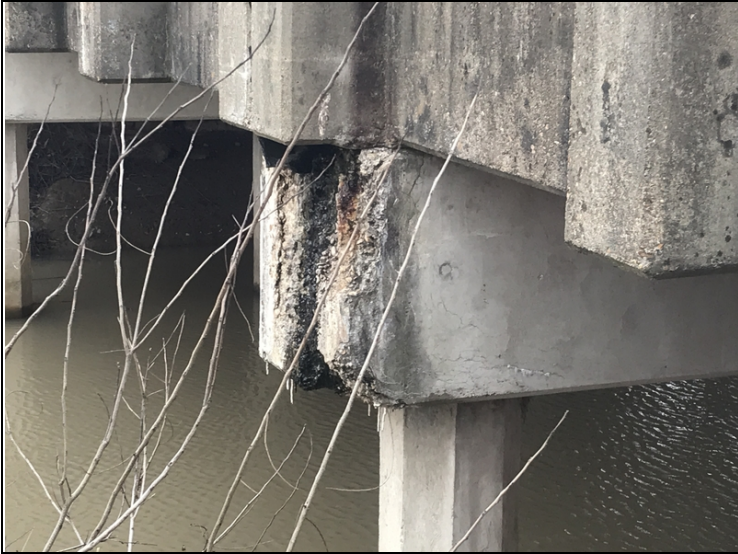
Bent 2 left side

Caps at bents 2 and 3 have some deterioration on Lt end, and a few minor spalls with rebar exposed.

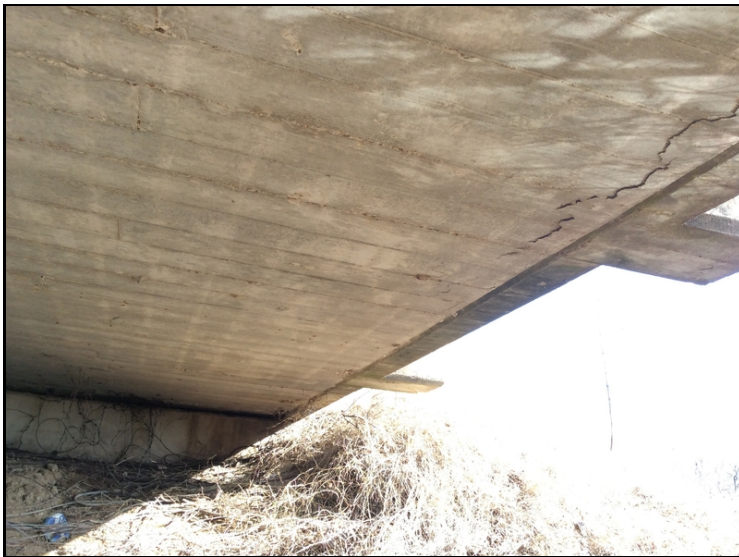
Soffit has a few small delaminated areas along edges.

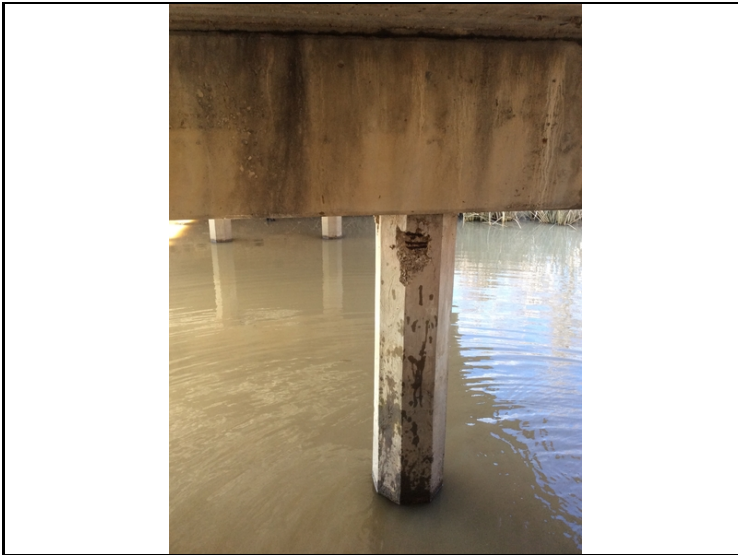
Bent 3 pile 2 has a small spall with rebar exposed at top of pile.
