Asset #02445(Routine)

SH 14-13- LM 2.65 over FLAG SLOUGH

Location: 2.65 MI E OF JACKSON CO

Team Lead: James Adams, Inspection Date: 02/03/2020

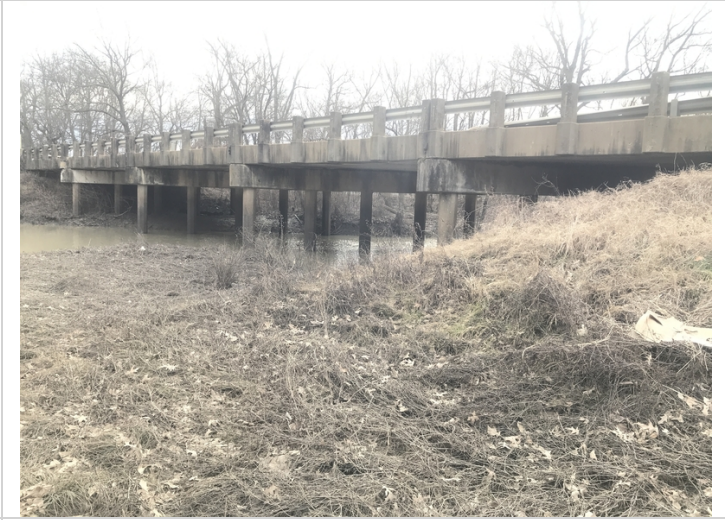
Elevation

Soffit has some rust stained cracks and delaminated areas along edges of slabs especially near drain openings. Some have rebar exposed.

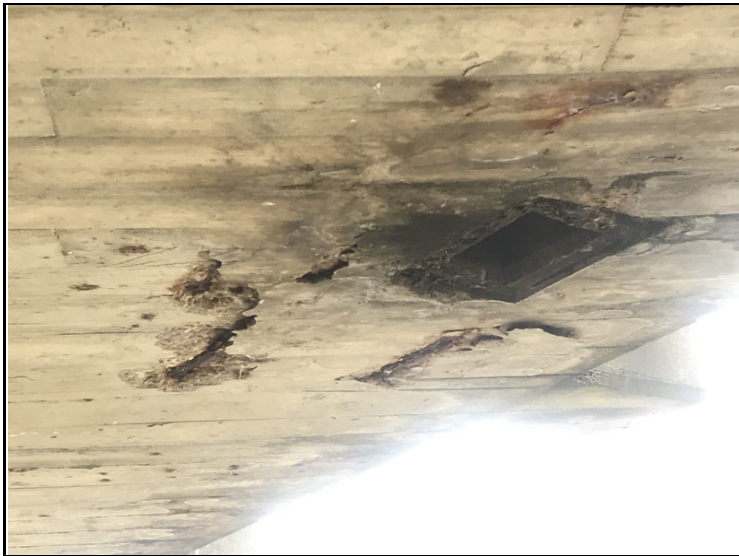
Soffit portion of slab has a few efflorescent cracks, some rust stained cracks and delaminated areas along edges of slabs especially near drain openings. Some have exposed rebar.

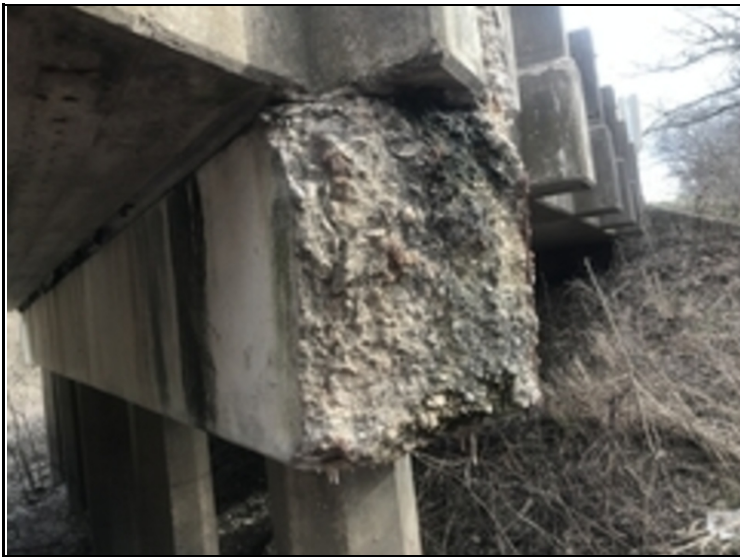
Bent 5 cap

Interior bent caps have deterioration & exposed rebar on ends, especially bents 3 and 5. See 2020 photos.

Comment: Interior bent caps have deterioration & exposed rebar on ends, especially bents 3 and 5. See 2020 photos.

Interior bent caps have deterioration on ends, especially bents 3 and 5.
Caps have a few minor cracks and spalls with some rebar exposed.

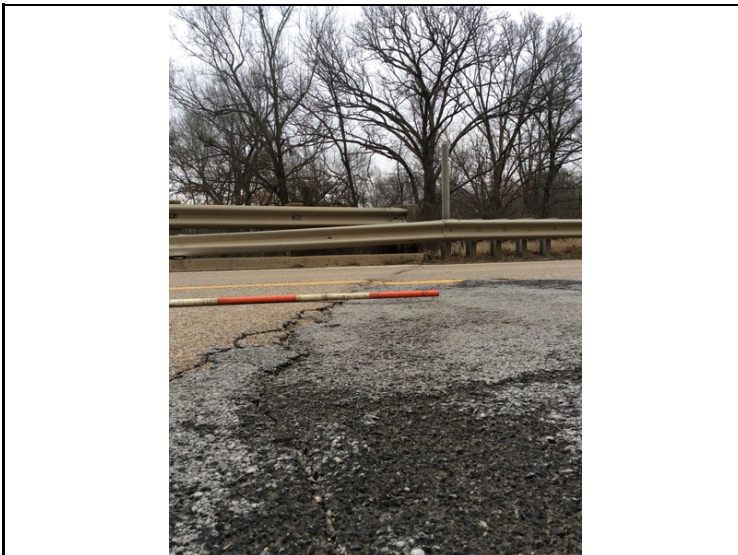
Approach roadway at bent 1 end has minor settlement. Approach roadway at bent 6 end has up to 1 in. of settlement.

Approach roadway at bent 1 end has minor settlement.
Approach roadway at bent 6 end has up to 1" of settlement.

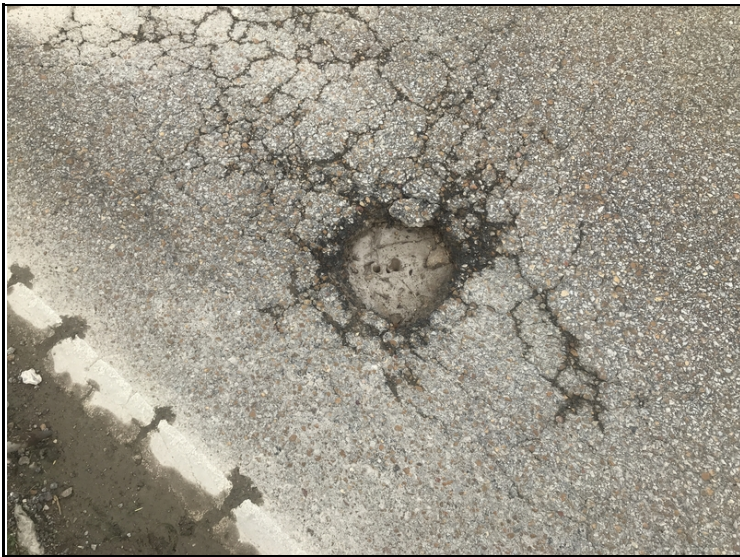
Span 5 right lane asphalt overlay has a 4 ft. wide area of map cracking with some efflorescence visible & a 1 ft. diameter hole in asphalt, see 2020 photo.

Span 5 right lane asphalt overlay has a 4 ft. wide area of map cracking with some efflorescence visible & a 1 ft. diameter hole in asphalt
