Asset #02446(Routine)

SH 14-13- LM 3.56 over BAYOU DEVIEW

Location: 2.4 MI W JCT OF SH 49

Team Lead: James Adams, Inspection Date: 02/19/2020

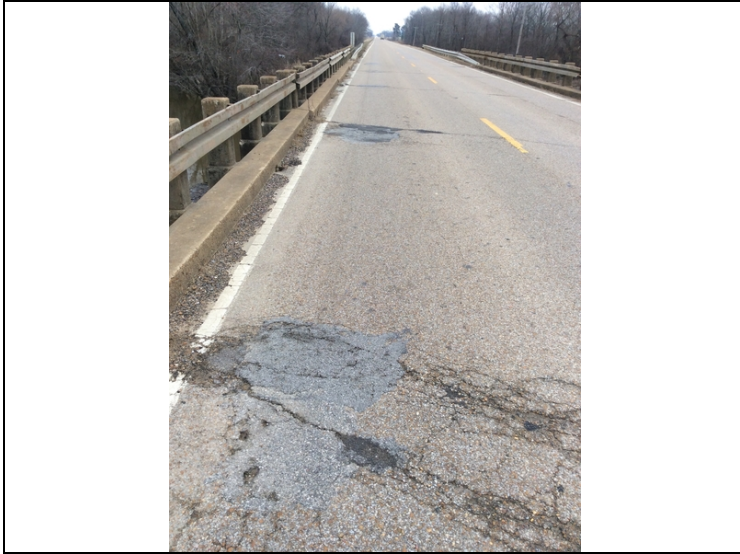
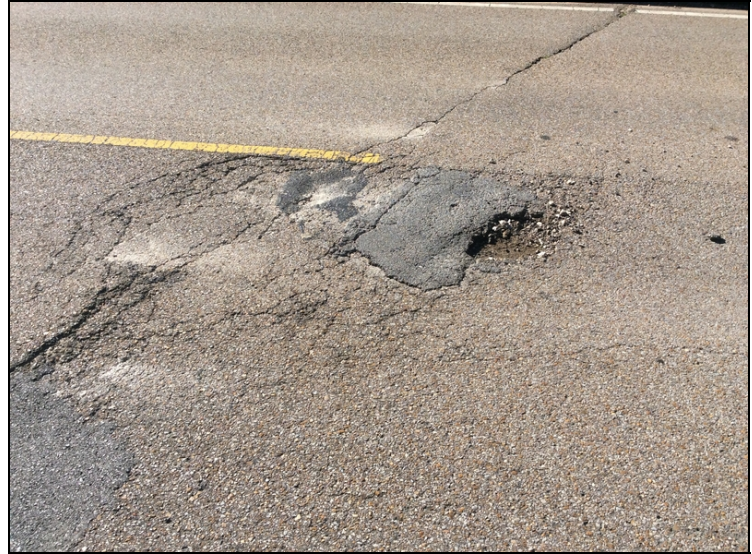
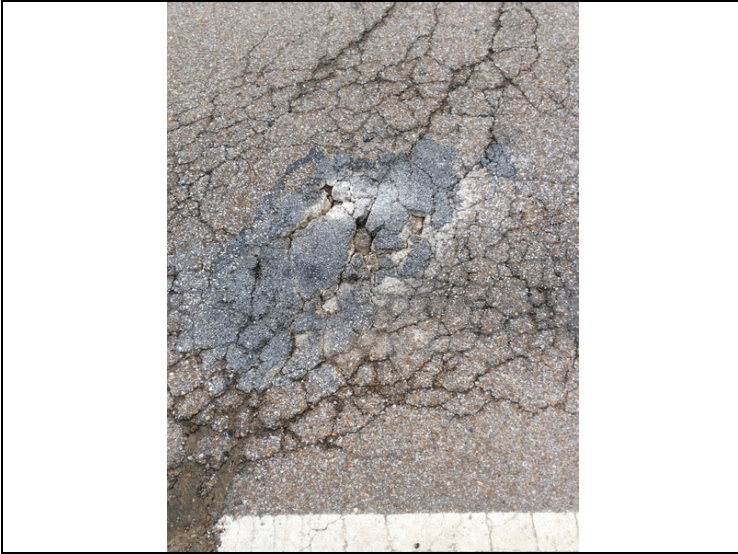
Wearing surface has several large delaminated areas with map cracking and rutting, especially in Lt lane near bents.

Lt and Rt curbs have a few delaminated and/or spalled areas.

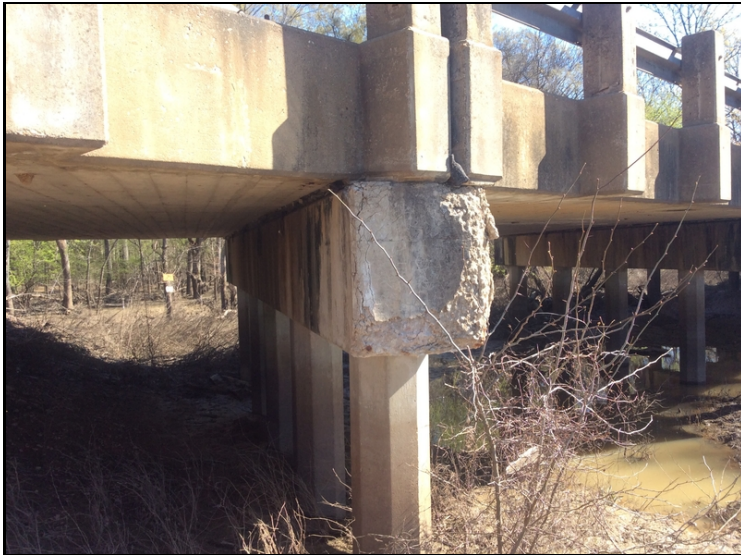
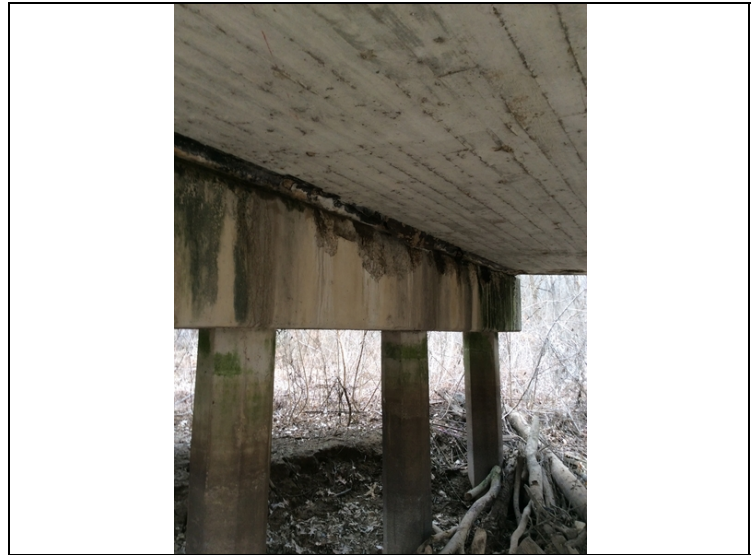
Interior bent caps have several small spalls on faces of caps. Caps have several spalls with rebar exposed on bottom. Ends of caps have some deterioration/spalls with rebar exposed. Bent 7 cap has several spalled/delaminated areas on ahead side. Bent 10 cap has 18' of spalls on ahead side with some loss of bearing area.

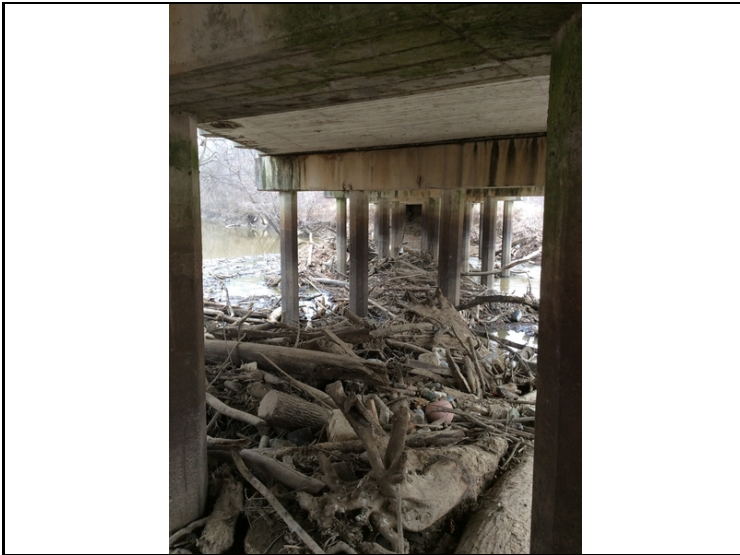
Channel profiled on 2/6/18. Channel embankment has scoured near bent 11. Bent 11 has approx. 4' loss of pile penetration.

Bent 16 is undermined in 2 locations. Approximately 10' of cap is undermined up to 1.5' below and 2' back under.

Large drift buildup across channel under spans 10 – 14.

Some drift in channel has been removed Observed at inspection 02-26-2020 JFA/CWS

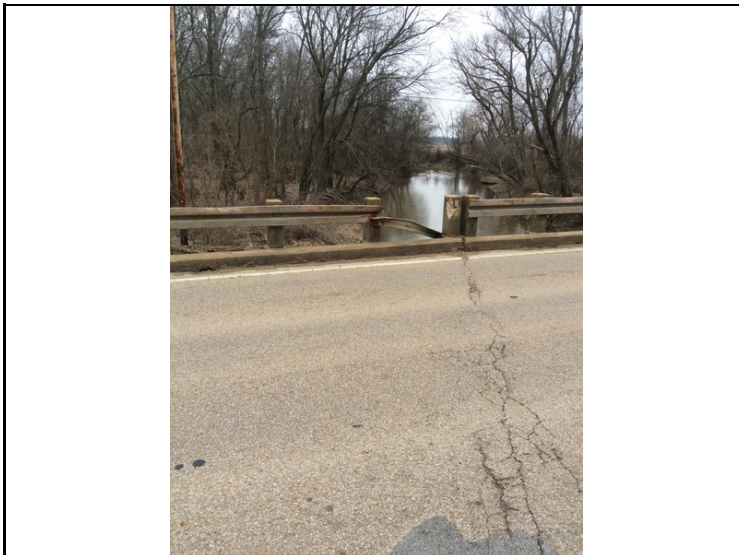
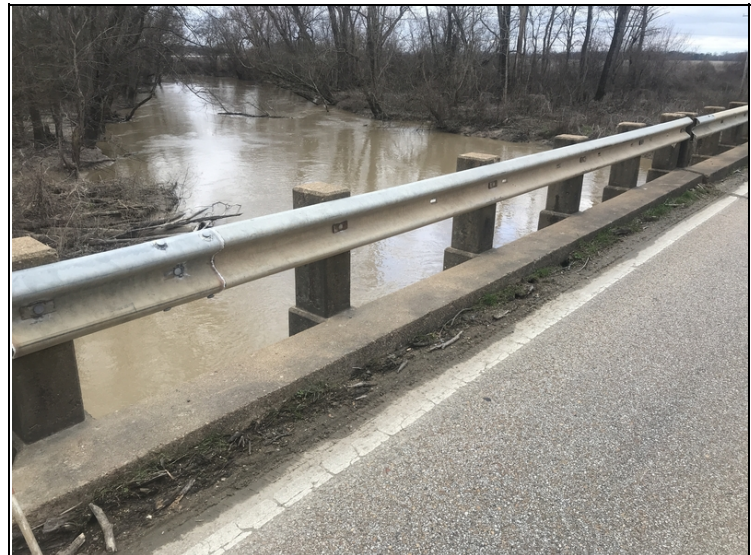
Lt rail at span 2 has minor impact damage.
Rt rail at span 13 has collision damage. 7' of rail near bent 13 is torn loose.

Span 13 rail right repaired

Span 13 rail has been repaired, see 2020 photo. Observed 02-26-2020 JFA/Cws

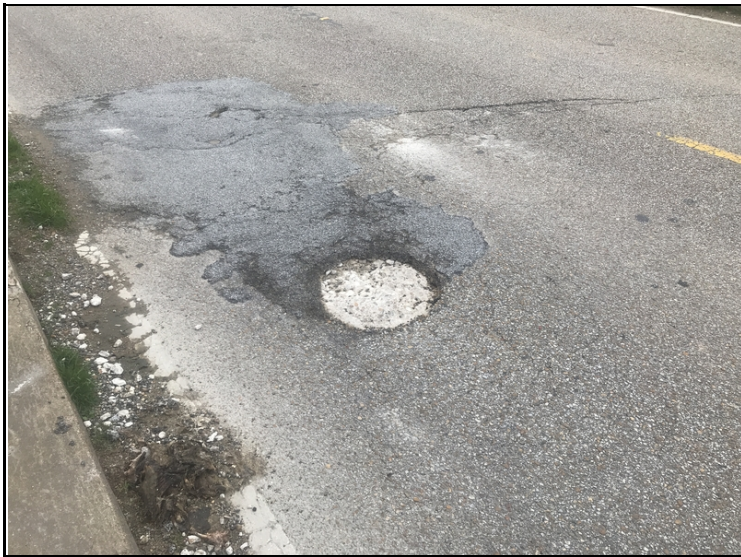
Span 7 left lane near bent 8 has a 2 ft. diameter spall in asphalt. See 2020 photo.

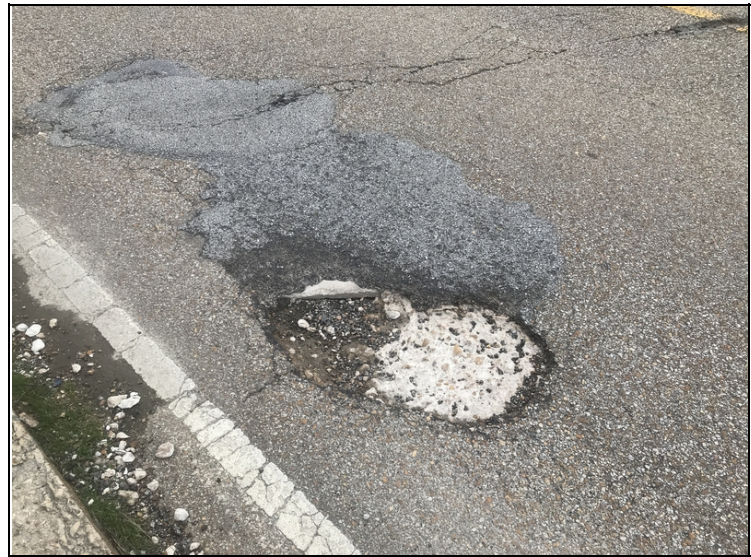
Span 14 left lane has a 2 ft. diameter spall in asphalt. See 2020 photo.
