Asset #03167(Routine)

SH 18-07- LM 2.57 over I 55-SEC 12

Location: Blytheville

Team Lead: Richard Jones, Inspection Date: 04/27/2022

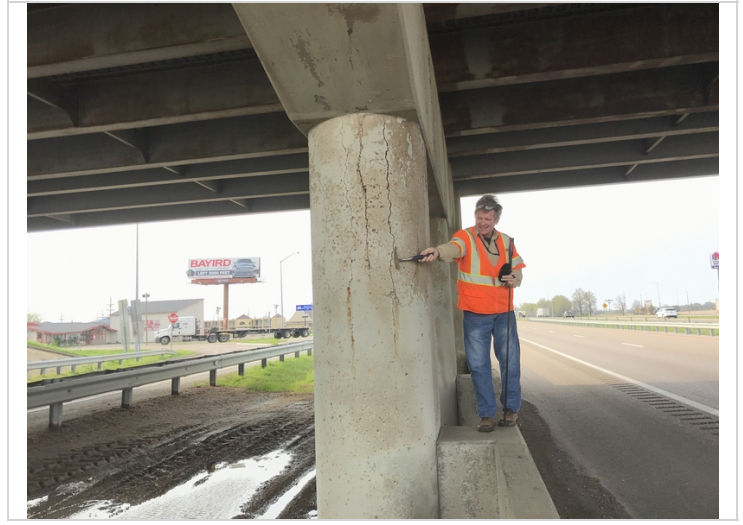
Bent 5 column 2 has 8' – 9' long vertical cracks (up to 3/8" wide) and delaminated areas near top.

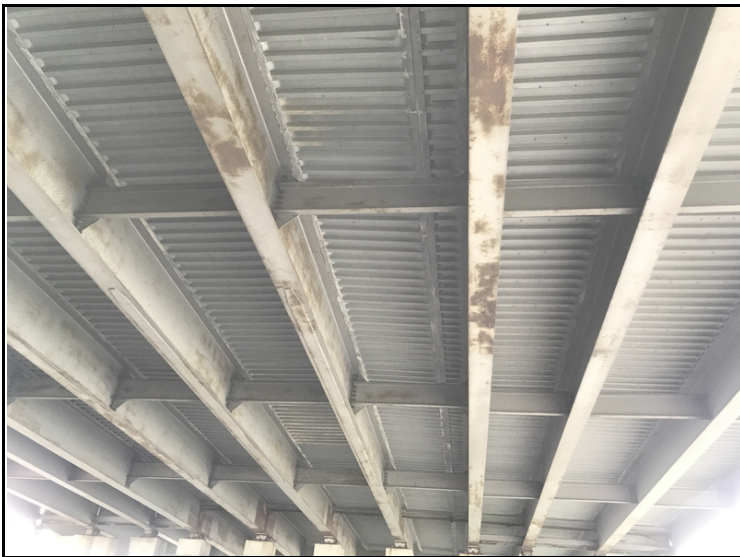
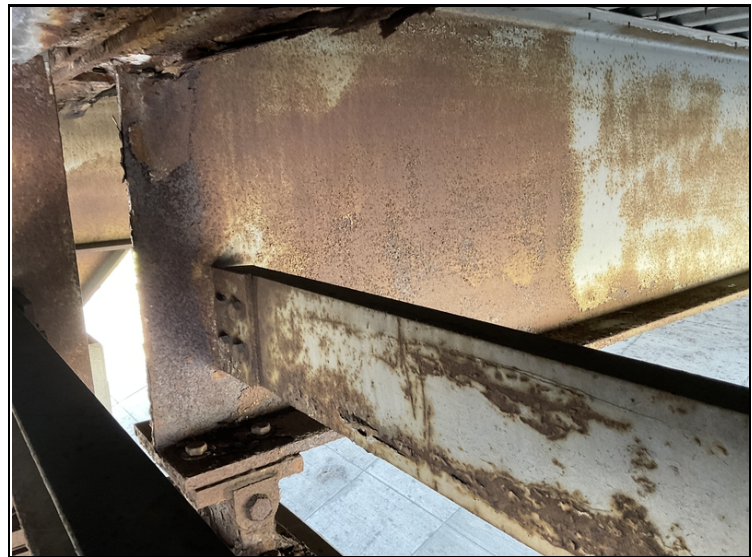
Bent 2 girder 4

Steel girders have areas of freckled surface rust throughout.

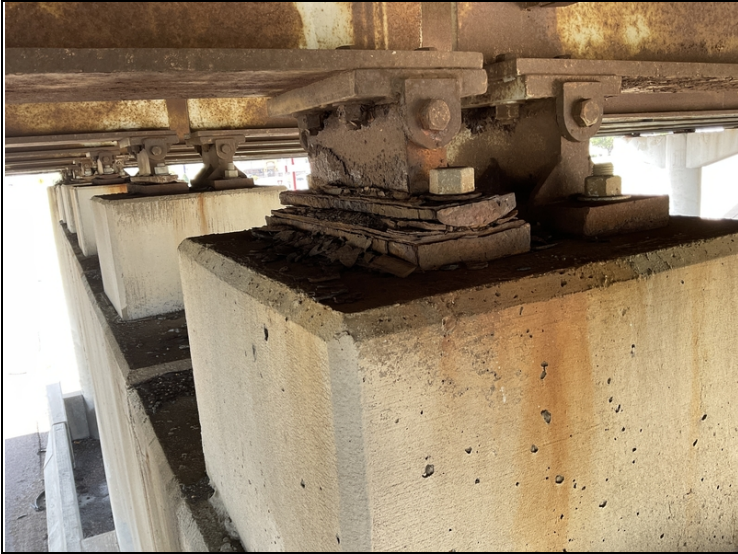
Span 3 bent 3 bearing 4 has pack rust and some section loss.

Span 3 bent 3 bearing 4

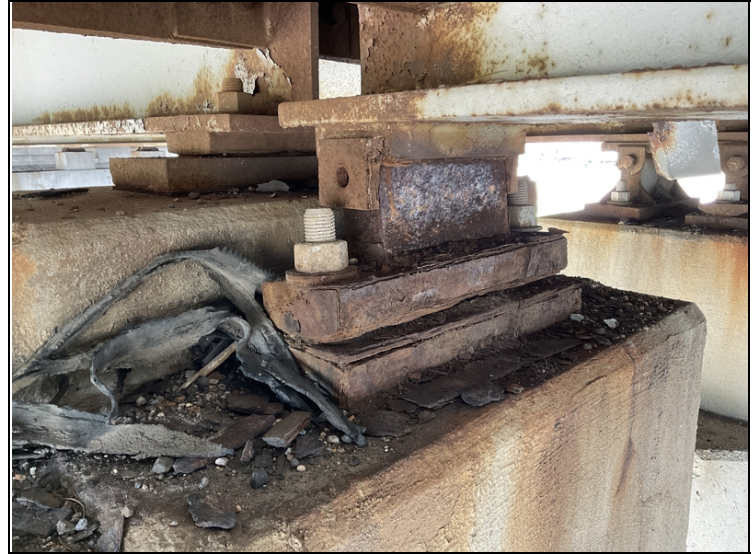
Span 3 bent 3 bearing 9 is missing a cap screw. Rocker is loose.

Span 3 bent 3 bearing 9 rocker is loose

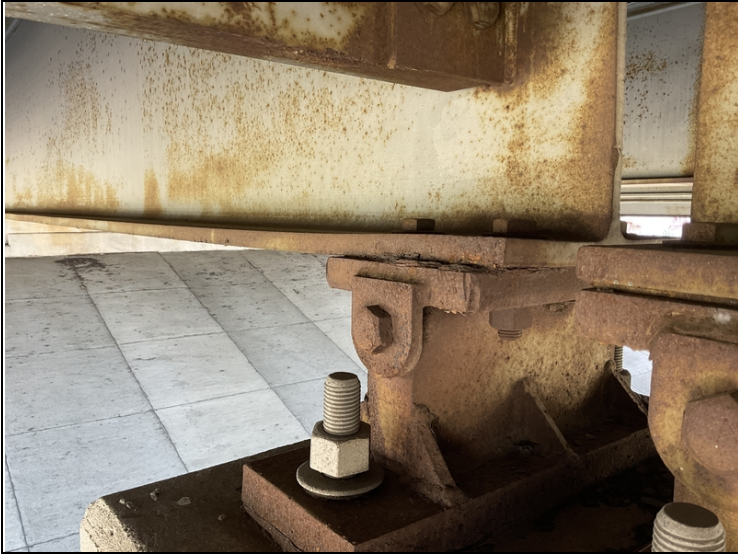
Span 6 bent 6 girder 4 has pack rust between bottom flange and top of bearing. Bottom flange has a minor bow.

Span 6 bent 6 girder 4 bow

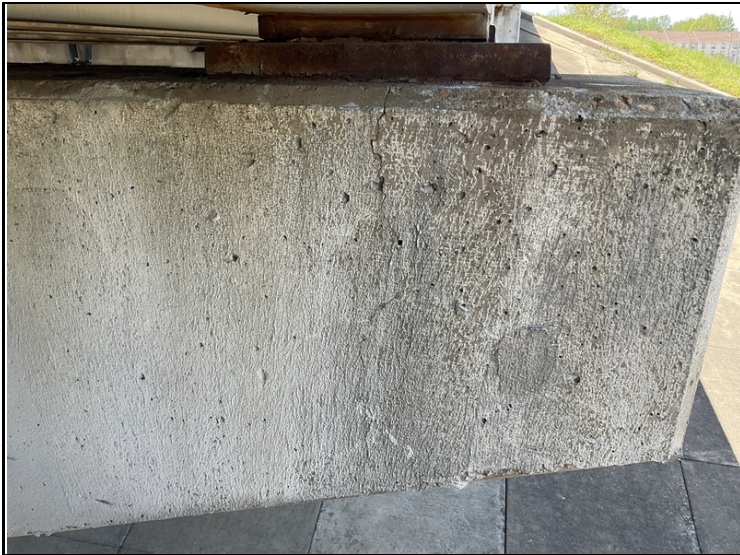
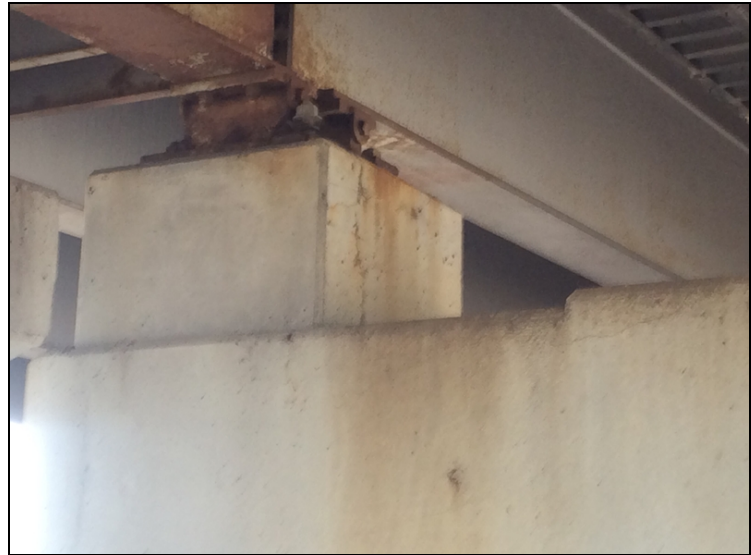
Bent 2 cap

Caps on extended portion of bridge have a few vertical cracks at bearings.  
Risers on original portion of caps have a few cracks.  
Caps have a few spalls with exposed rebar on bottom, mostly from lack of coverage.

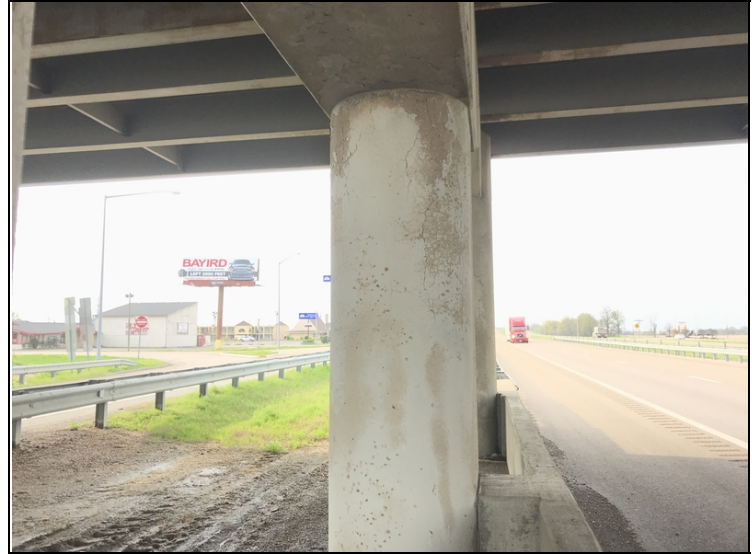
Bent 5 column 3 left

Bent 5 column 3 has 8'-9' vertical cracks and delaminated areas all the way around column. Some have rust stains.

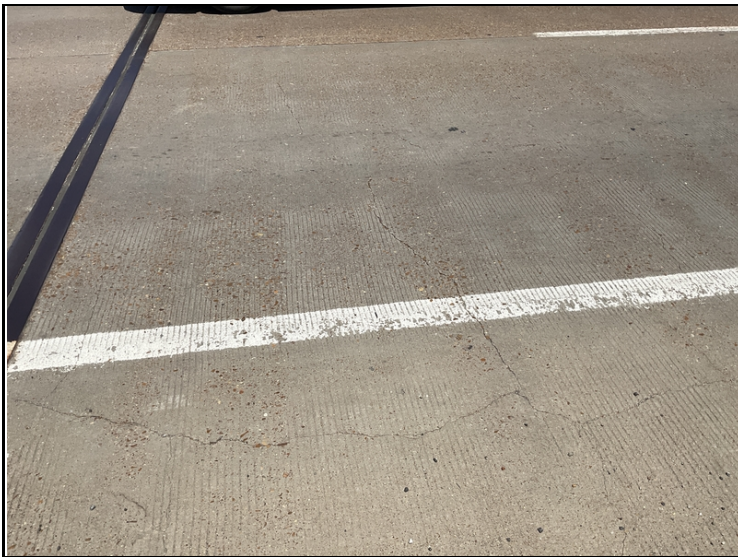
Deck has abrasion in wheel path. Deck has several unsealed transverse and longitudinal cracks.

deck cracks

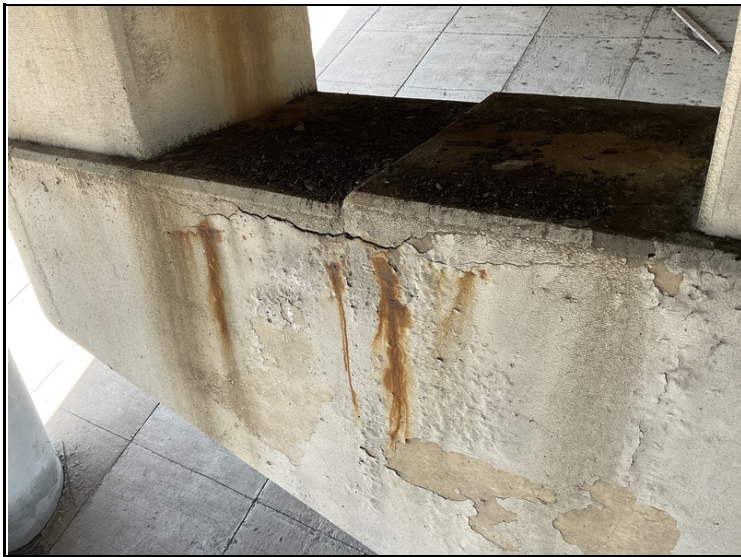
Bent 2 ahead

Bent 2 original cap on ahead side has a 3' crack/delaminated area with rust stains.

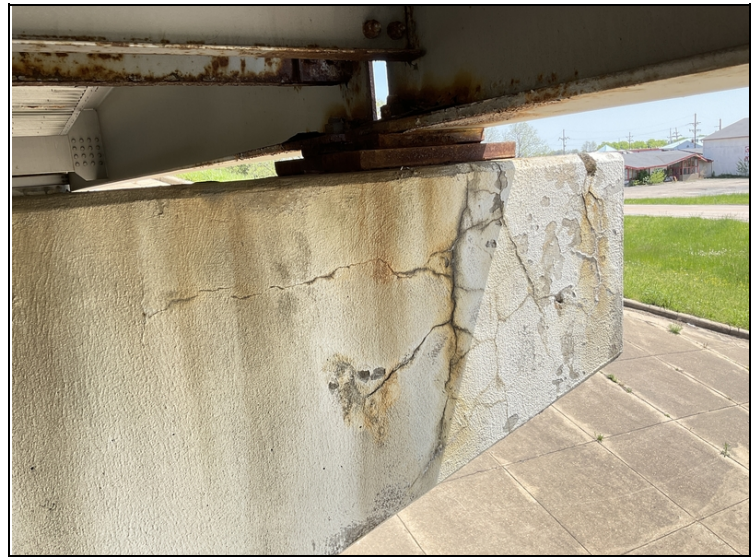
Bent 6 Rt

Bent 6 cap has map cracks with efflorescence under girder 11.

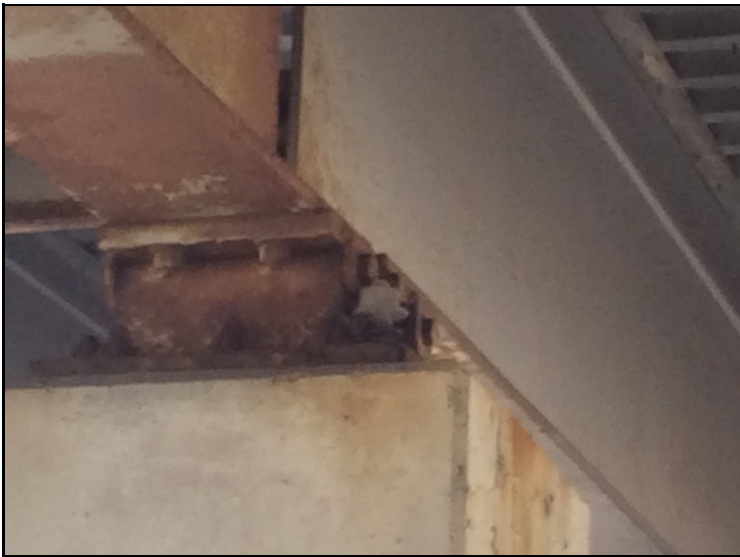
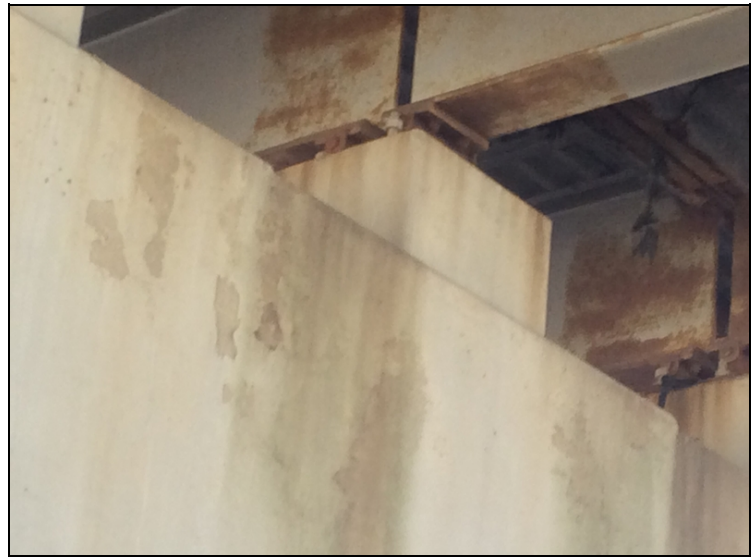
Span 1 bent 2 bearing 4 has one anchor bolt protruding out of cap 4" to 5".  
Span 5 bent 5 bearings 5 and 11 each have one anchor bolt protruding out of cap 2" - 5".

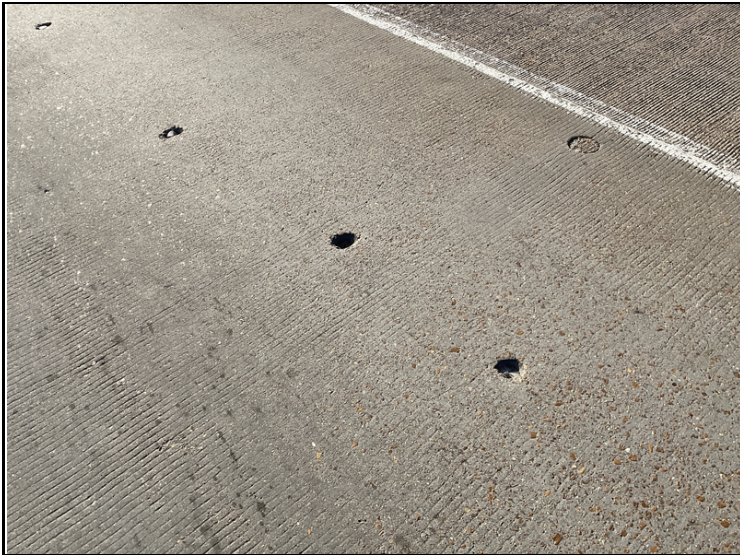
Deck has several core holes. Some are only partially filled. Deck has a few spalled areas.

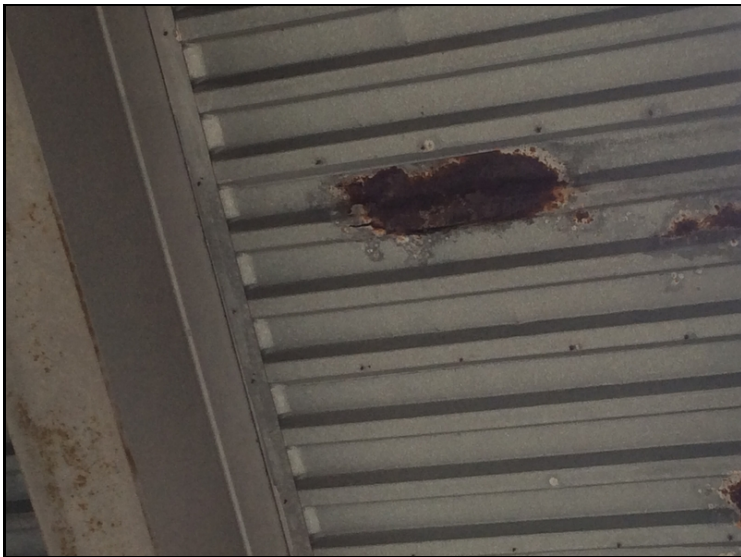
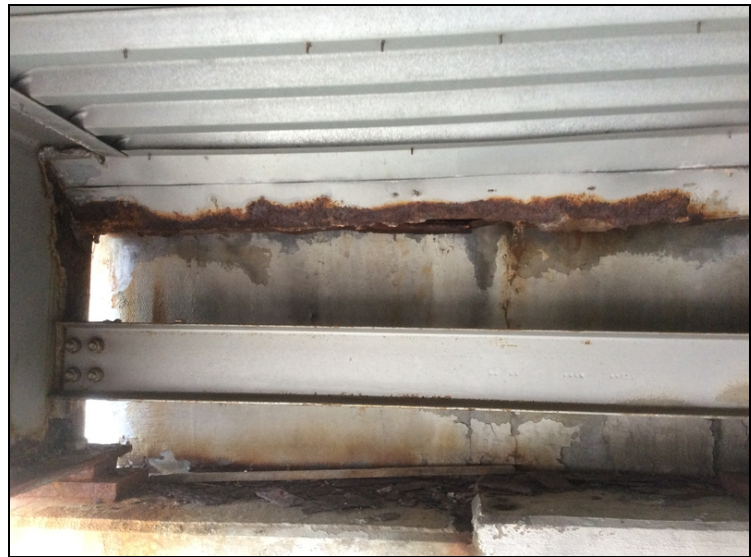
SIP forms have a few scattered areas of rust with section loss.

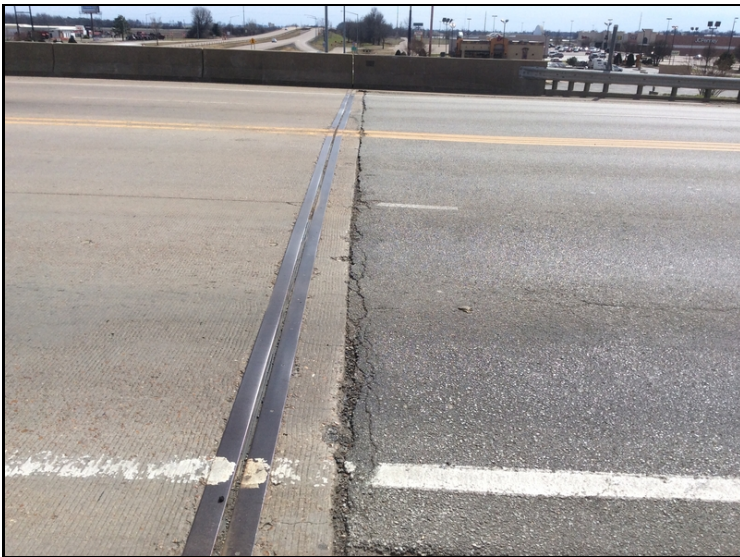
Approach roadways have some minor settlement.

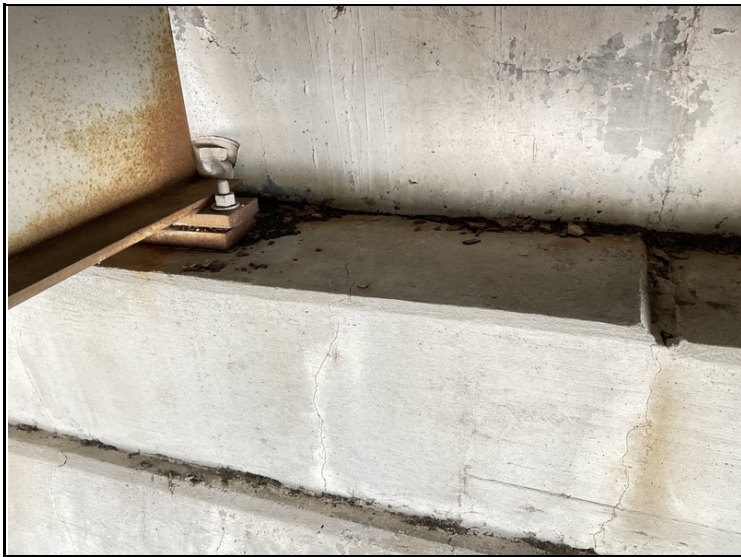
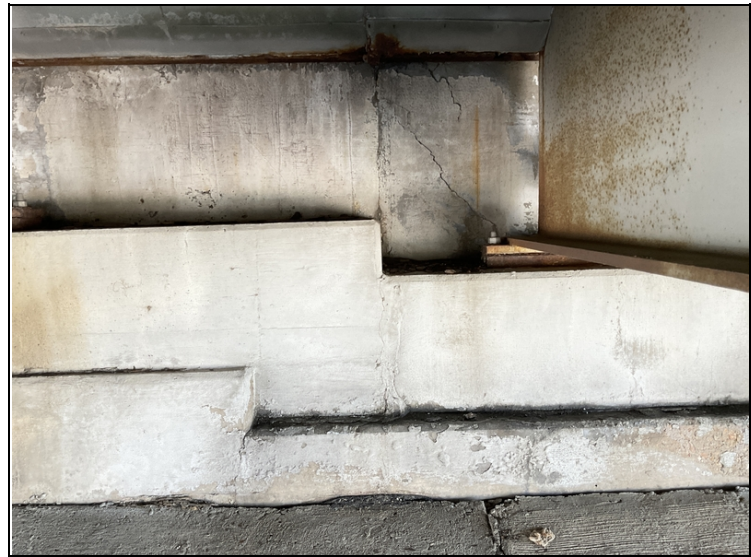
Bent 7 abutment has a few vertical cracks. Cap has a possible settlement crack that extends across top of cap. Back wall has a cracked delaminated area.

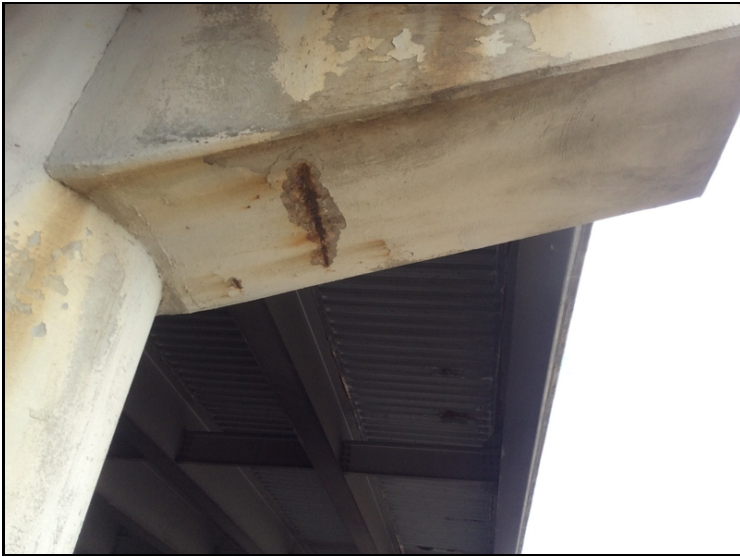
Caps have a few spalls with exposed rebar on bottom, mostly from lack of coverage.

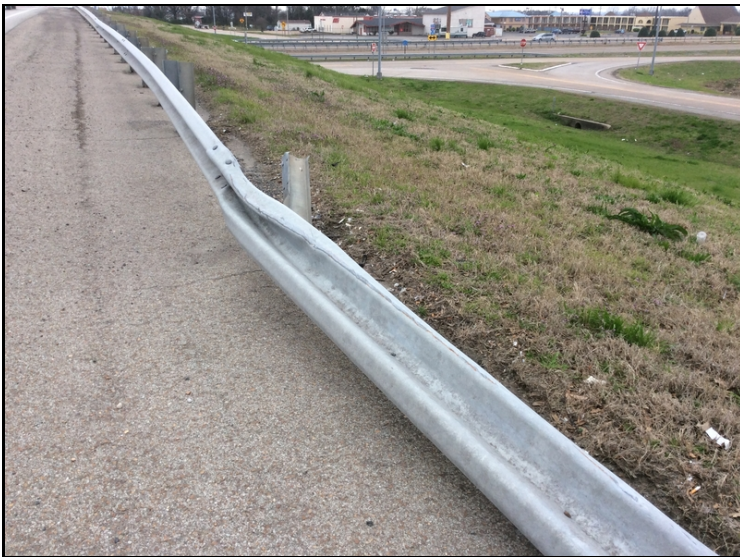
Approach rails have areas of minor collision damage.

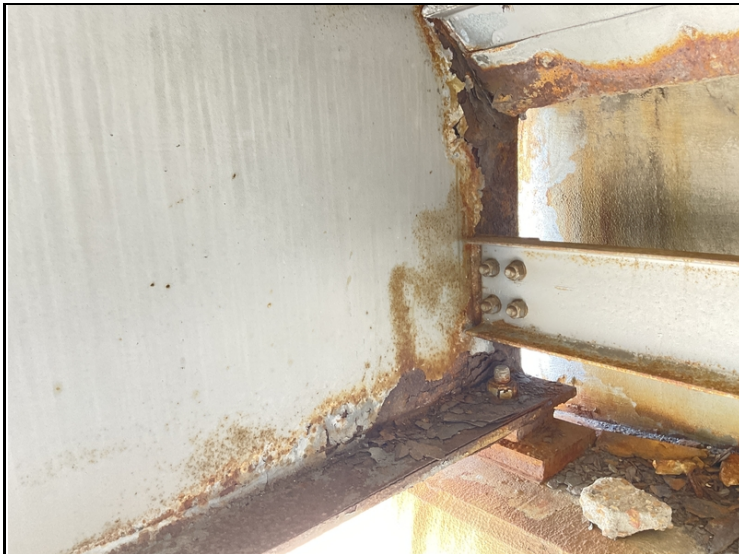
Span 1 bent 1 girder 11 has flaking rust with some minor measurable section loss (up to 1/16") at web below haunch, and along bottom of web and bottom flange.

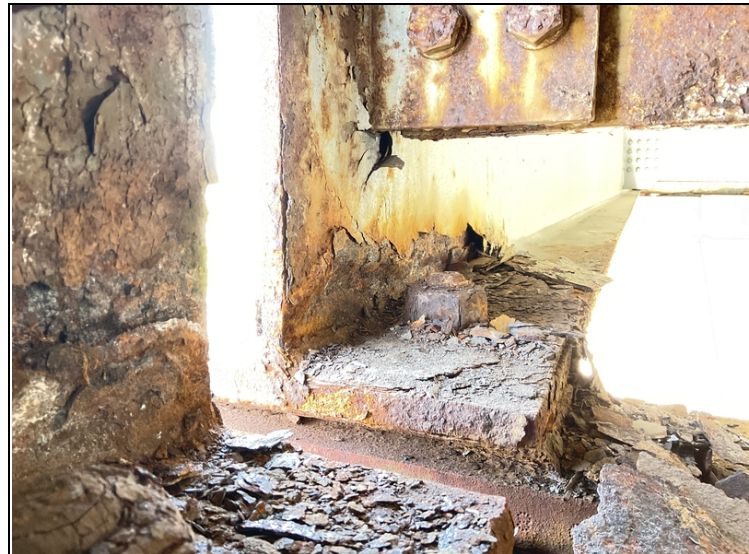
Span 1 bent 2 girder 11 has up to 1/8" section loss along bottom of web over bearing.

Span 1 bent 2 girder 11 - 1/8" section loss

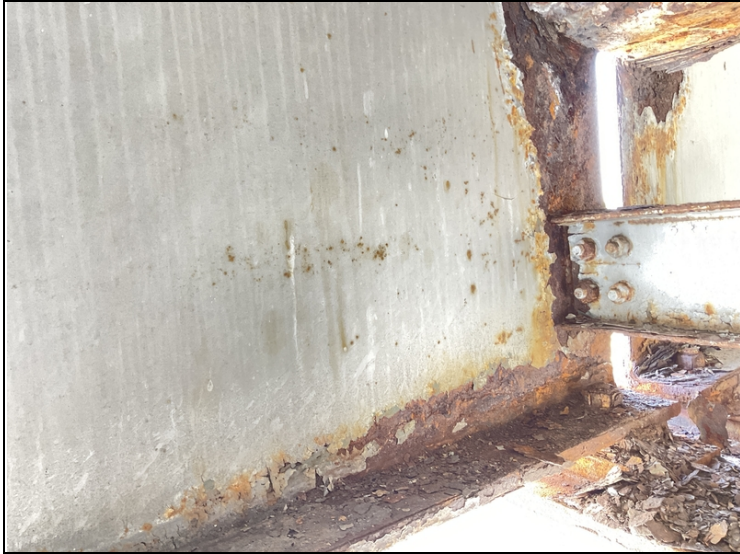
Span 2 bent 2 girder 11 has flaking rust with some section loss at web below haunch

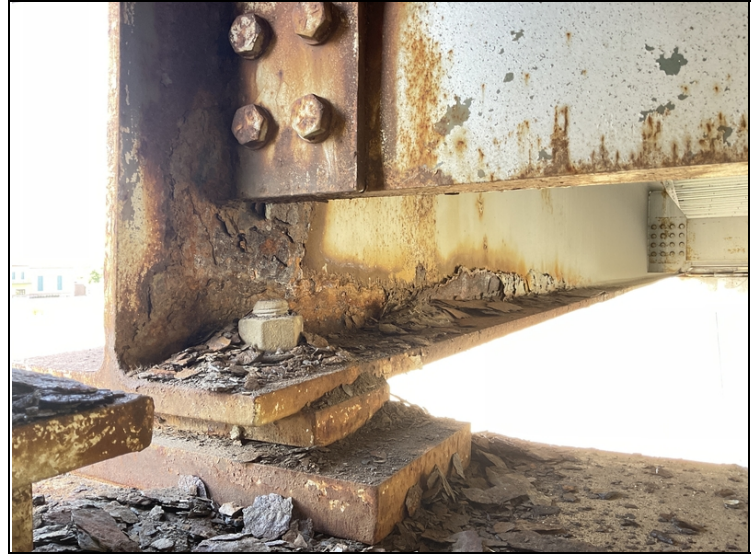
Span 2 bent 3 girder 11 has flaking rust with minor measurable section loss at diaphragm connection and for 6' along bottom of web.

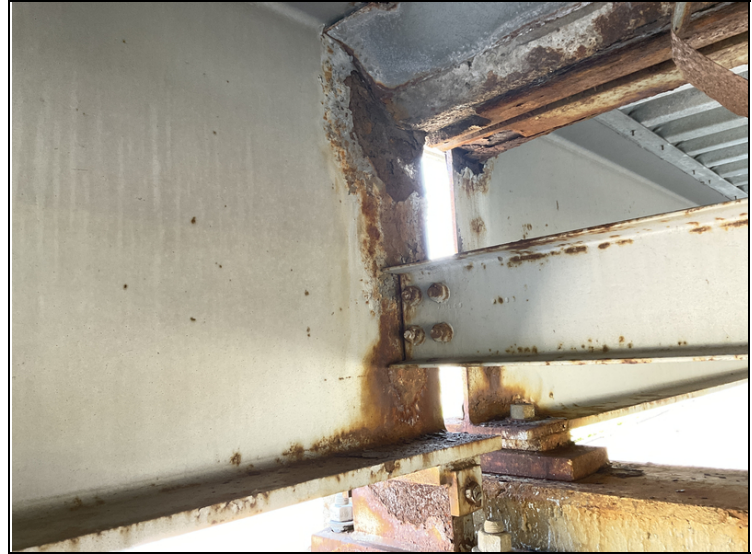
Span 4 bent 5 girder 1 has flaking rust with some section loss at web below haunch.
