Asset #03083(Routine, Underwater type 2)
US 49-02- LM 9.21 over HENDERSON CREEK

Team Lead: Tim Myrick, Inspection Date: 11/07/2022

Asset #03083(Routine, Underwater type 2)

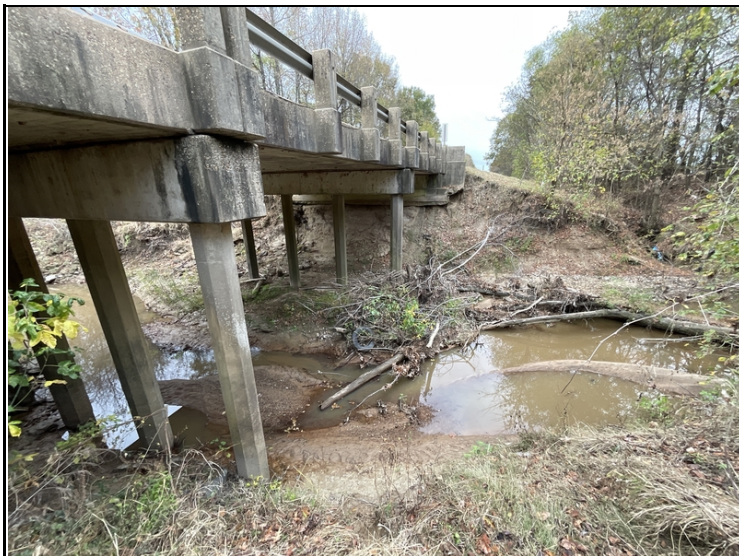
B4

Bent 4 scour repair is beginning to undermine on left end.

Bent 1 beginning to undermine.
Bent 4 scour repair is beginning to undermine on left end, 1 ft. below & 1 ft. back under near centerline.
Embankment is eroded under and adjacent to bridge near bent 4 upstream side.
Very little berm remaining at bent 4.

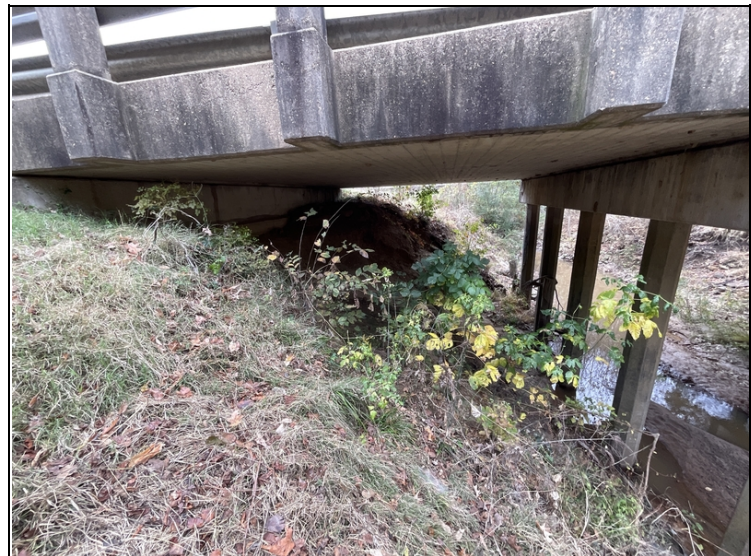
B1

Comment: Scour repaired at bent 1 some time in the past, repair is beginning to undermine 1 ft. below & 1 ft. back under repair near centerline.

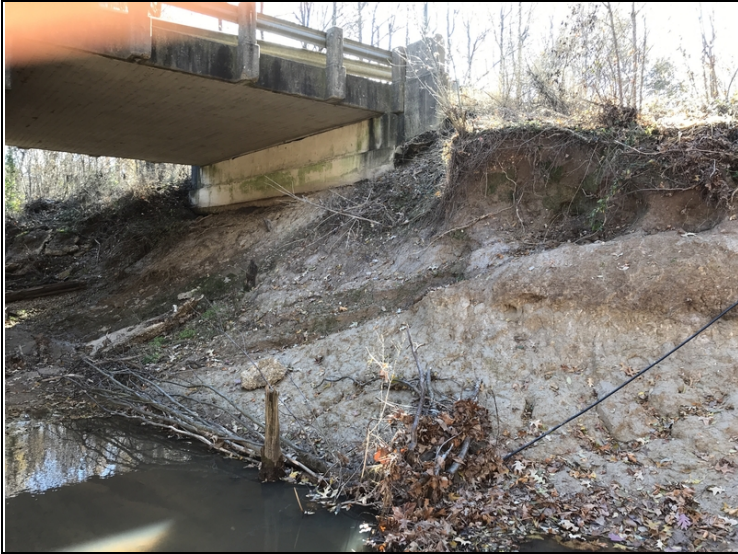
Bent 4 embankment

Embankment is eroded under and adjacent to bridge near bent 4 upstream side.

Very little berm remaining at bent 4.

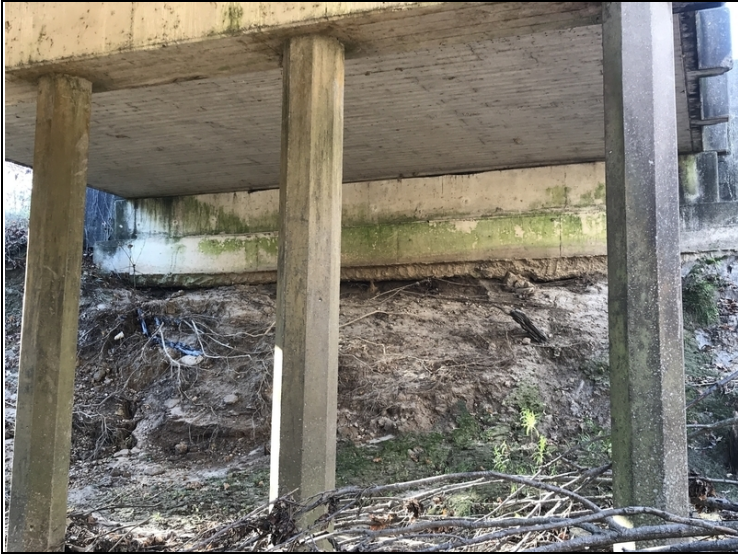
Bent 4 erosion 2020

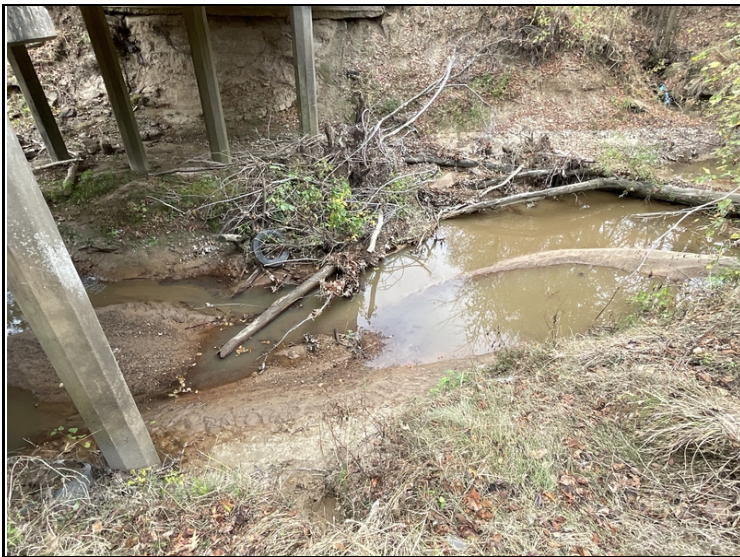
B3 drift

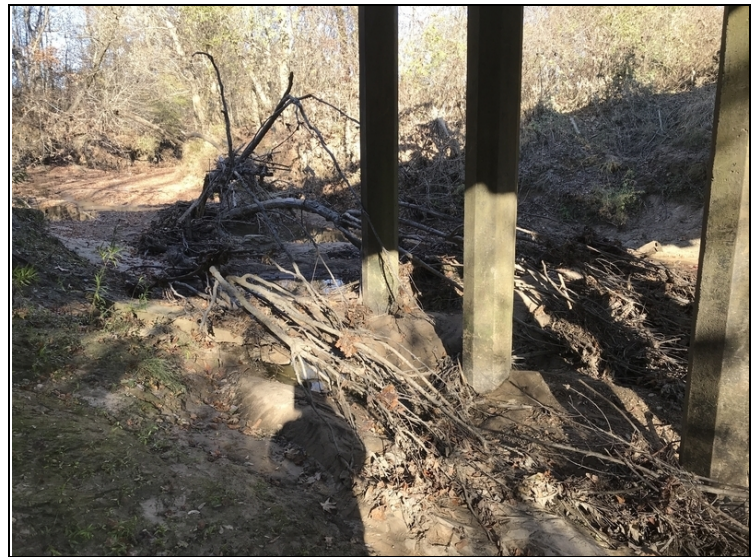
Large tree under span 2 & 3.

Drift span 2&3
