Asset #03084(Routine, Underwater type 2)
US 49-02- LM 8.71 over HURRICANE CREEK

Location: 8.09 N JCT US 412

Team Lead: Tim Myrick, Inspection Date: 11/03/2022

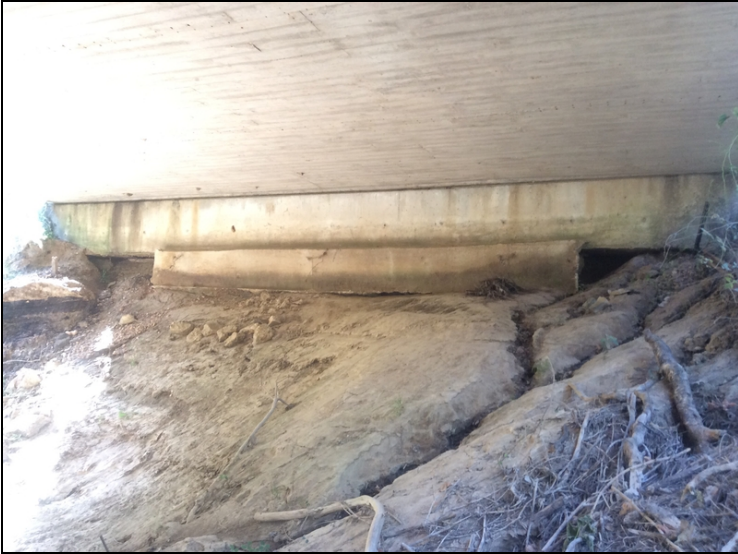
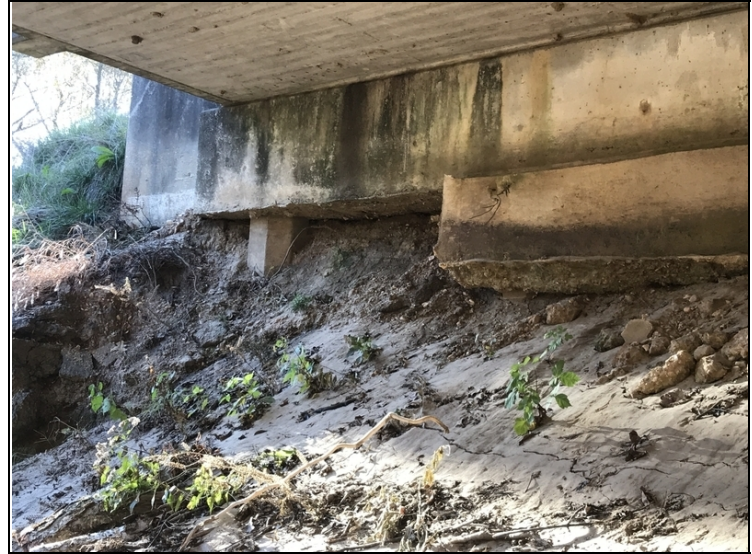
Bent 4 erosion

Bent 4 is undermined for 8' on each end up to 2 ft. below and 3 ft. back under abutment.

Bent 1 abutment is undermined up to 1.5' below and 2' back under. Bent 4 is undermined for 8' on each end up to 2' below and 3' back under abutment. Some repairs have been made in the past near centerline.

Date Reported: 01/03/2011
Priority: C - Important
Type of Work: Repair (General)
Status: Monitor
Component: Substructure

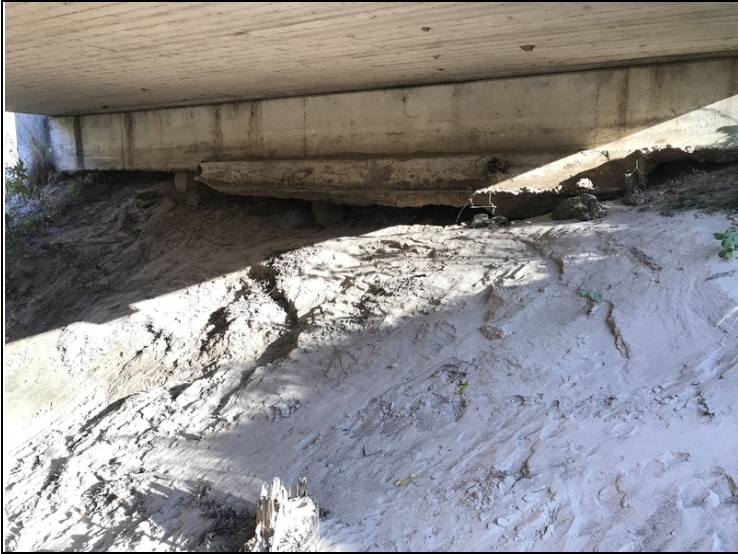
Bent 1 erosion

Comment: Bent 1 abutment is undermined up to 1.5 ft. below and 2 ft. back under.

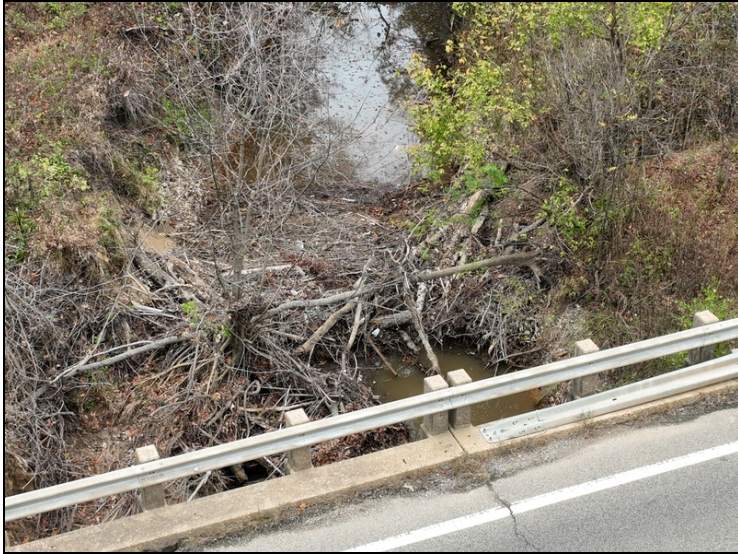
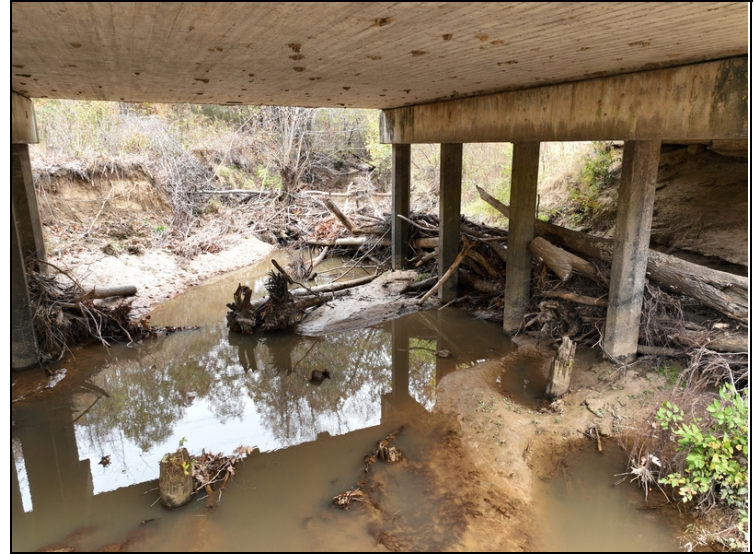
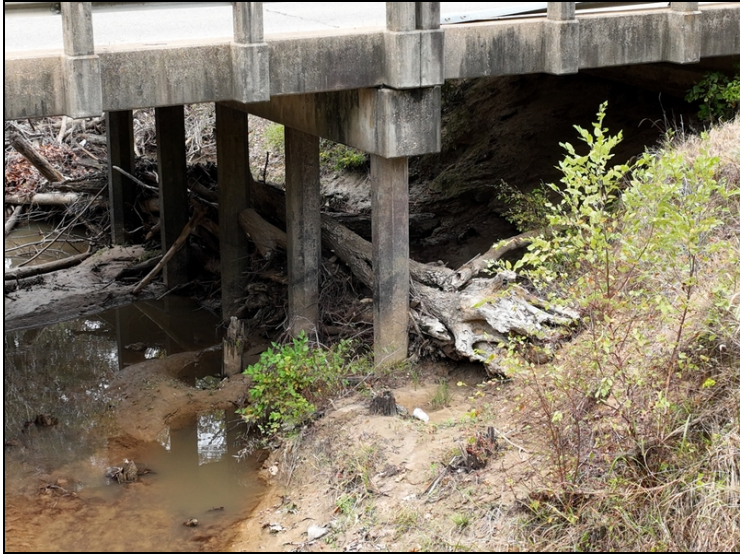
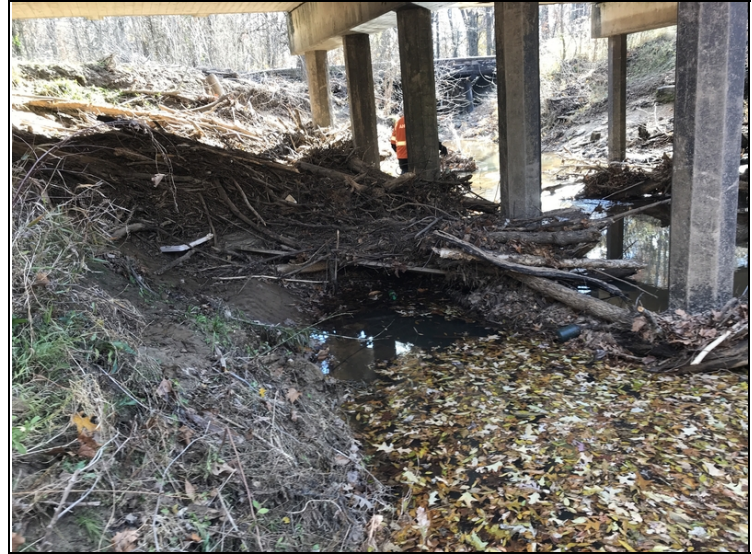
Bent 2 Drift

Large tree and stump drift buildup on bent 2 piles and slope under span 1.

Large tree and stump drift buildup on bent 2 piles and slope under span 1. See photo 2022
Moderate drift buildup on slope under span 1 and against bent 2 piles.

to Greene Co Crew for removal KAW 2/15/19
