Asset #03086(Routine, Underwater type 2)

US 49-02- LM 6.18 over SLAVENS CREEK

Location: .50 MI SO OF MARMADUKE

Team Lead: Tim Myrick, Inspection Date: 11/03/2022

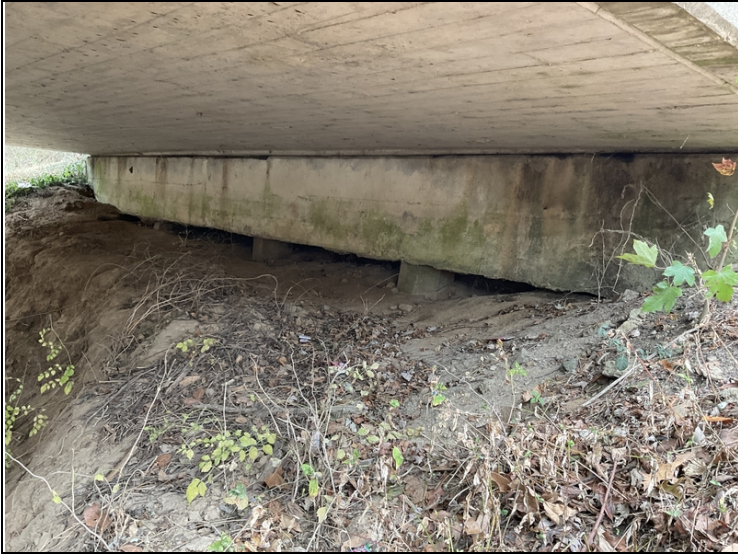
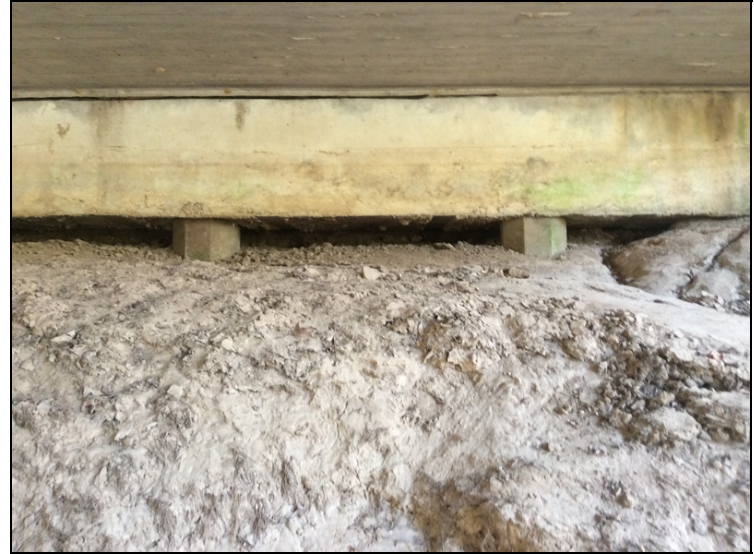
B4

Bent 4 is undermined up to 1' below and 3' back under abutment with 3 piles exposed.

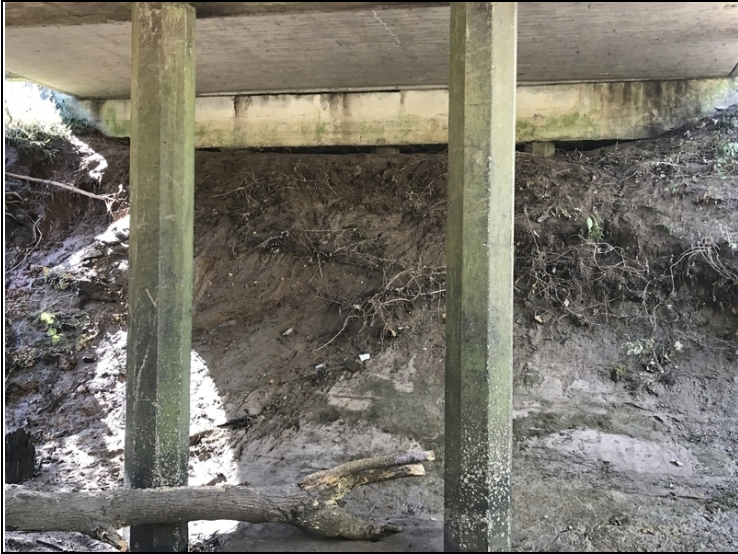
Comment: Bent 4 is undermined up to 1 ft. below and 3 ft. back under abutment with 3 piles exposed.

Bent 4 erosion

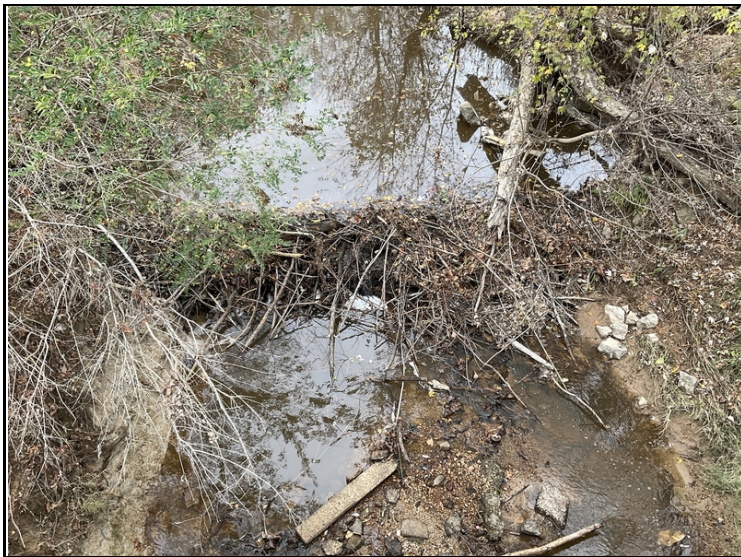
Beaver dam 25' upstream side.

Upstream beaver dam

to Greene Co Crew for removal KAW 1-25-21

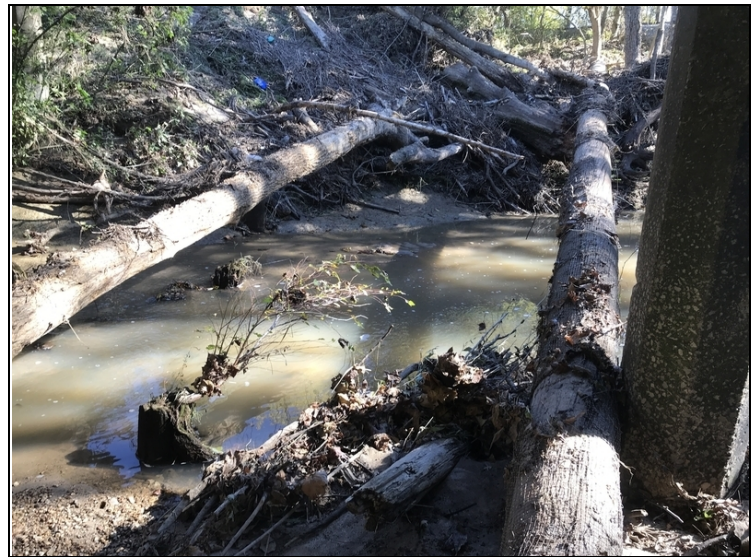
Large tree & utility pole lodged under bridge drift on Bent 3.

Span 2 drift
