Asset #07086(Routine)

US 49-02-LM 16.13 over EIGHT MILE CREEK

Location: 0.67 MI N JCT US 412

Team Lead: Tim Myrick, Inspection Date: 06/15/2022

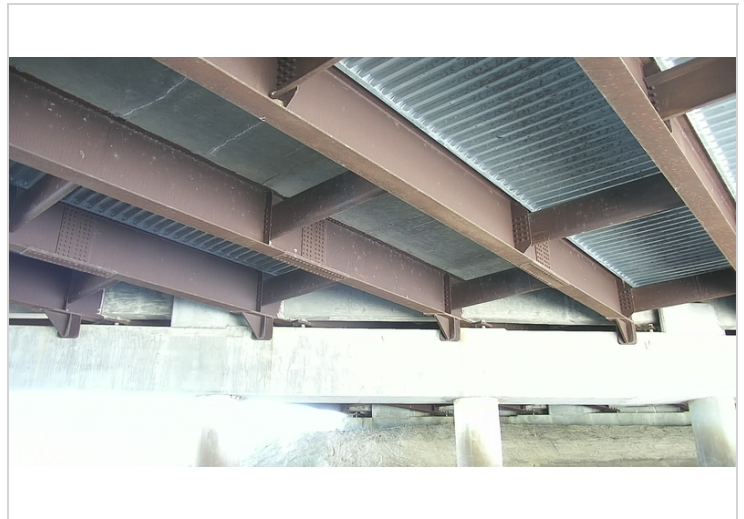
soffit

Soffit has several transverse cracks with efflorescence at overhangs and between girders 4 and 5.

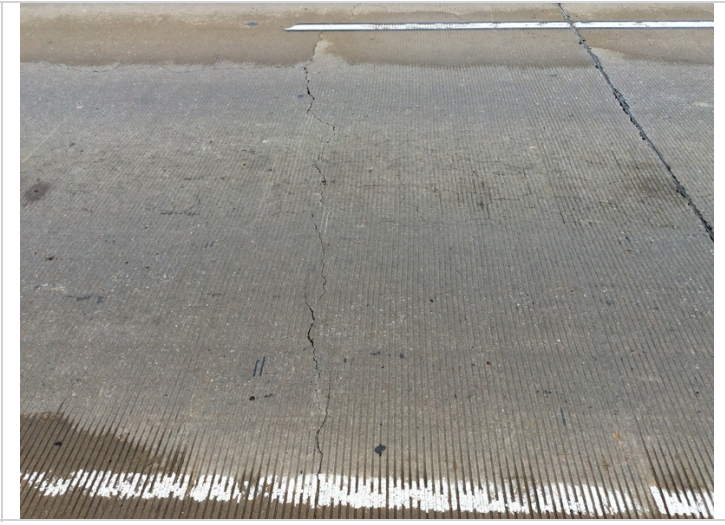
Bent 1 Approach Slab

Comment: Approach slabs have several unsealed transverse and longitudinal cracks.

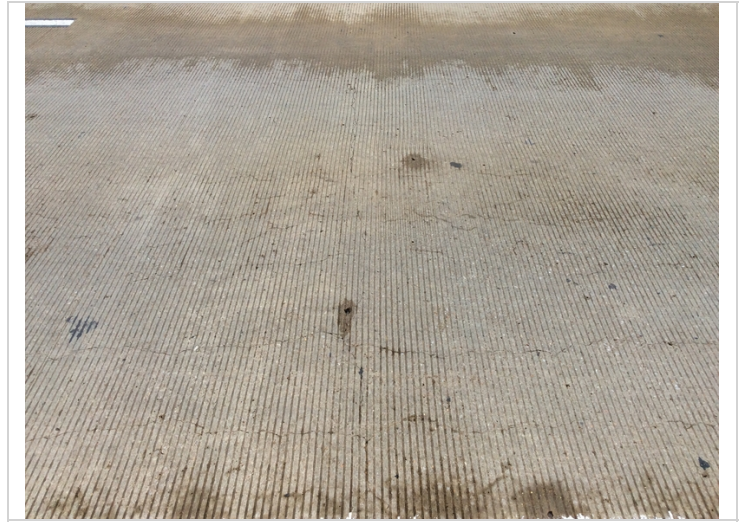
Span 2 Deck
Right Outside Travel Lane

Deck has numerous unsealed transverse and longitudinal cracks.

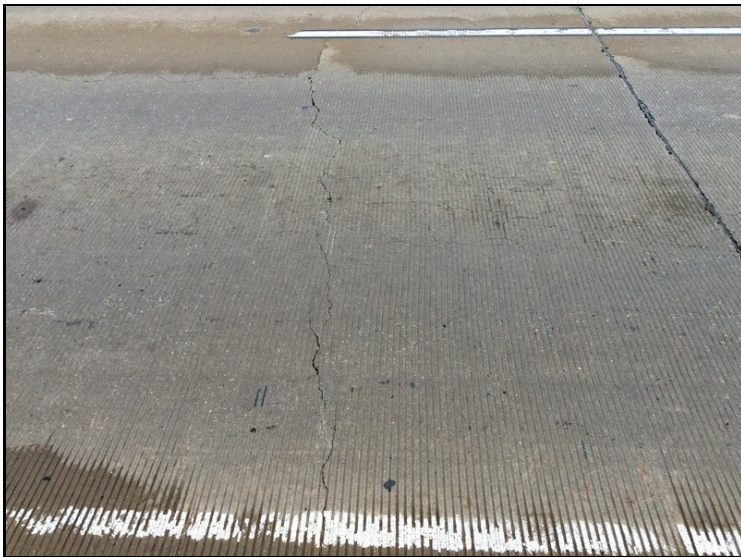
Approach slabs have several unsealed transverse and longitudinal cracks.

Date Reported: 07/02/2014
Priority: (Inactive) (Inactive) G - General/ Preventive maintenance
Type of Work: Repair (General)
Status: Monitor
Component: Approach

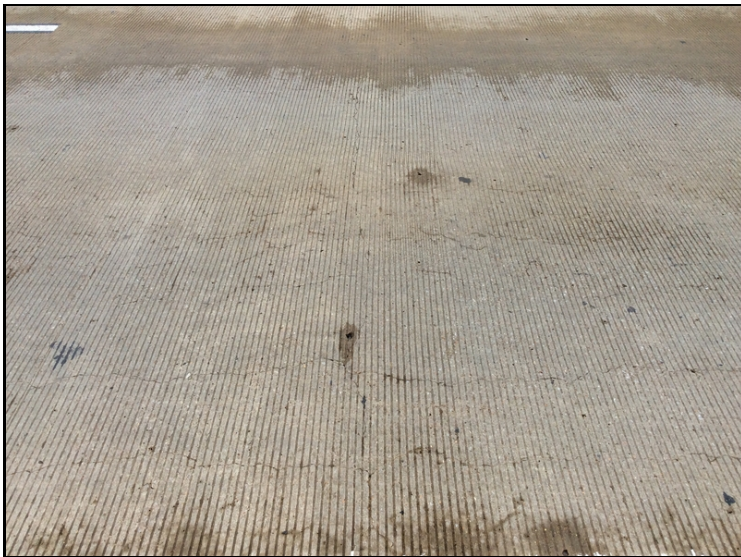
Deck has numerous unsealed transverse and longitudinal cracks.

Date Reported: 06/20/2018
Priority: C - Important
Type of Work: Repair (General)
Status: Monitor
Component: Deck
