Asset #03824(Routine)

SH 181-02- LM 1.75 over DRAINAGE DITCH NO. 40

Location: 1.75 MI N SH 140

Team Lead: Richard Jones, Inspection Date: 05/24/2022

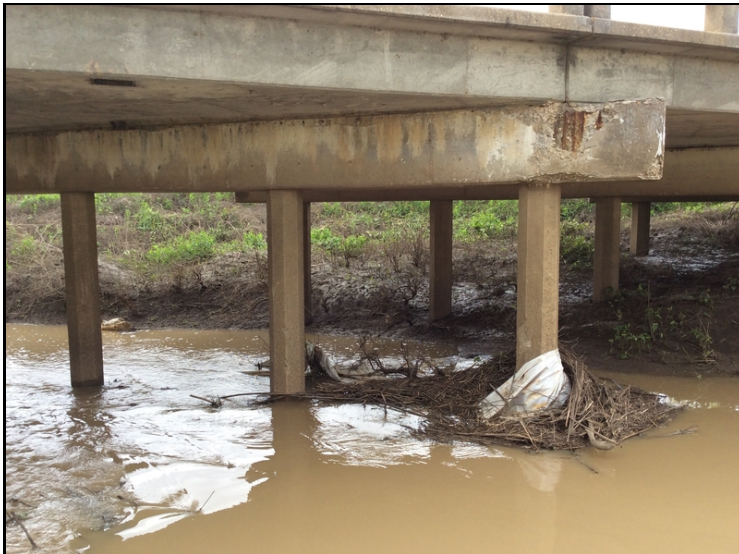
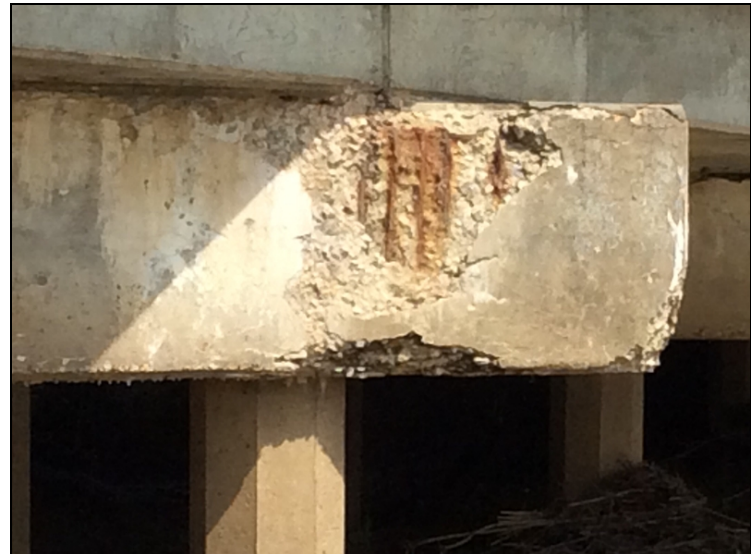
Bent 5 Rt

Concrete caps have several minor cracks, spalls, or delaminated areas near key ways.

Caps have a few minor cracks or spalls with exposed rebar on bottom.

Ends of caps have areas of concrete disintegration with some rebar exposed near Lt and Rt ends.

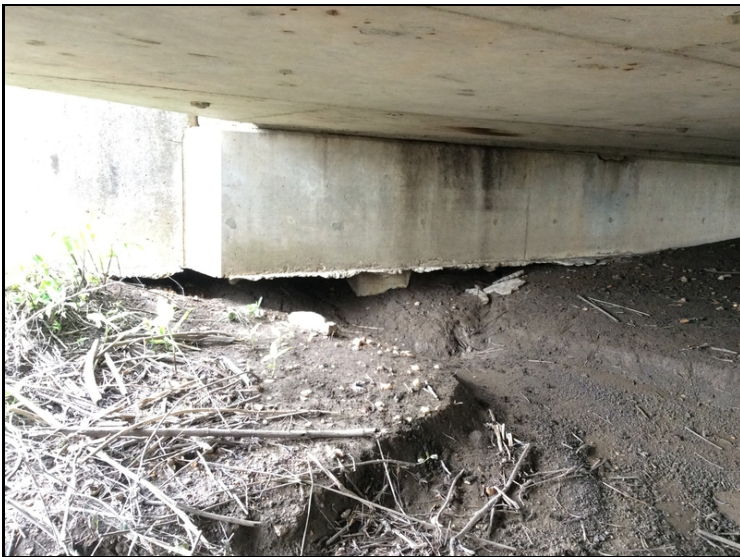
Bent 8 abutment is undermined for approximately 10' on Lt end up to 1.5' below and 2' back under.
