Asset #03825(Routine)

SH 181-02- LM 3.76 over DRAINAGE DITCH NUMBER 31

Location: 3.76 MI N SH 140

Team Lead: Richard Jones, Inspection Date: 05/24/2022

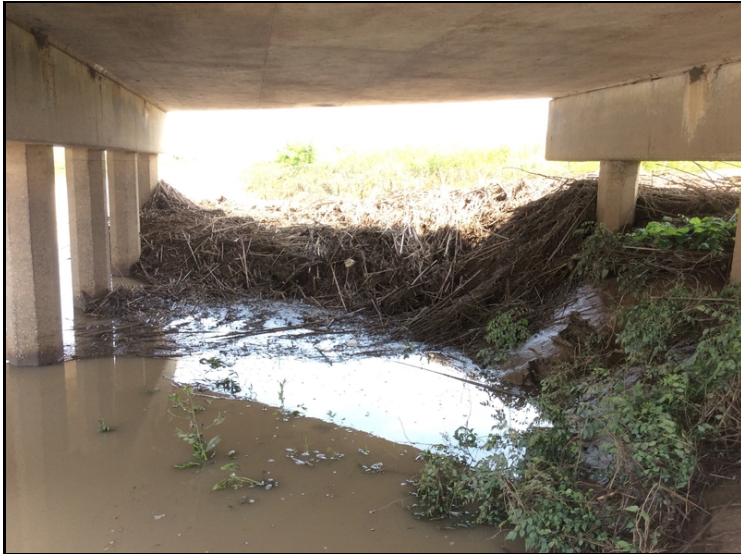
Moderate drift across span 3 & 7, see 2018 photo of span 3.

Majority of drift has been removed. Observed during routine inspection. RRJ

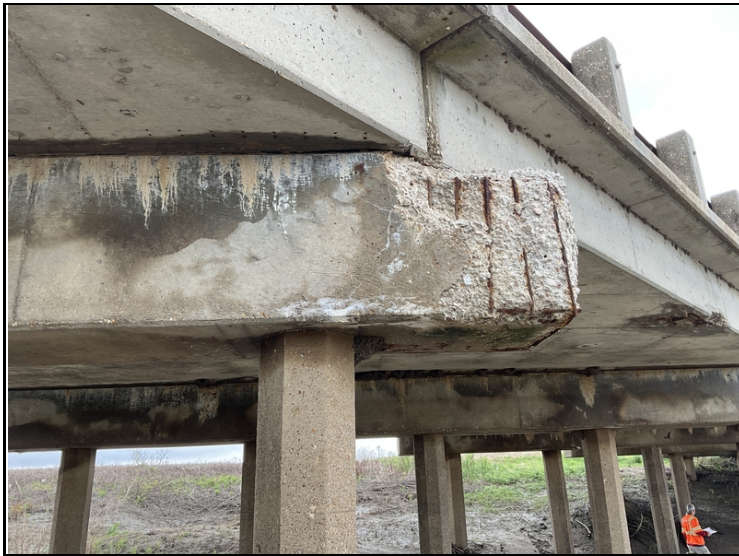
2022 - Bent 7 Lt

Ends of caps have areas of concrete disintegration with some rebar exposed near Lt and Rt ends, especially at bents 7 and 8.
