Asset #M2232(Routine)

SH 181-02- LM 0.49 over DITCH 44

Location: 0.5 MI N JCT SH 140

Team Lead: Richard Jones, Inspection Date: 10/19/2022

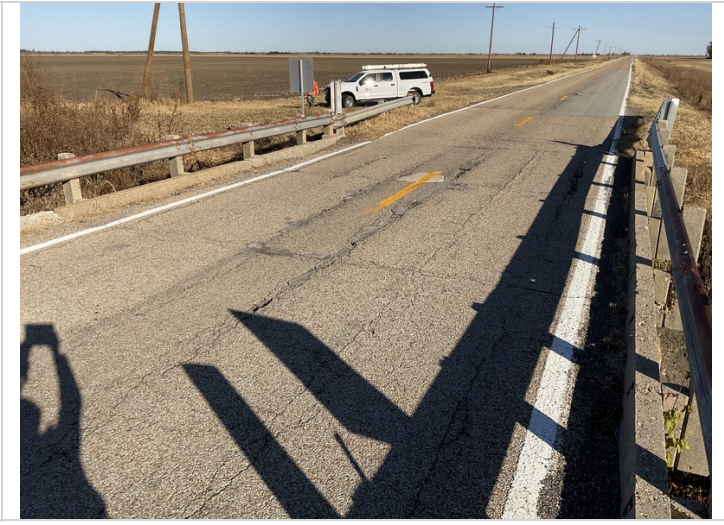
Asphalt wearing surface is cracked and delaminated over joints between units. Asphalt is raveling out along joints between units at spans 2 and 3. Units are moving/flexing under traffic.

wearing surface

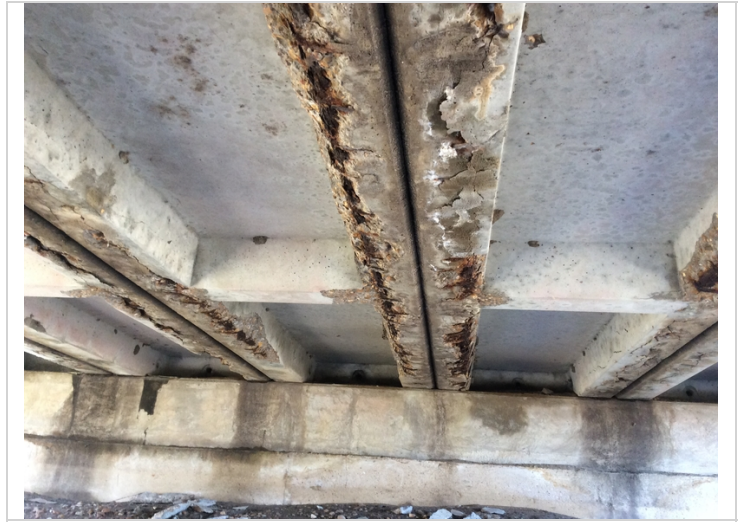
Soffit portion of exterior units have some cracks with efflorescence.

soffit

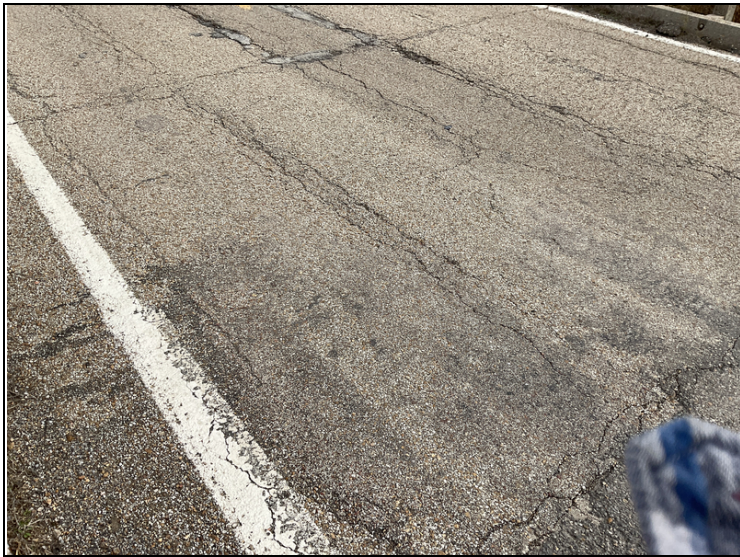
Span 1

Asphalt wearing surface is cracked and delaminated over joints between units. Asphalt is raveling out along joints between units at spans 2 and 3. Units are moving/flexing under traffic.

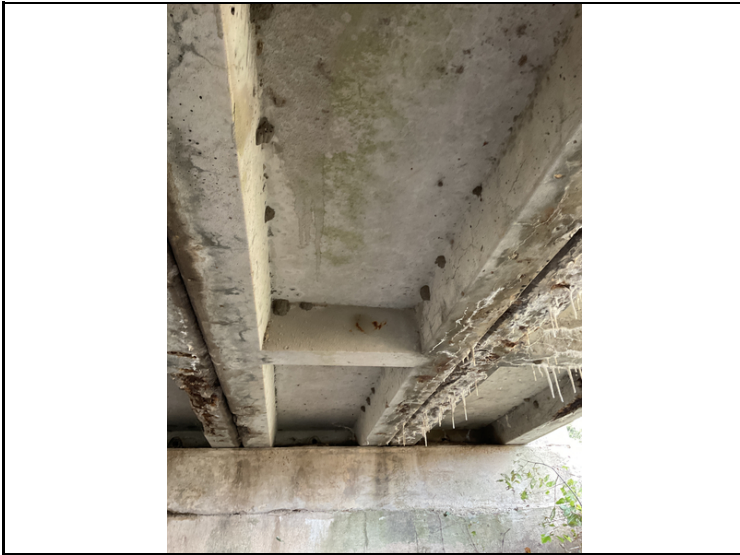
2021 - Span 1 unit 2

Span 1 unit 2 has 2' of rebar exposed on Rt leg. Lt leg has efflorescent map cracks throughout.

Concrete channel units have several areas of map cracks with efflorescence or rust stains. Girder portion has several longitudinal cracks and delaminated areas or spalls with rebar exposed.

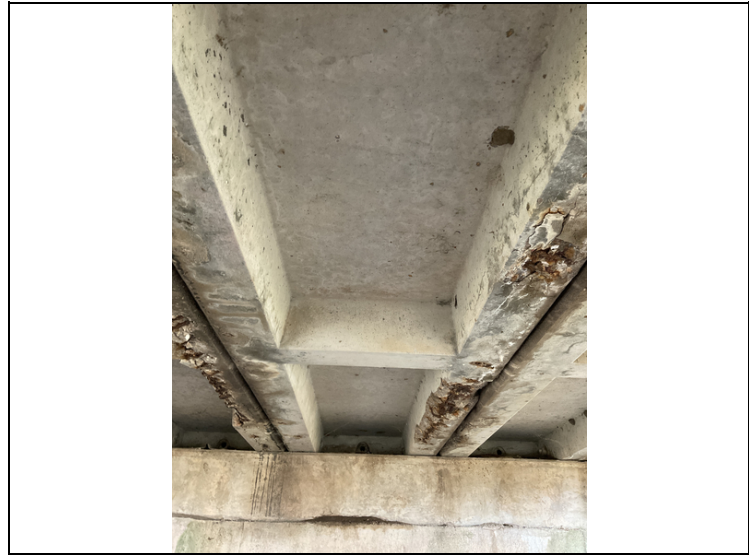
2021 - Span 1 unit 3

Span 1 unit 3 has 5' of rebar exposed on Lt leg.

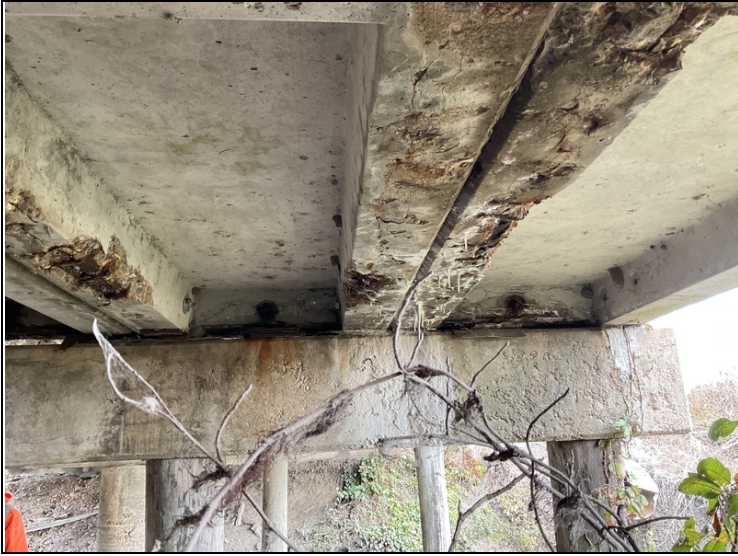
2021 - Span 1 units 6 and 7

Span 1 unit 6 has 11' of rebar exposed.

Span 1 unit 7 has 11' of rebar exposed. Unit has efflorescence map cracks on Lt leg and diaphragm at bent 2 end.

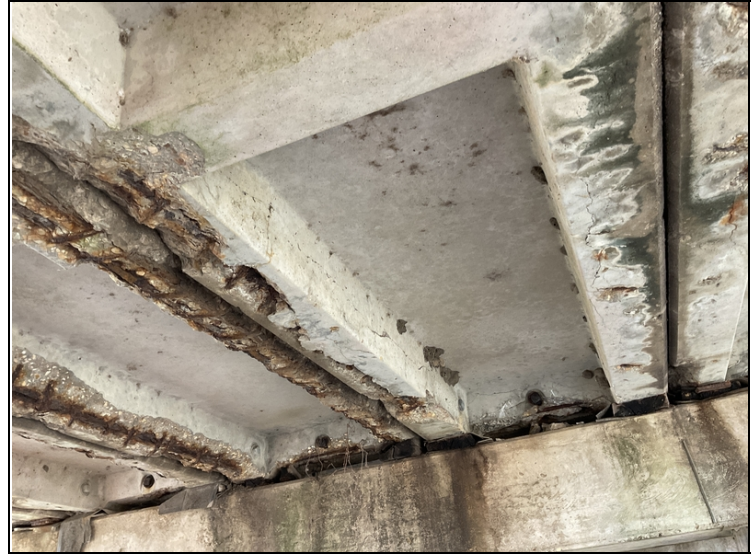
2021 - Span 2 bent 2 unit 3

Span 2 unit 3 has 7' of rebar exposed.

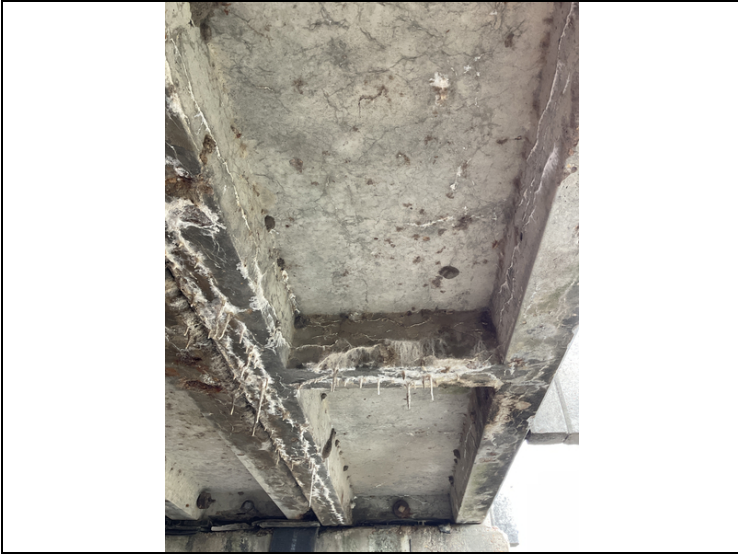
2021 - Span 2 unit 7

Span 2 unit 7 has efflorescence throughout. Legs have 2' of rebar exposed. Soffit has map cracks with efflorescence.

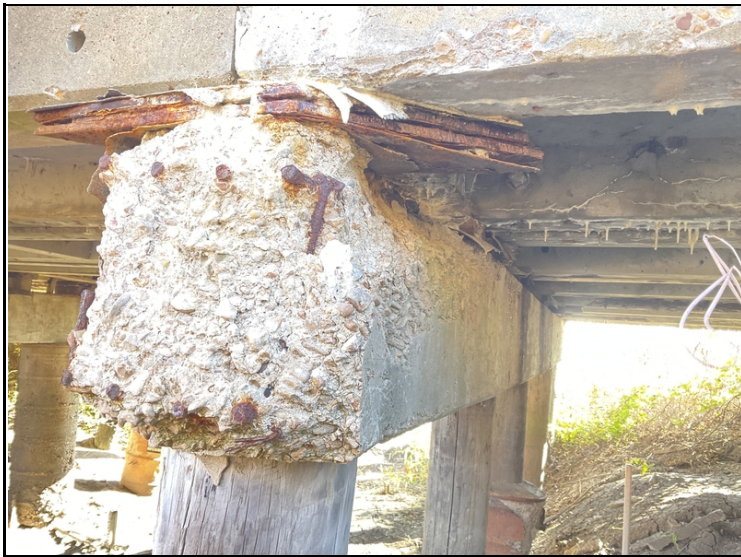
2022 - Bent 2 Lt

Bent 2 cap has 5' of concrete disintegration on Lt end. Top of cap is spalled up to 3.5" deep with exposed rebar and some loss of bearing area under unit 1.

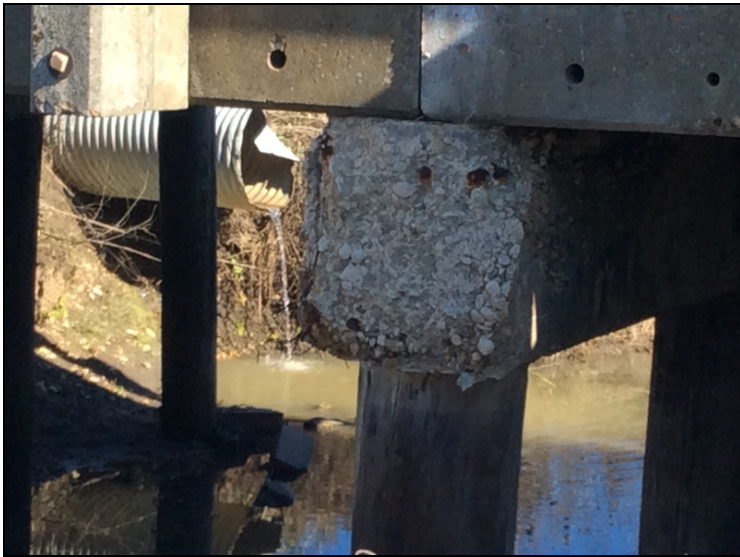
Left end bent 2 cap.

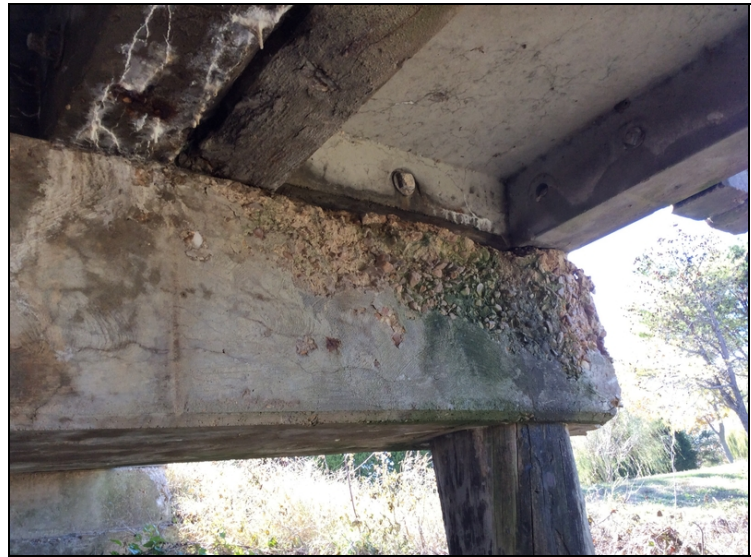
Left end bent 2 cap span 2 side.

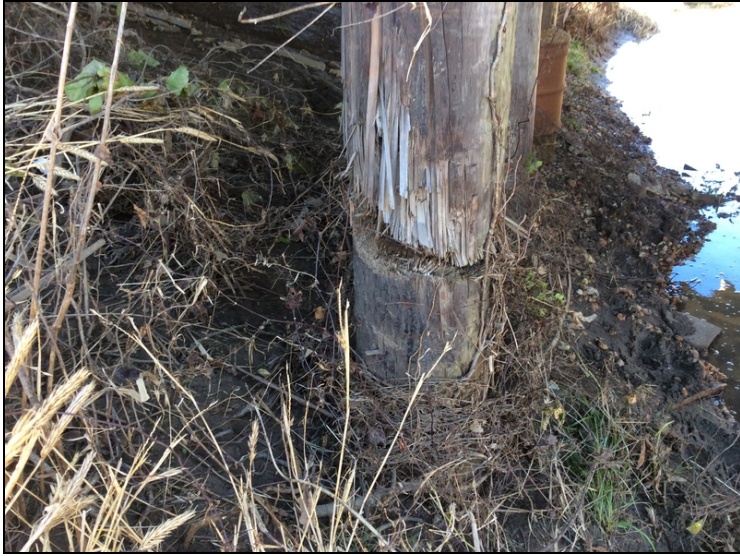
Bent 2 pile 5.

Bent 2 pile 5 has a 4" deep damaged area on Rt side. Possibly hit by bush hog.

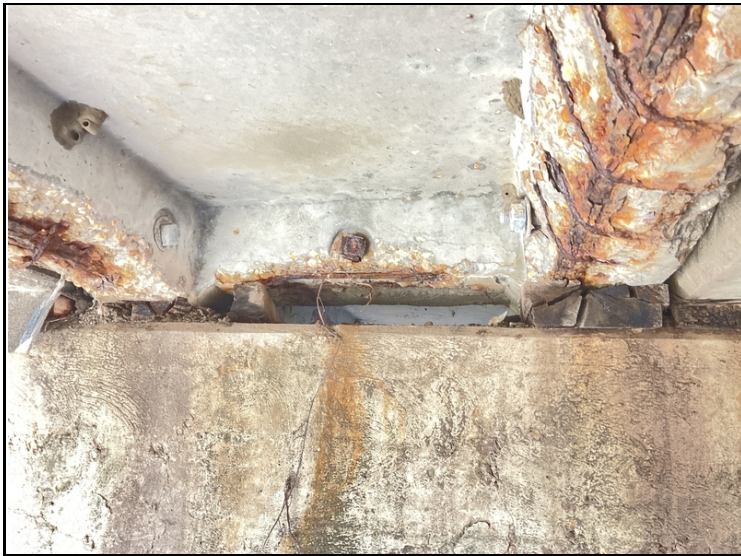
Bents 2 and 3 have had settlement noted since 2011. Caps have settlement cracks near center line 1/16" - 1/8" wide. Units over bents 2 and 3 have steel, timber, or rubber shims between cap and units to level the deck. Shims are up to 8" thick. Several timber shims are decayed, split, and crushing under units. Bent 3 cap has a 2.5" bow and settlement cracks from piles 2 -4. Lt end of cap is approximately 6.25" lower than Rt end.

Timber shims

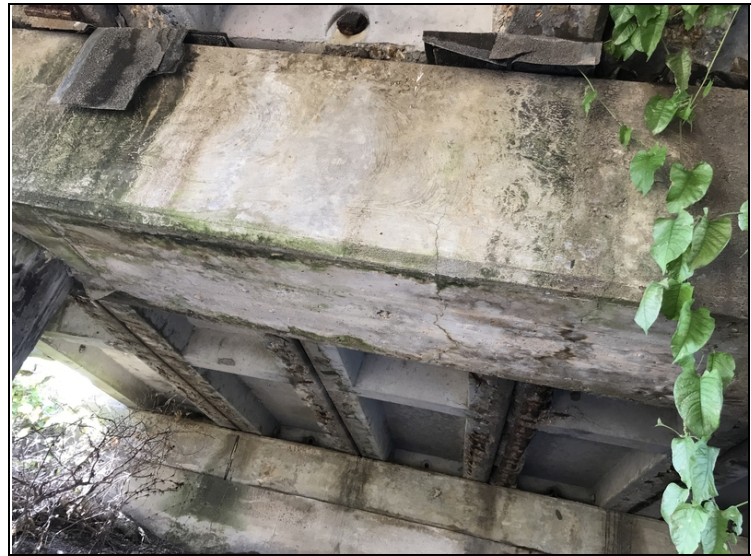
Bent 2 cracks

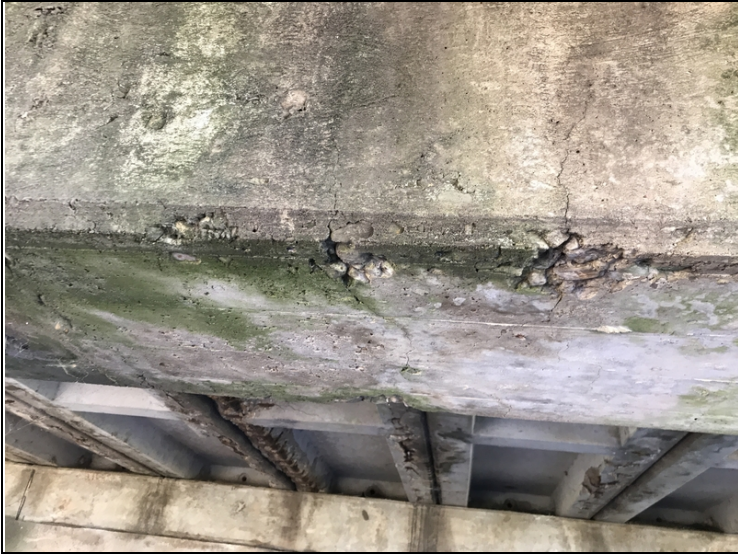
Bent 2 cracks

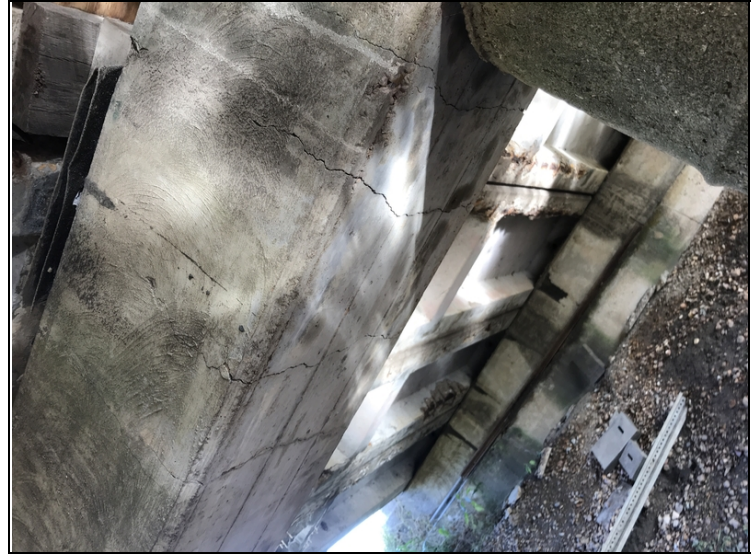
B3 left p3

Pile 3 is encased in concrete above ground level. Pile 3 is partially exposed under encasement. Pile has some outside decay.

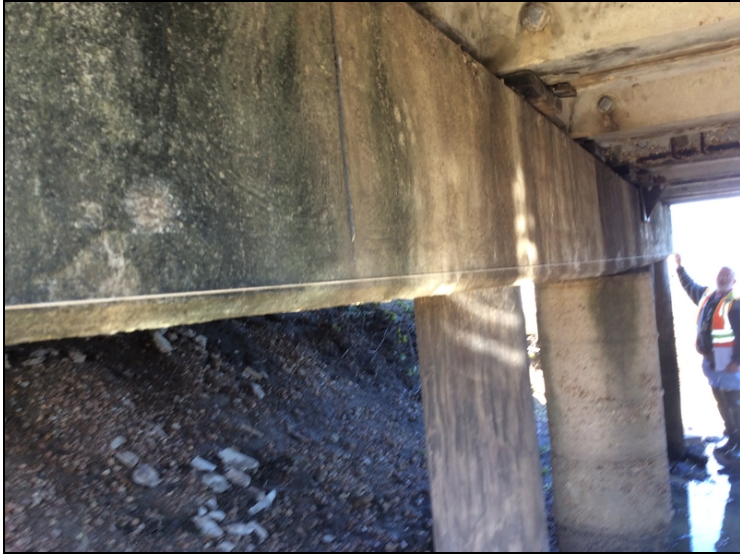
Bent 3 cap.

Bent 3 cap has a 2.5" bow and settlement cracks from piles 2 -4. Lt end of cap is approximately 6.25" lower than Rt end.

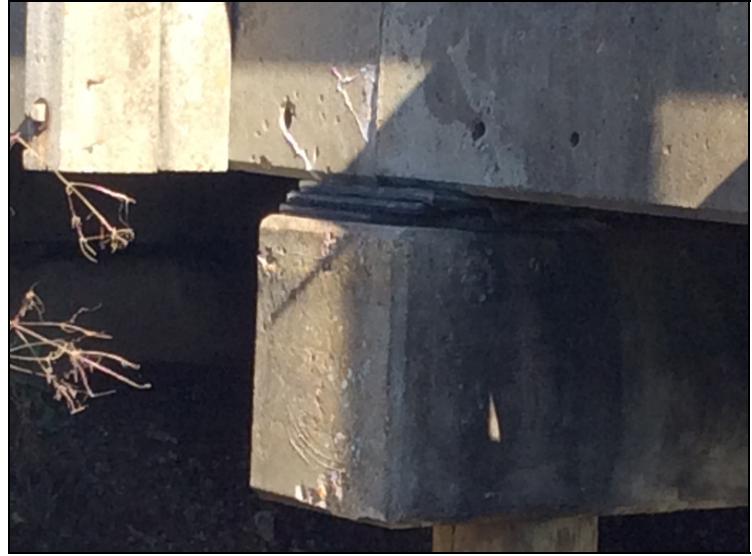
**Bent 3 repair.**

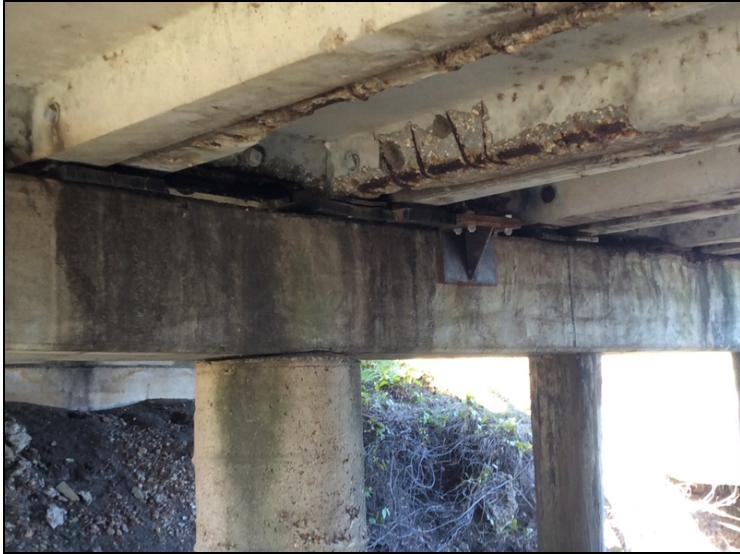
Bent 3 cap repair span 2 side.

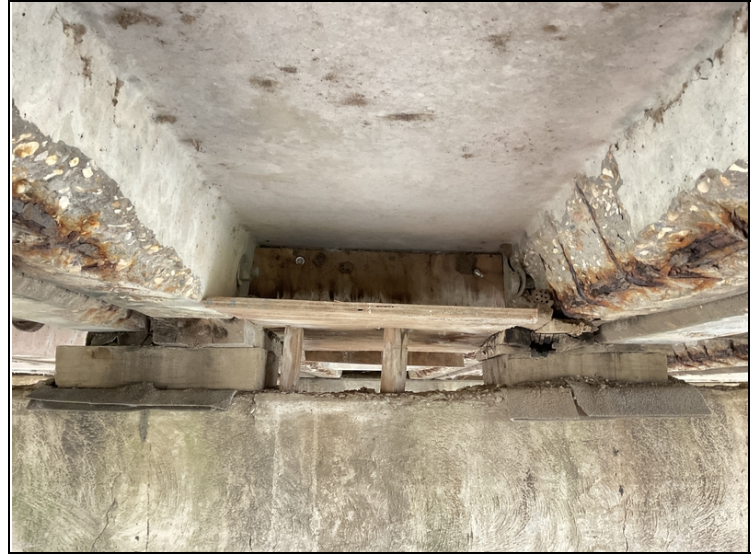
2021 - Span 2 bent 3 unit 4

Span 2 bent 3 unit 4 has a full depth patch at diaphragm on end.

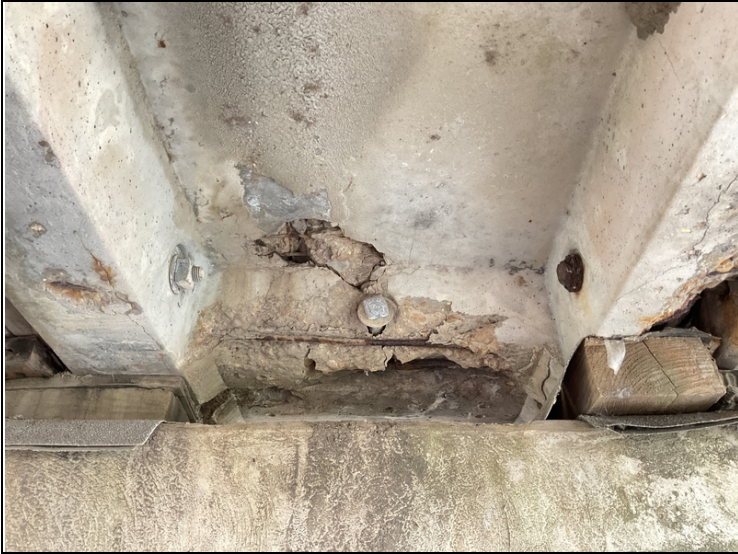
2021 - Span 2 bent 3 unit 5

Span 2 bent 3 unit 5 has a 6" diameter hole with reinforcement wire exposed on soffit portion.

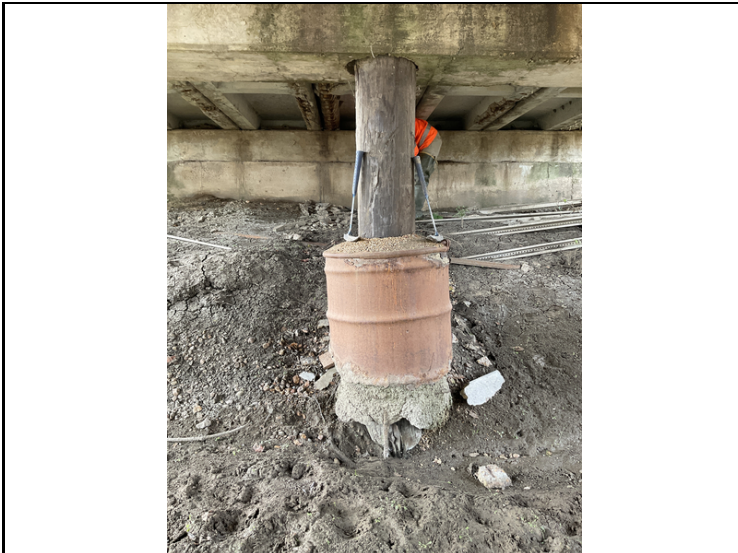
Bent 2 pile 3 was spliced in the past. Pile is exposed beneath concrete collar. Pile below splice has some outside decay.

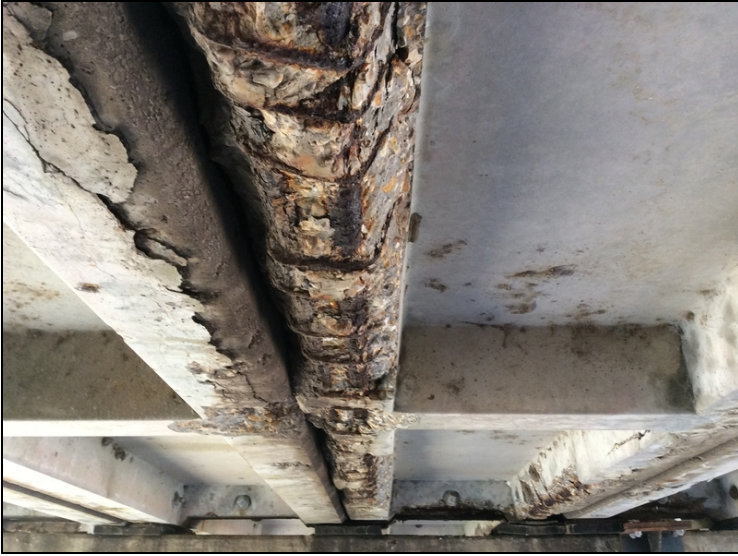
Span 2 unit 4.

Span 2 unit 4 has 14' of rebar exposed.

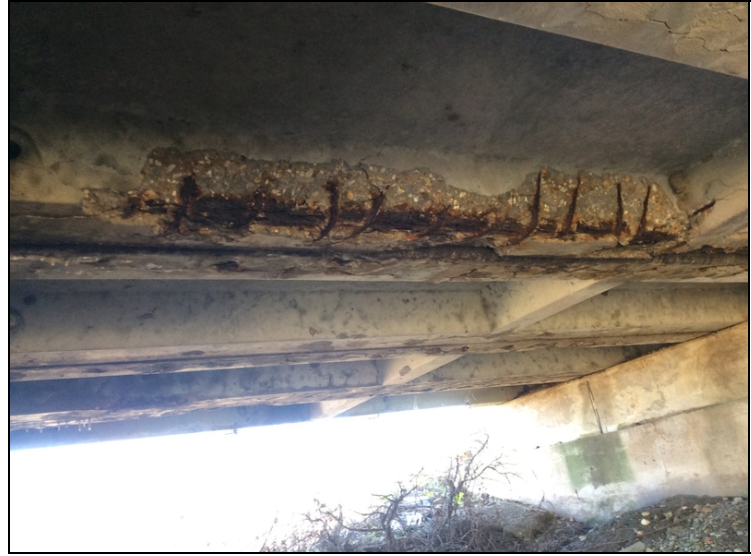
Span 1 unit 4.

Span 1 unit 4 has 13' of rebar exposed. Stirrup bars have up to 100% section loss.

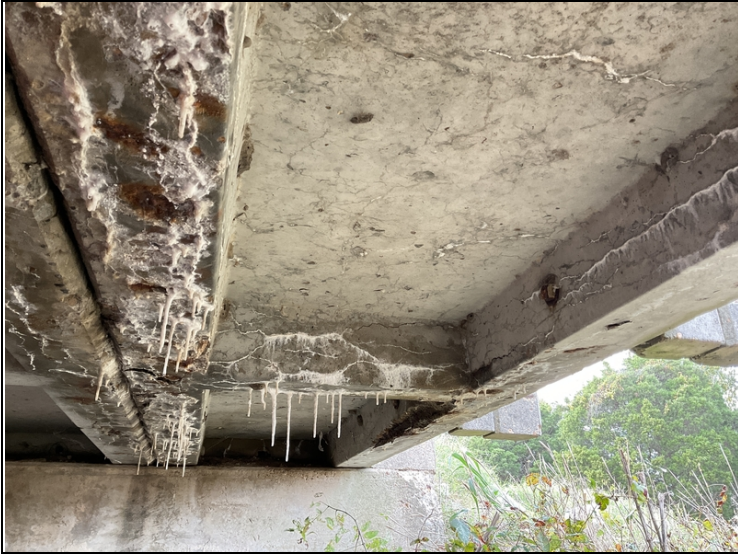
2021 - Span 1 unit 1

Span 1 unit 1 has efflorescent map cracks throughout, and 3' of rebar exposed.

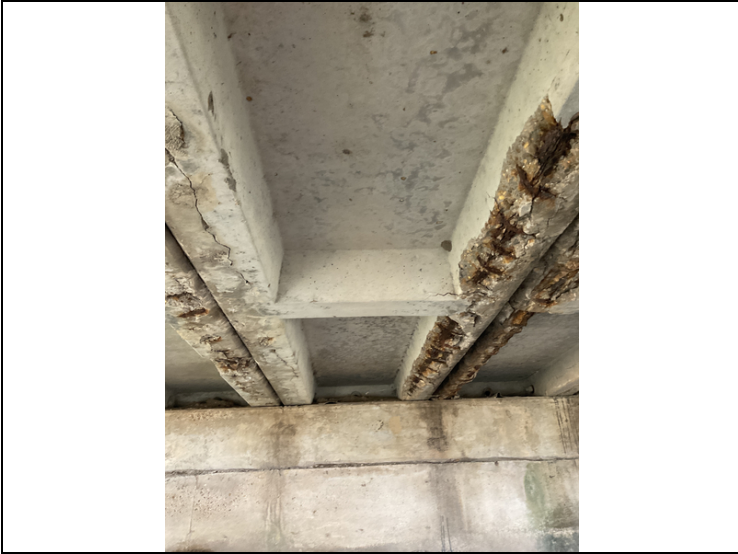
2021 - Span 1 unit 5

Span 1 unit 5 has 8' of rebar exposed.

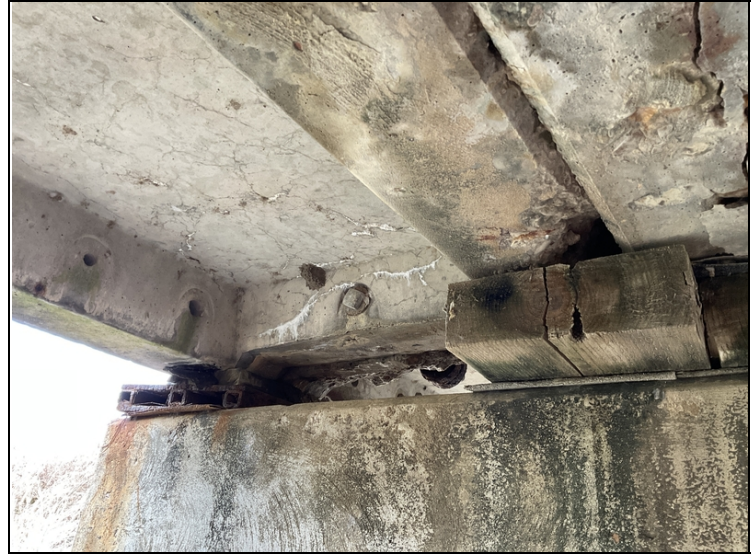
2021 - Span 2 bent 3 unit 1

Span 2 unit 1 has 6' of stirrup bars exposed. Rt leg over bent 3 is spalled with rebar exposed. Soffit has map cracks with efflorescence.

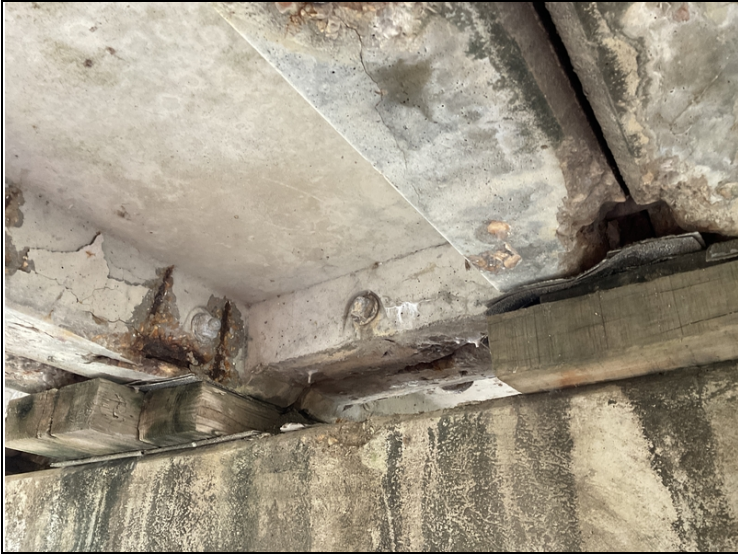
2021 - Span 2 bent 2 unit 2

Span 2 unit 2 has 9' of rebar exposed. Rt leg is spalled over shims at bents 2 and 3.

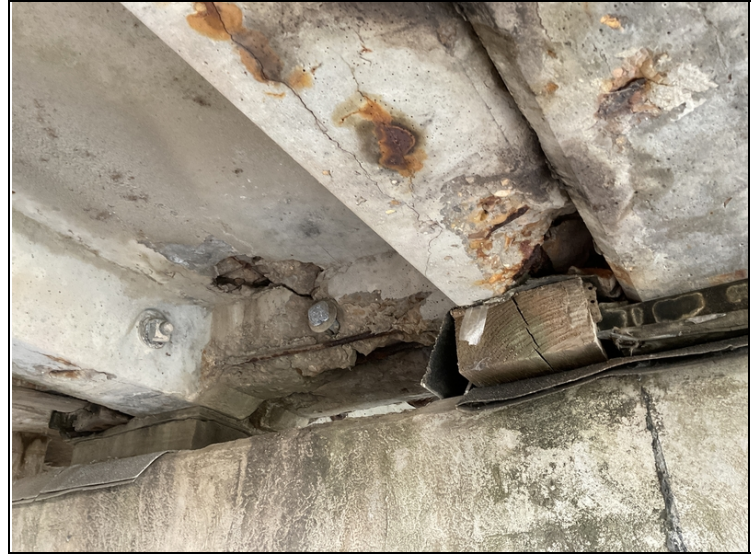
2021 - Span 2 bent 3 unit 5 Rt leg

Span 2 unit 5 has 8' of rebar exposed. Rt leg is spalled over shims at bent 3.

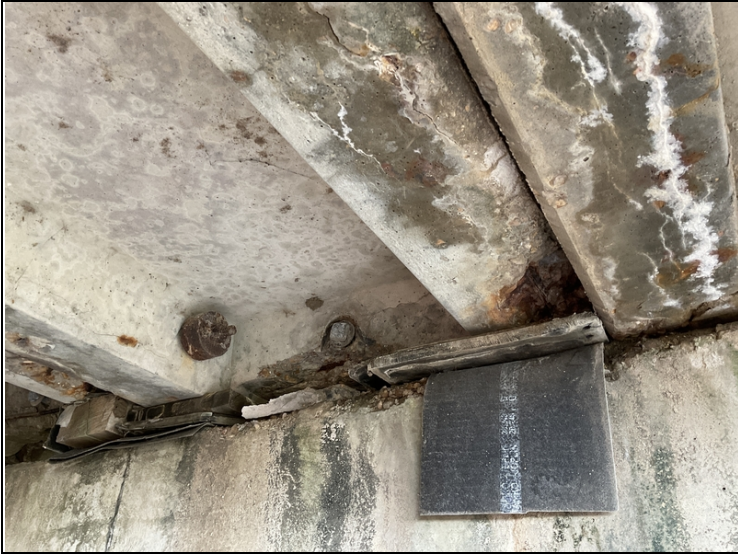
2021 - Span 2 bent 3 unit 6 Rt leg

Span 2 unit 6 has 5' of rebar exposed. Rt leg is spalled over shims at bent 3

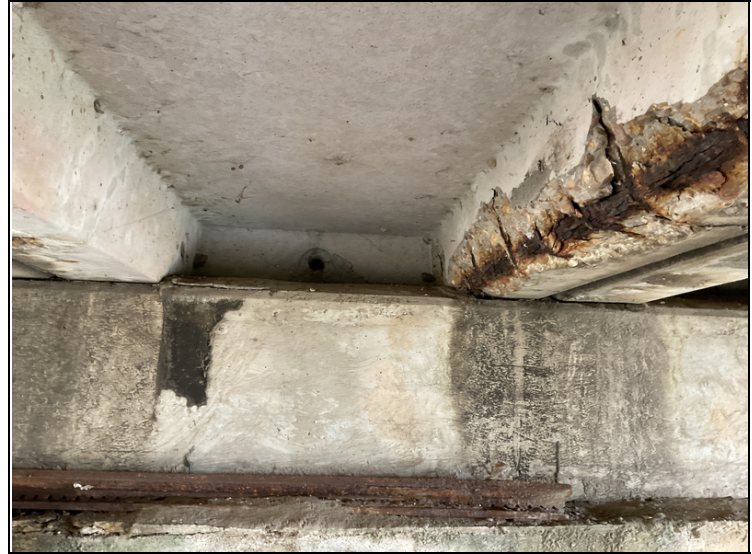
2021 - Span 3 unit 3 - bent 4 end

Span 3 unit 3 has 13' of rebar exposed.

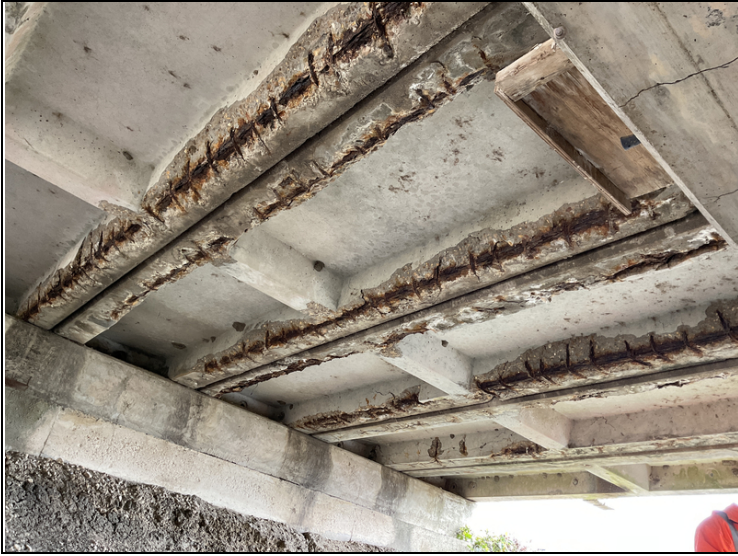
2021 - Span 3 units 3 - 5

Span 3 unit 4 has 12' of rebar exposed. Top flange portion has a full depth patch at bent 3 end. Patch was poured even with bottom of girders. Forms were left in place.

Span 3 unit 5 has 13' of rebar exposed.

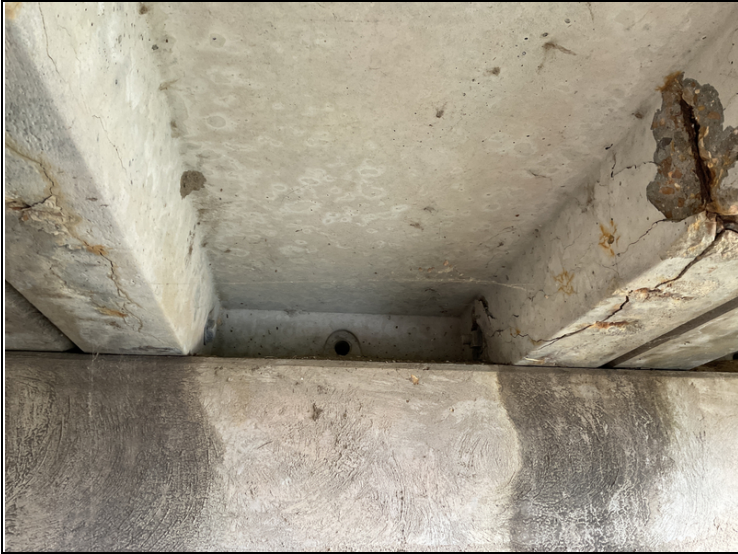
2021 - Span 3 bent 4 unit 6

Span 3 unit 6 has 9' of rebar exposed.

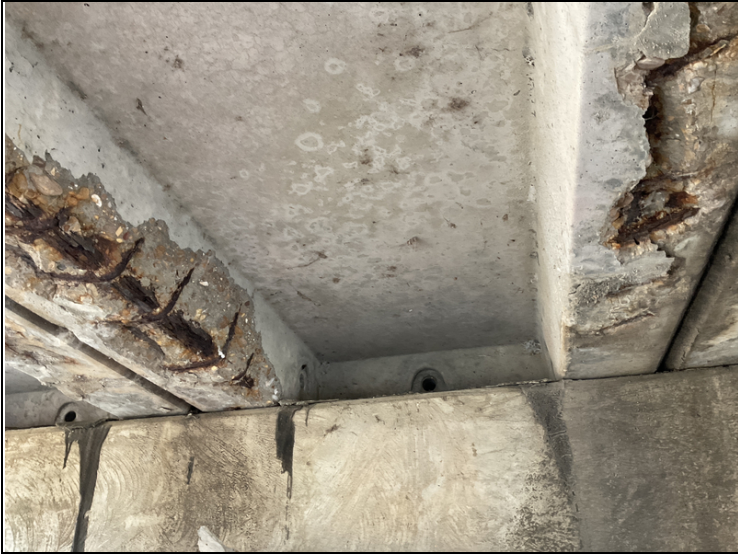
2021 - Span 3 unit 2 - bent 4 end

Span 3 unit 2 has 7' of rebar exposed.

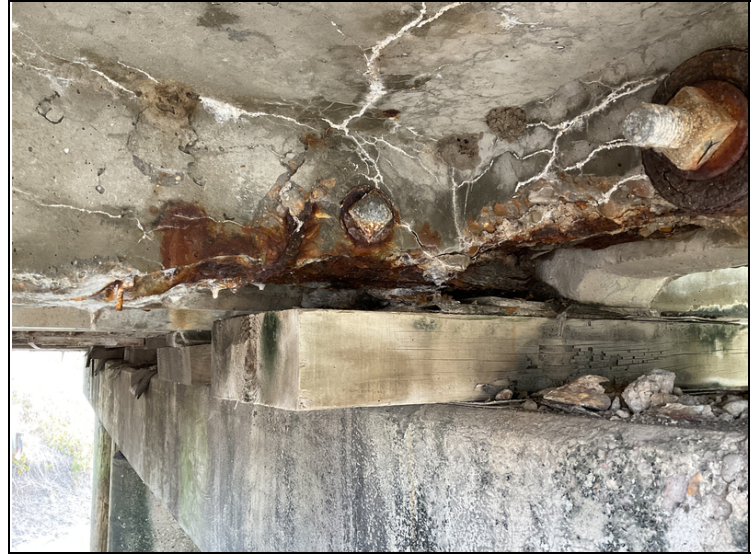
2021 - Span 3 bent 3 unit 1 - Rt leg

Span 3 unit 1 has 5' of rebar exposed. Rt leg at bent 3 end has a possible shear crack at transverse bolt connection. Crack has efflorescent buildup, and runs into soffit portion of unit.

Combined some of these from previous maintenance needs and increased priority to A due to the continued deterioration on ends and the possible shear crack on Unit 1 at beginning of span 3. - RRJ 10/27/21
