Asset #05201 (Routine, Underwater type 2)

SH 351-00 LM 0.05 over WHITEMAN DITCH

Location: 0.10MI N SH 63

Team Lead: James Adams, Inspection Date: 12/13/2022

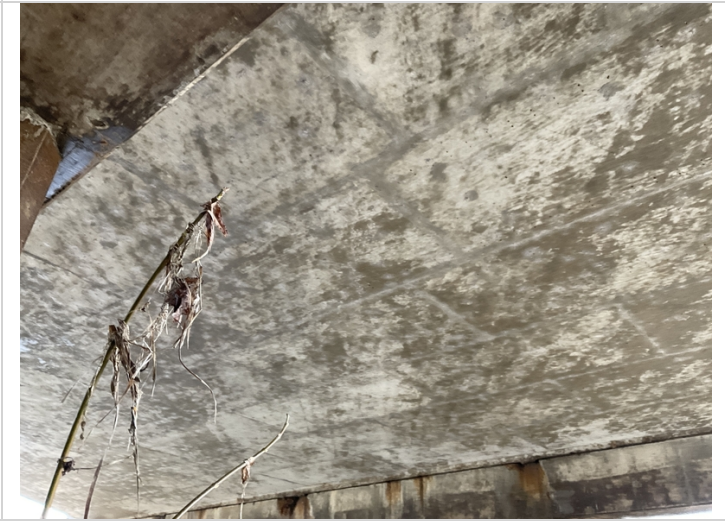
Slab soffit has a few longitudinal cracks. Soffit has a few small delaminated areas and a few small spalls with exposed rebar.

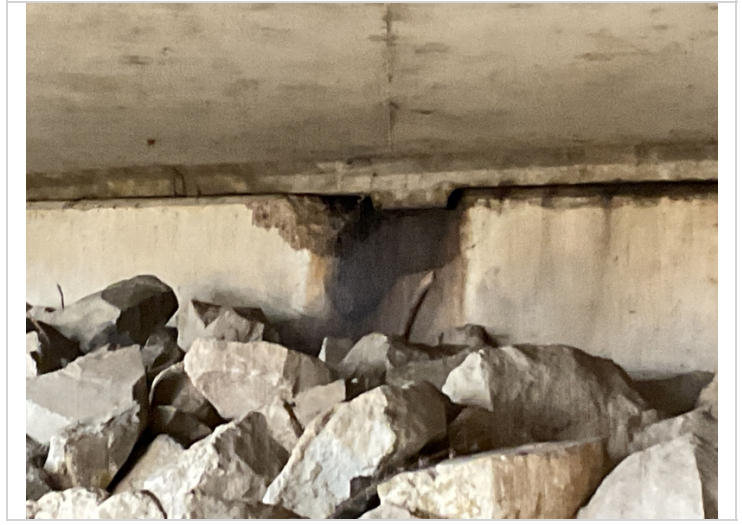
Underwater type 2 inspection performed this report. Minor scour at bent 2. Caps and abutments have cracks, spalls, or delaminated areas at key ways. Bent 1 abutment has 3ft. of map cracking & delamination near center keyway. Bent 2 cap has a 2ft. x 1ft. x 8in. deep spall with exposed rebar on span 2 side at center key way. Bent 3 cap has a 4ft. x 1.5ft. x 6in. deep spall with exposed rebar on span 2 side at left key way. Channel was excavated in 2018 and rip rap was placed on slopes. Minor drift under span 1.

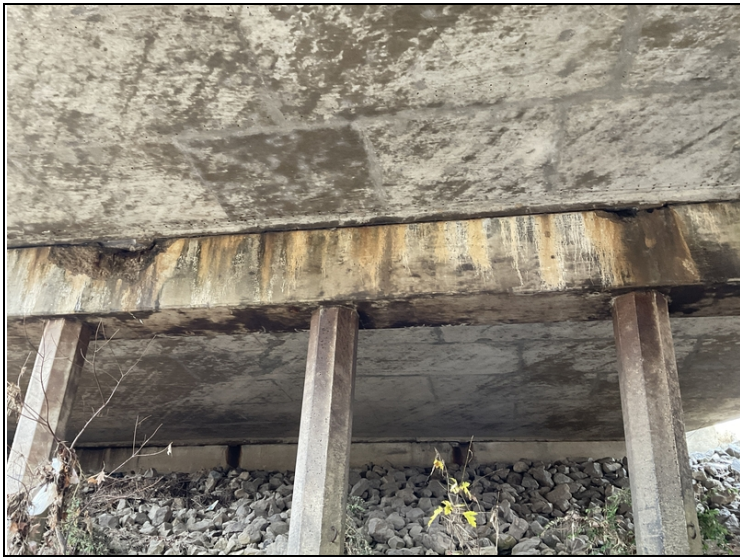
Span 2 bent 3 cap

Bent 3 cap has a 4ft. x 1.5ft. x 6in. deep spall with exposed rebar on span 2 side at left key way.

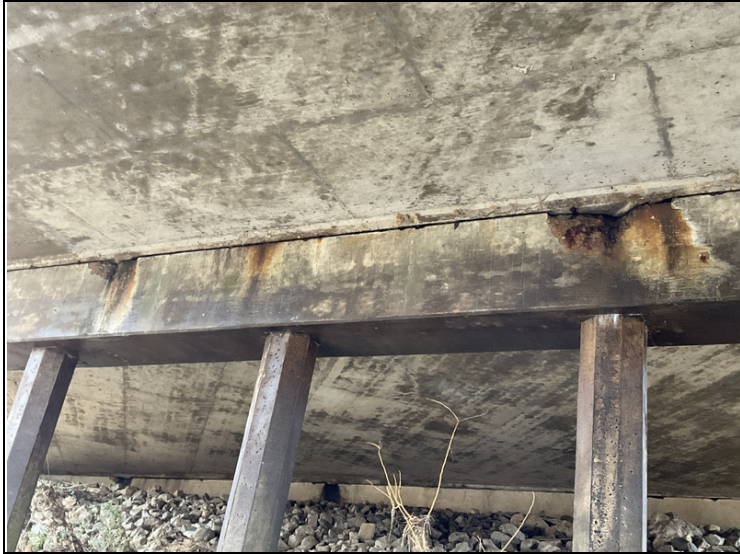
Span 2 bent 2 cap

Bent 2 cap has a 2ft. x 1ft. x 8in. deep spall with exposed rebar on bent 2 side at center key way.

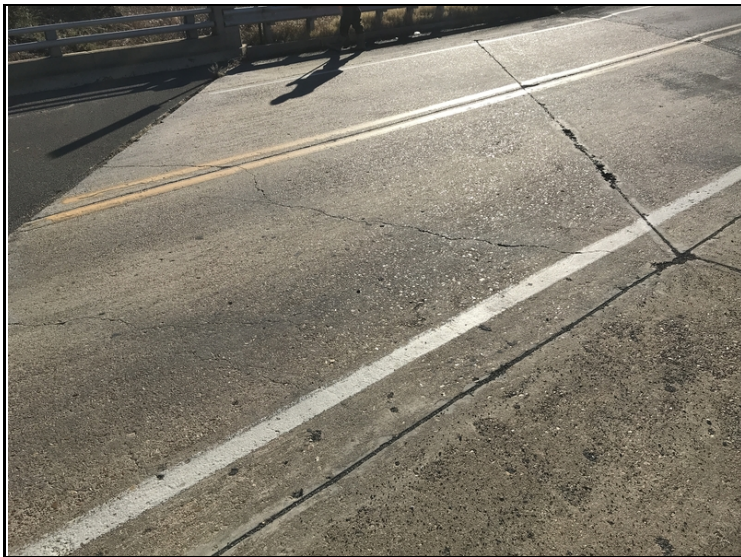
Approach slab cracks

Concrete approach slabs have open unsealed cracks.

HBM to apply polymer overlay

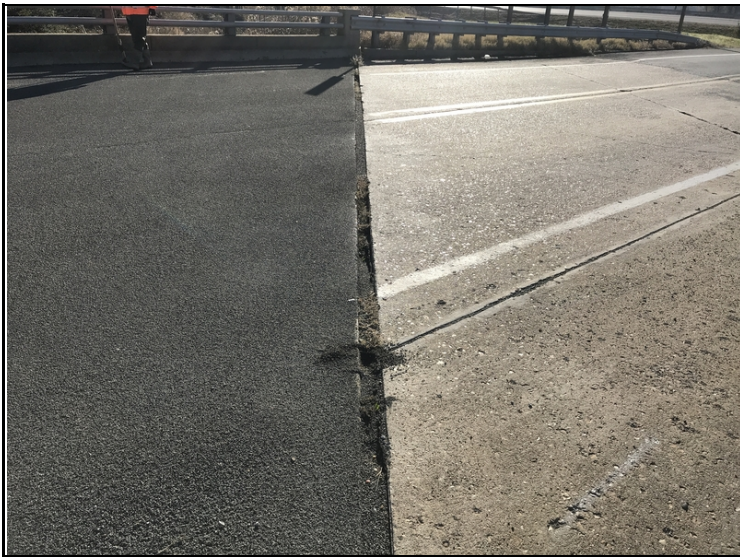
Typ gap at approach slabs

Approach roadways have gaps between roadway and approach slabs. Approach gutters have a few areas beginning to undermine.
