Asset #06012(Routine)

US 49-04- LM 8.20 over BLACK FORK DITCH

Location: 1.5 MI S OF SH 226

Team Lead: James Adams, Inspection Date: 12/07/2022

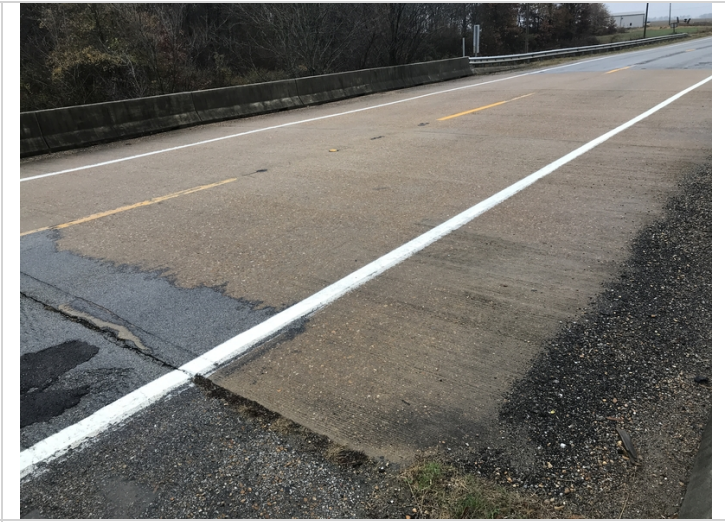
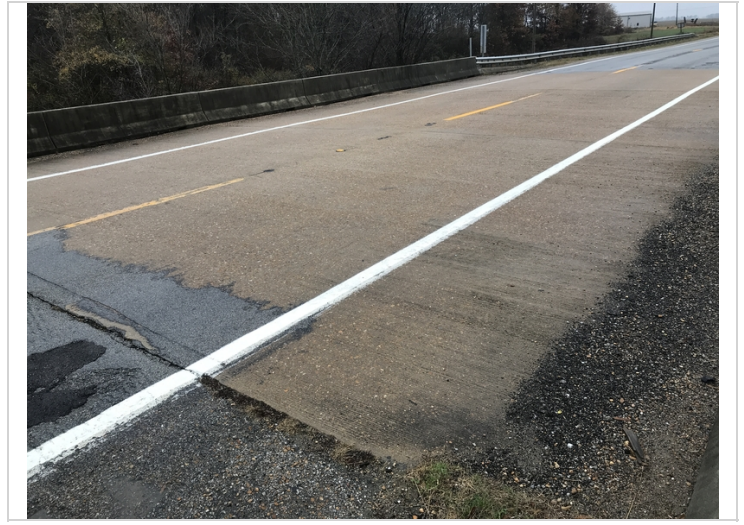
Deck

Top of slab has minor abrasion and a few moderate width longitudinal cracks.

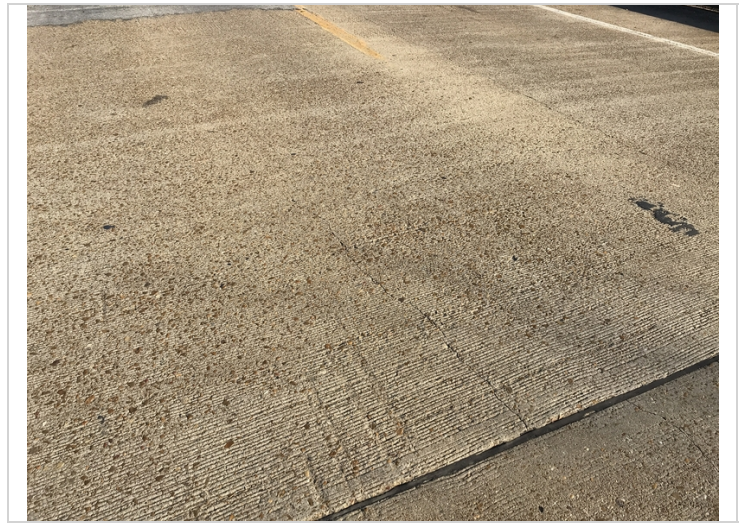
Longitudinal cracks and abrasion

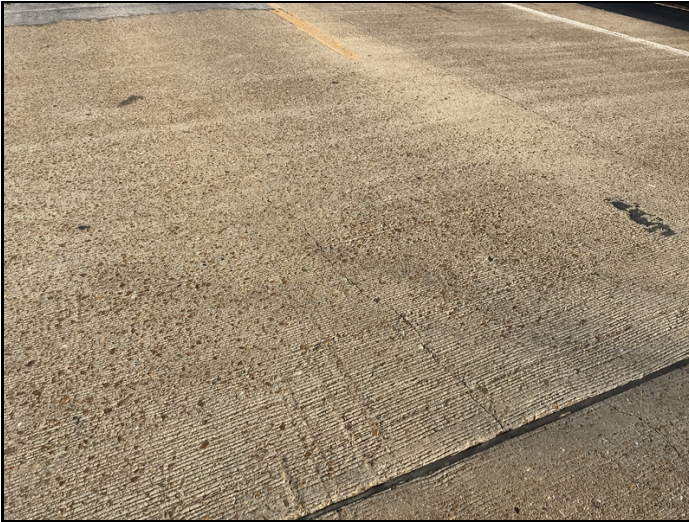
*Top of slab has minor abrasion and a few moderate width longitudinal cracks.

Longitudinal cracks and abrasion

*Closed and added to Routine Maintenance page, 12-7-2022. JFA/CWS

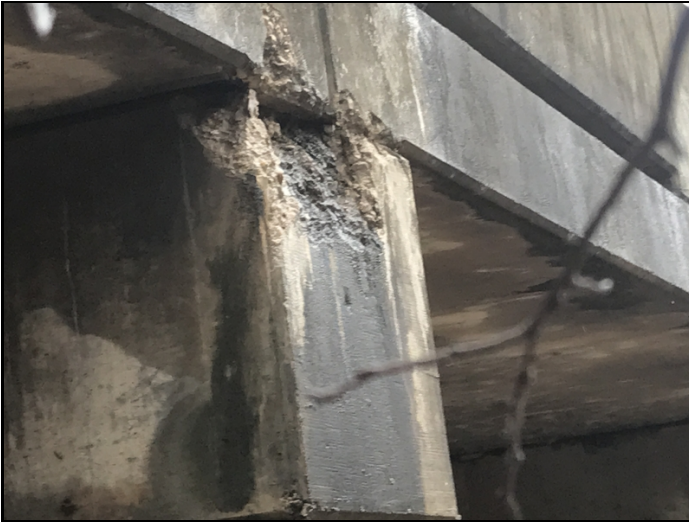
Bent 3 left 12-7-2022

Bent 3 cap has spalls at top of cap on Lt and Rt ends.

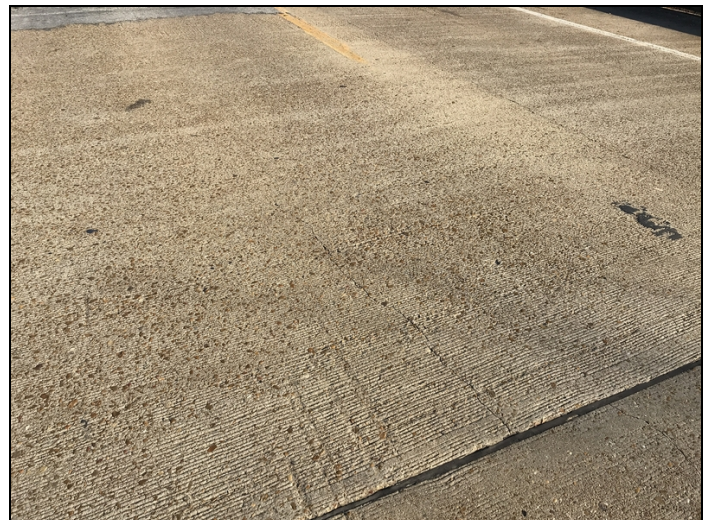
Longitudinal cracks and abrasion

A-54 - Sealable Deck Cracks (Yes)
