Asset #A7224(Routine)

## US Hwy 412 Spur over Eight Mile Creek

Location: 4.9 miles E of Hwy 49

Team Lead: Tim Myrick, Inspection Date: 10/20/2022

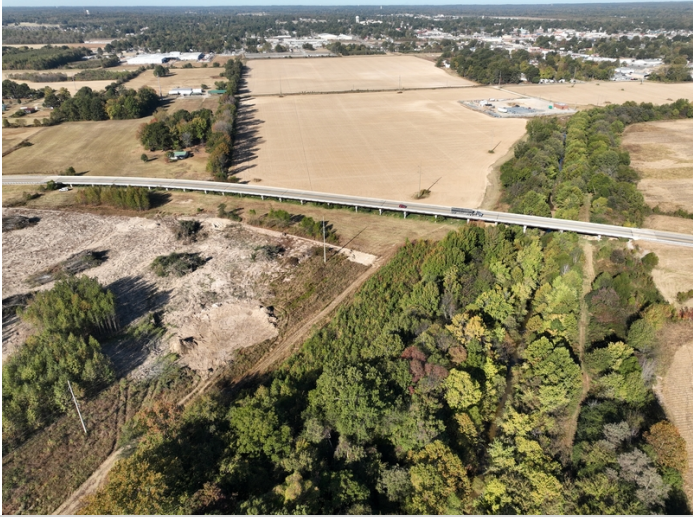
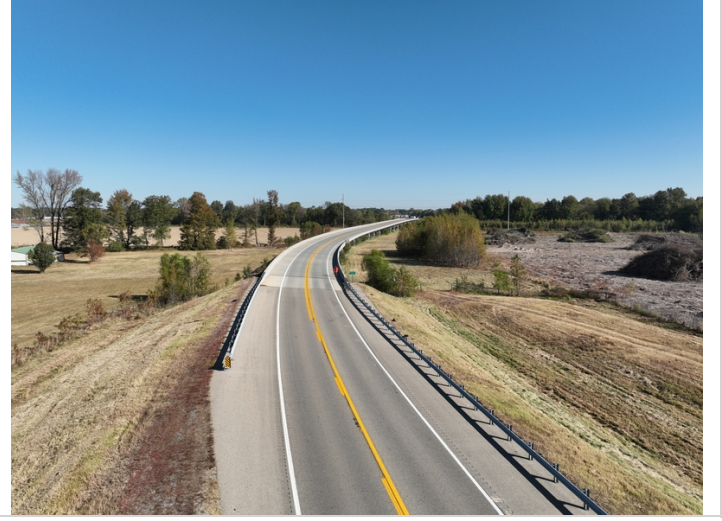
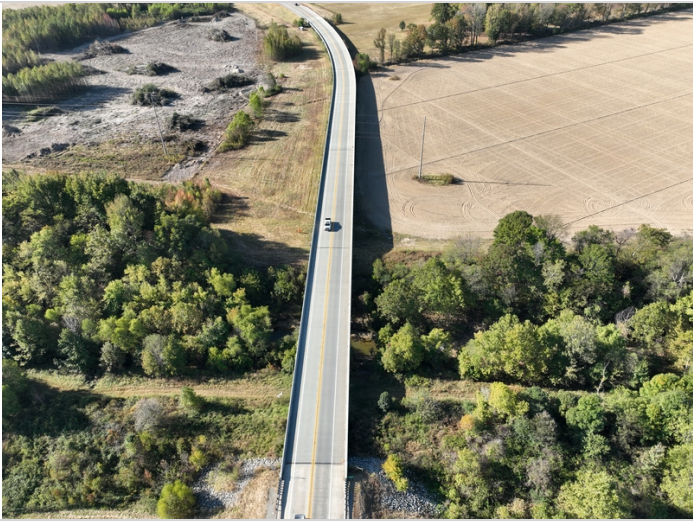
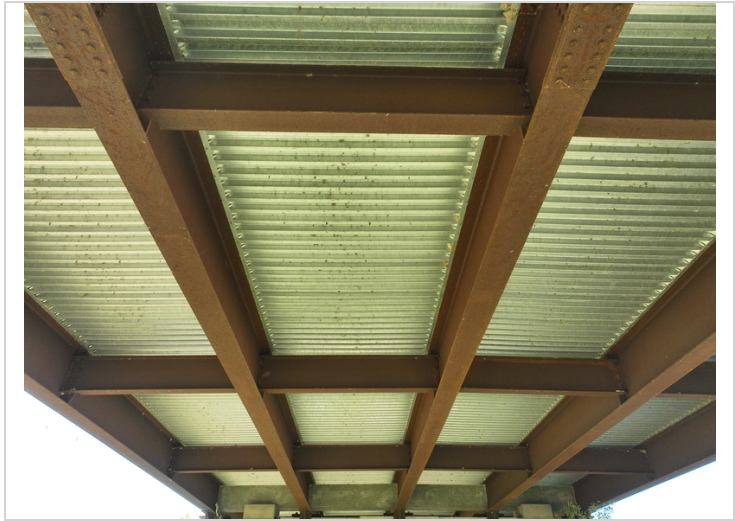
Deck has a few unsealed transverse and longitudinal cracks.

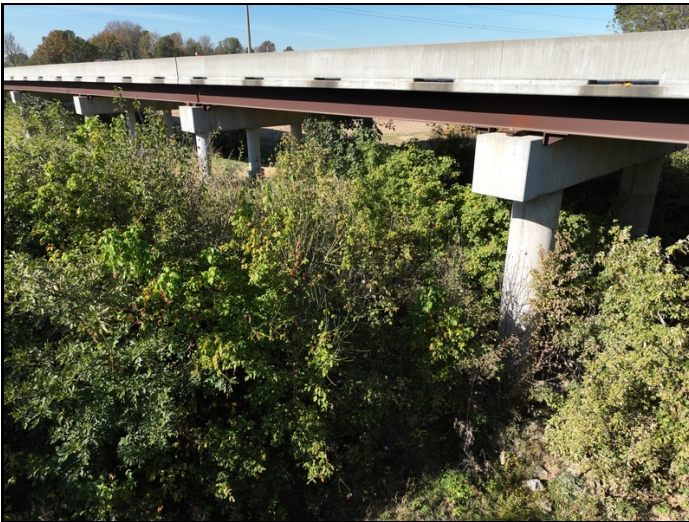
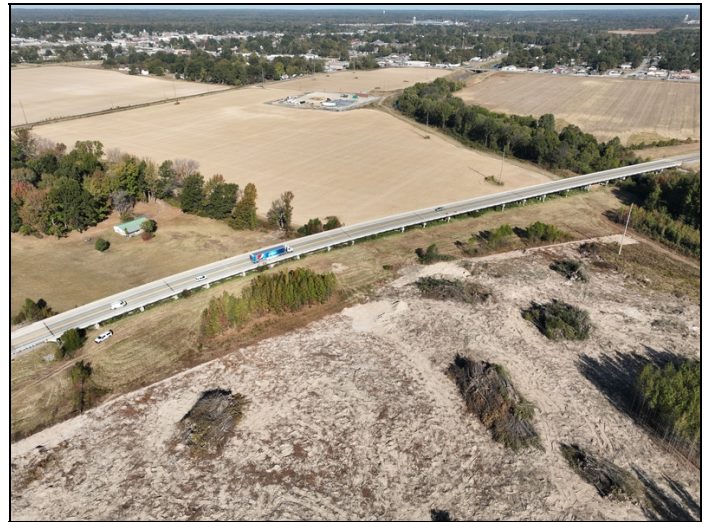
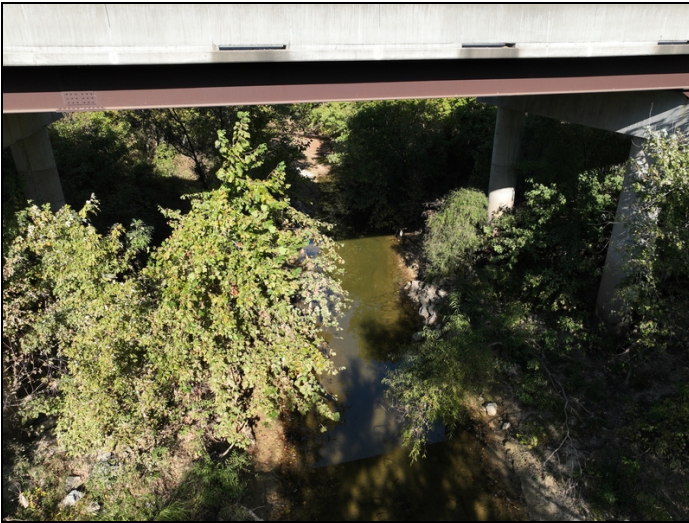
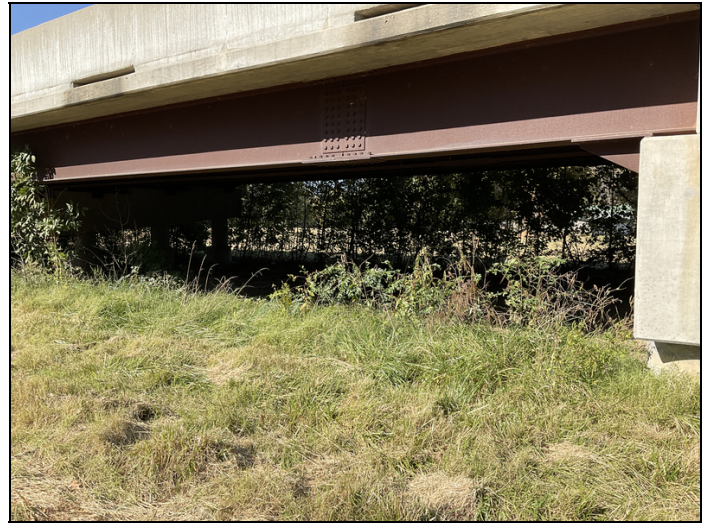
Moderate sized brush & small trees & some large logs under bridge.  
Minor erosion at bents 22 & 23.
