Asset #02138(Other Special Recurring, Underwater type 2)

SH 77-02- LM 0.71 over DITCH NO 13

Location: .70 MI S JCT SH 18

Team Lead: James Adams, Inspection Date: 06/06/2023

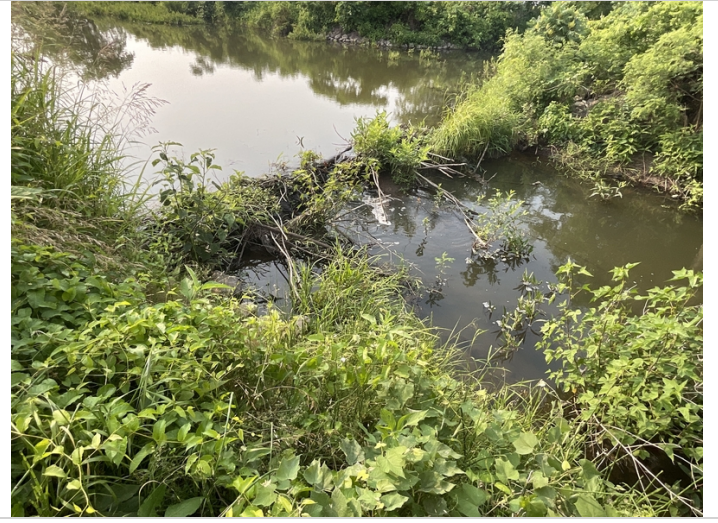
Beaver dam upstream  
6-6-2023

Large beaver dam east side in channel is restricting flow.

**Type of Work:** Channel Work/Drift Removal

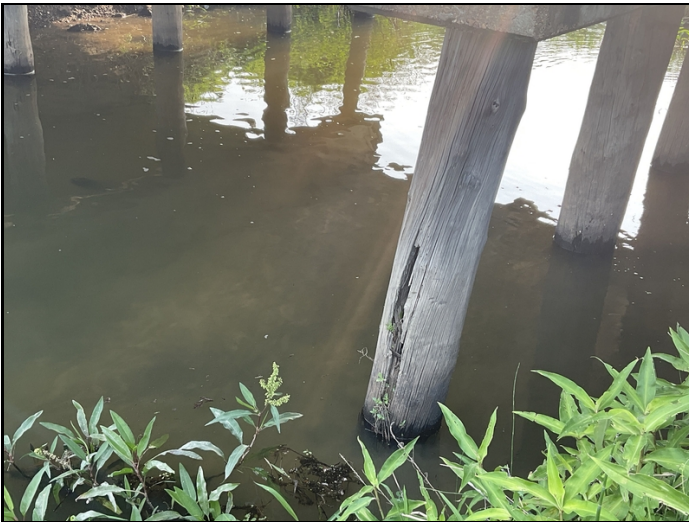
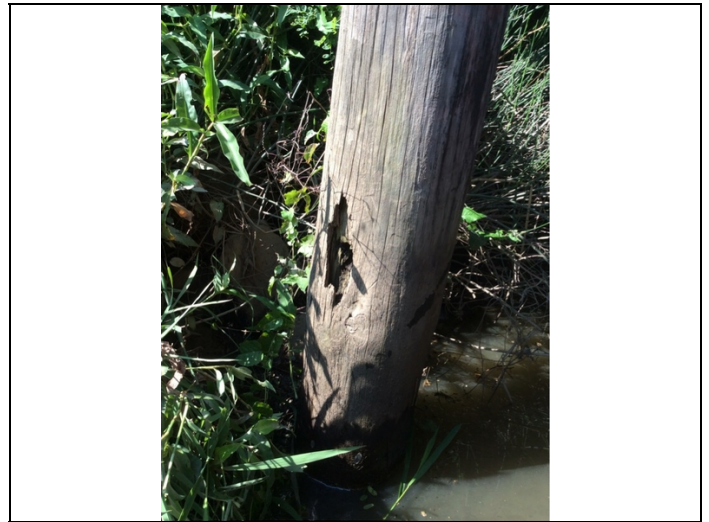
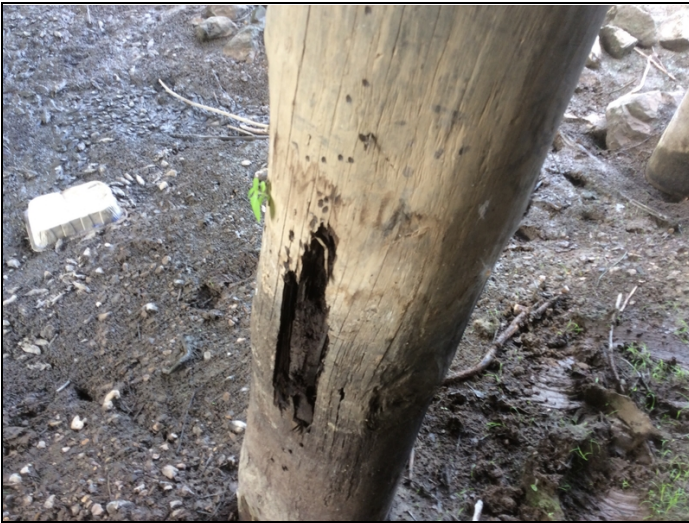
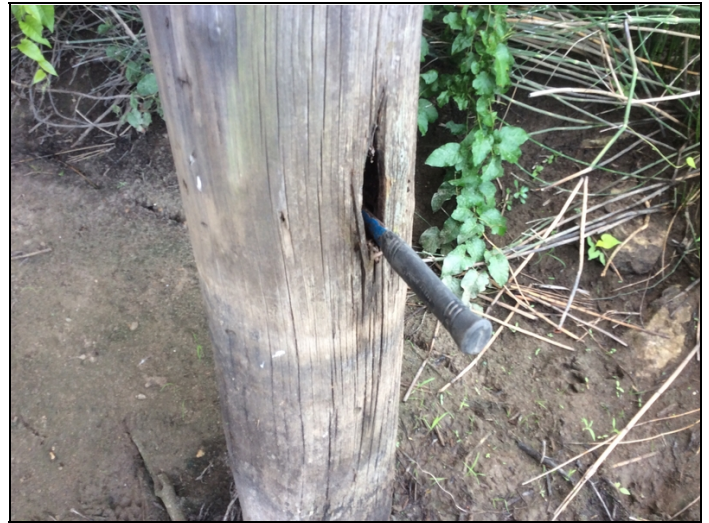
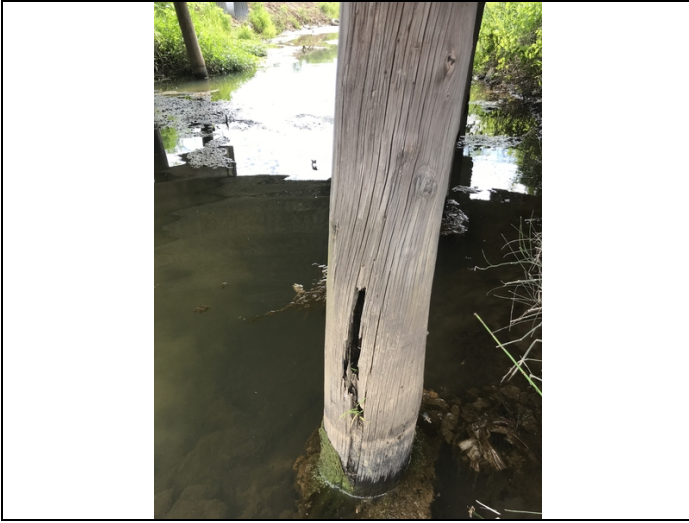
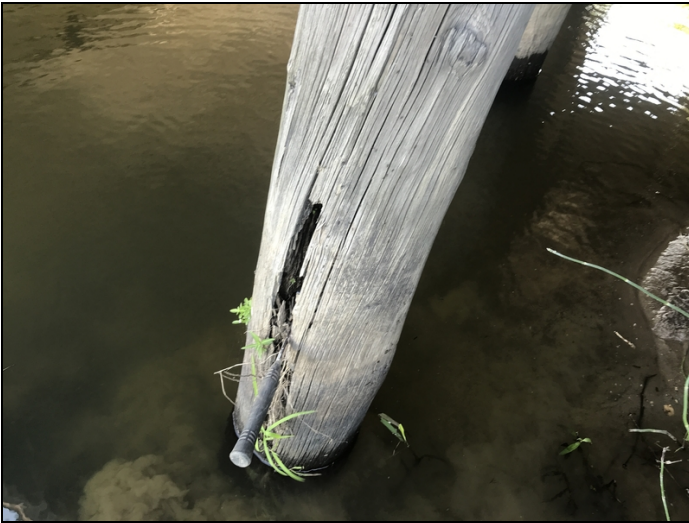
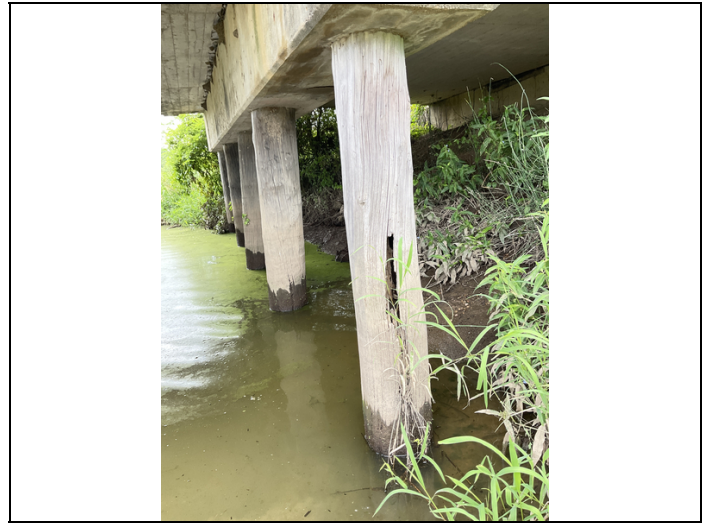
Bent 3 pile 5  
6-6-2023

Bent 3 pile 5 is decayed and hollow. Pile has soft core and partial outer shell remaining.

to Dist Bridge Crew for repairs when they have time - KAW 8/30/18

Bridge Crew currently working on other priorities, will continue to monitor. KAW 6/28/19

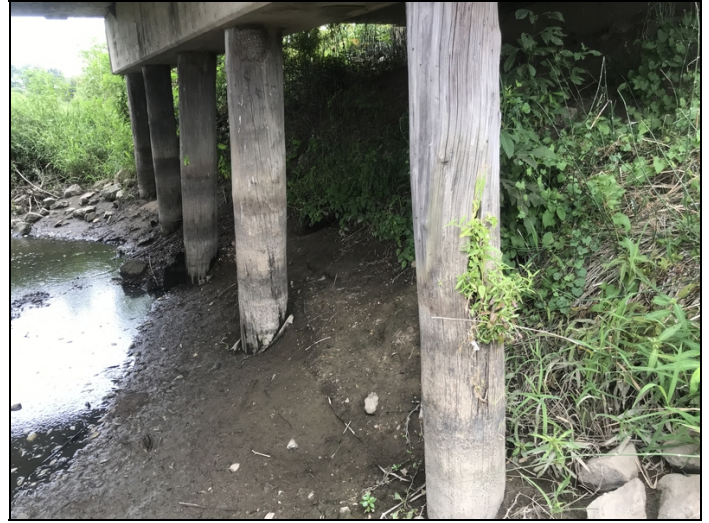
b3 p4 & 5

Bent 3 piles 3 and 4 have checks with up to 1in. outside decay.

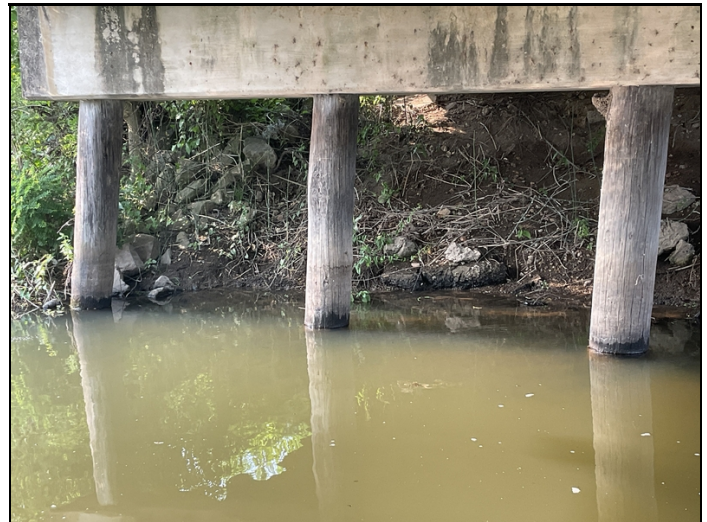
Bent 3 pile 1,2,3

Bent 3 pile 1 has core decay and is partially hollow.

Bent 3 pile 2 has 1in. outside decay with a few outer delaminated areas.

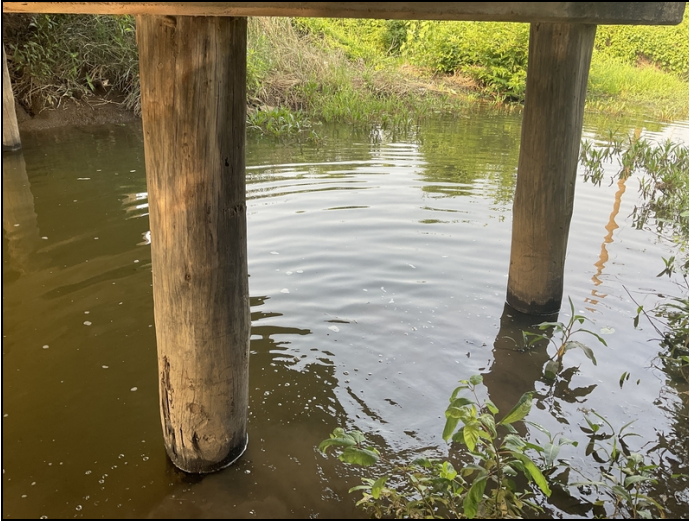
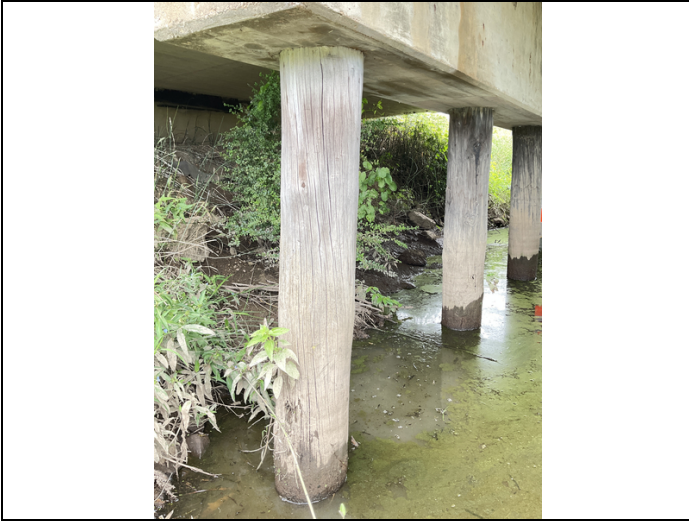
Bent 2 pile 4&5

Bent 2 piles 4 and 5 have up to 1in. of outside decay.

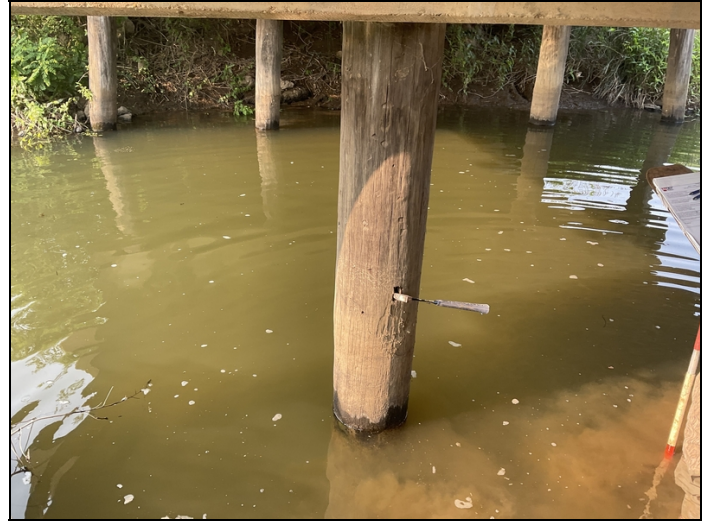
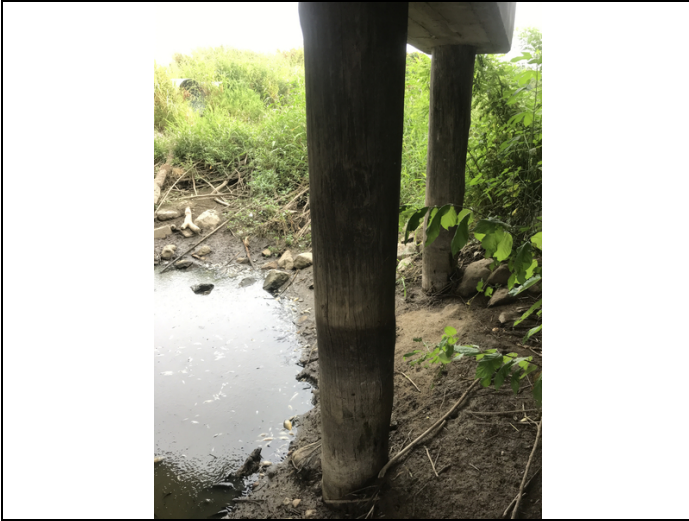
Bent 2 pile 2 is decayed and partially hollow.

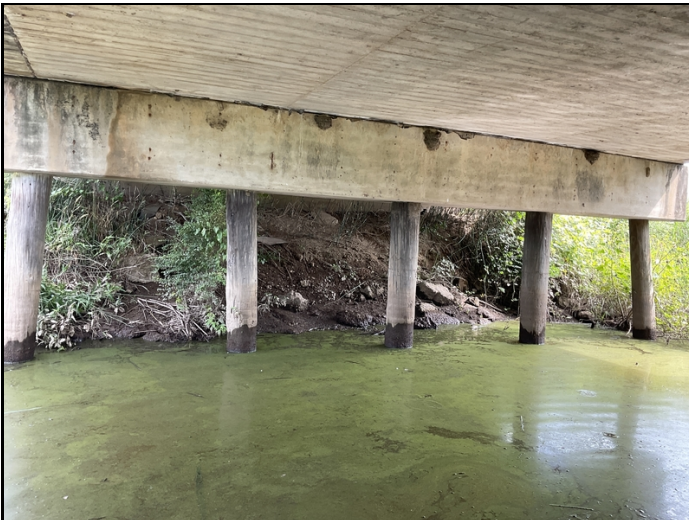
Bent 2 cap has 2 small delaminated areas. Ahead face has a stirrup bar exposed from lack of coverage.  
Bent 3 cap has a 1' delaminated area on bottom between piles 4 and 5.

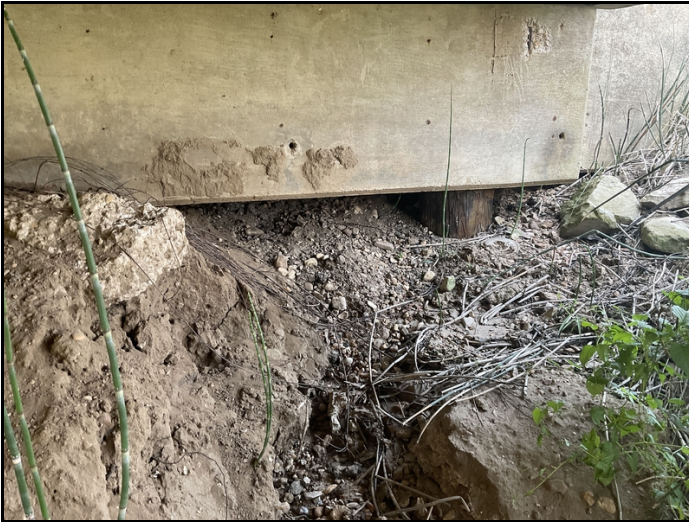
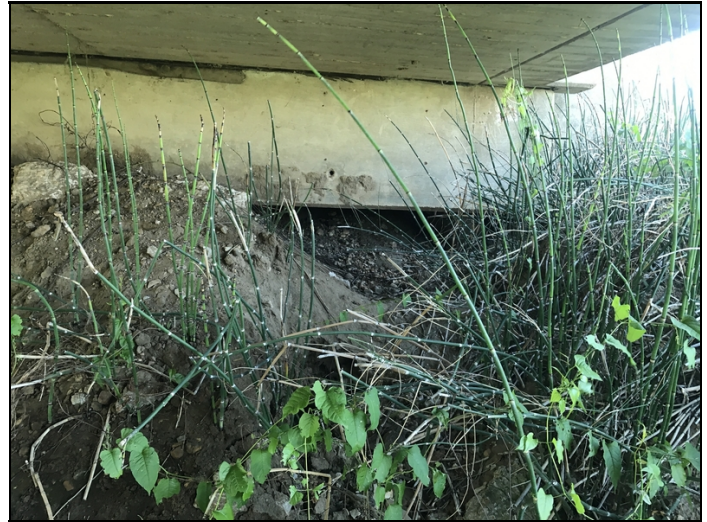
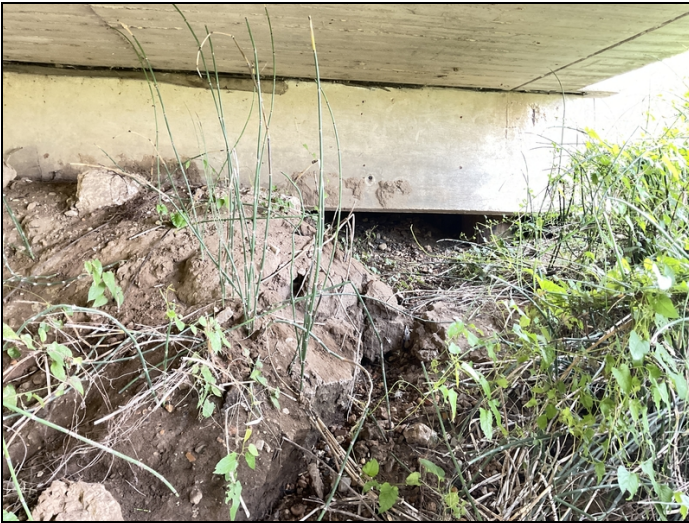
Bent 4 right

Undermining extends into roadway embankment and roadway.

Bent 4 abutment Rt end is undermined for 5' up to 1' below and 2' back under.

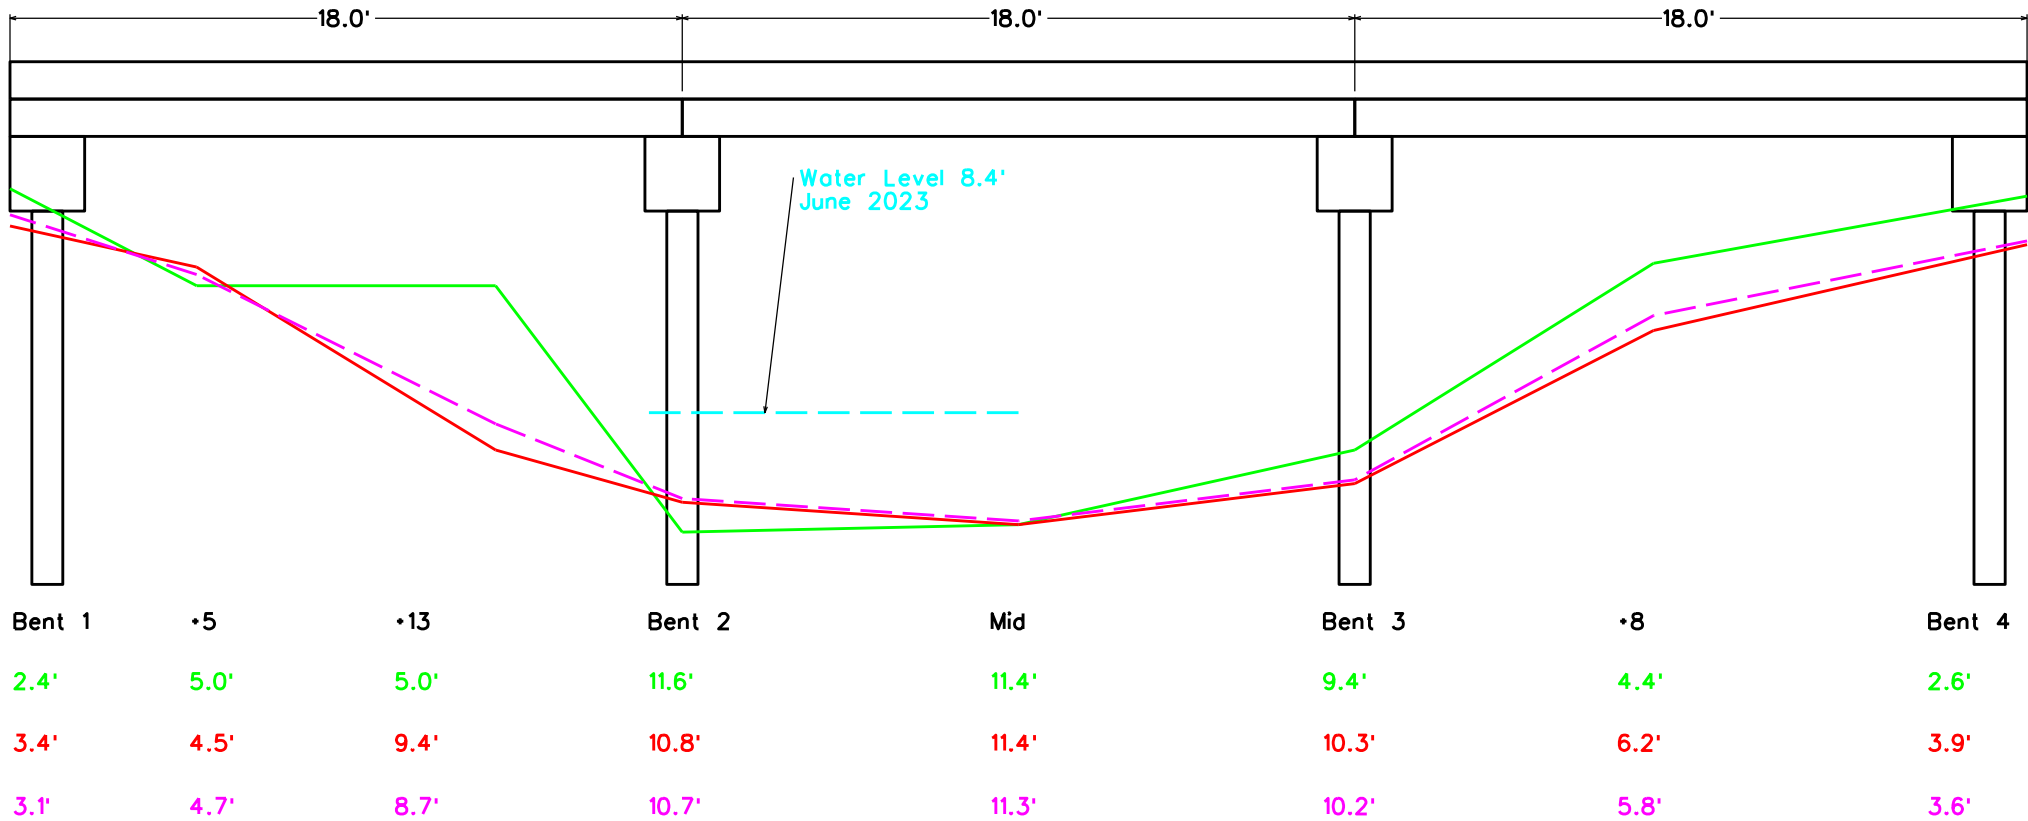
Soundings taken from top of deck, LEFT SIDE

Green line & readings taken on 8-13-90

Red line & readings taken on 8-8-2018

Pink dashed-line taken 6-6-2023
