Asset #02139(Other Special Recurring)

SH 77-02-LM 1.9 over DITCH NO 20

Team Lead: James Adams, Inspection Date: 08/02/2023

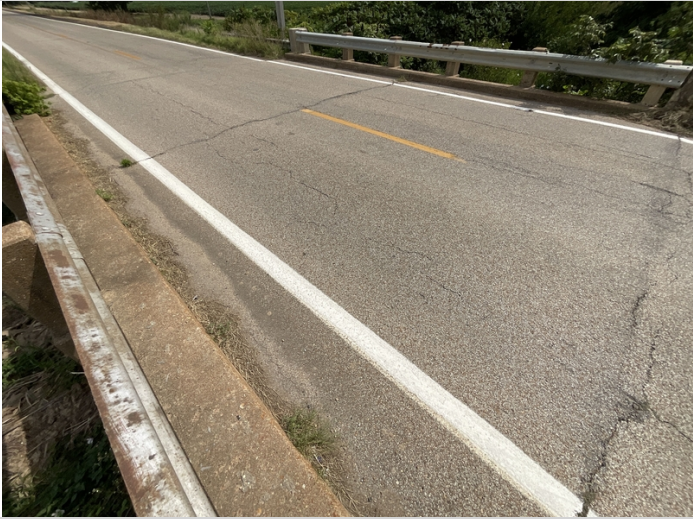
Deck

Approach roadway has settlement at each end of bridge. Approach roadway embankment at bent 3 Rt has some erosion. Rt bridge rail has areas of minor surface rust. Lt endpost at bent 1 was repaired sometime in the past. Asphalt wearing surface has several longitudinal cracks. Asphalt is cracked over bent 2 joint. Lt and Rt corners of slabs have cracks/spalls over bent 2.

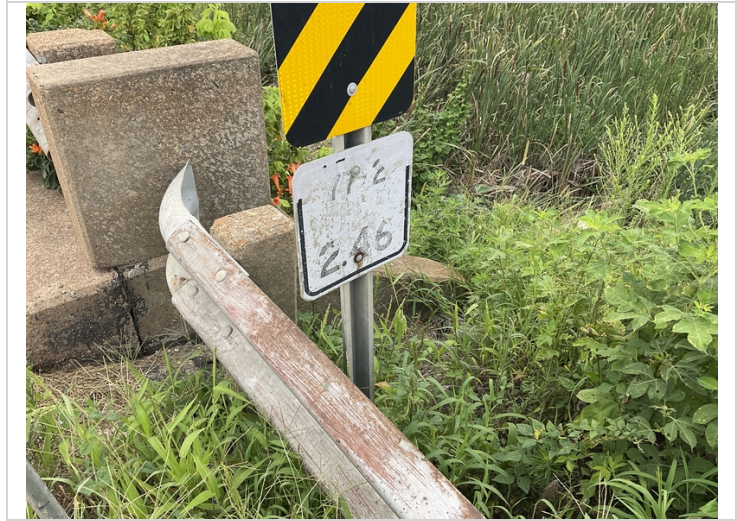
Log Mile 2.46 sign,
Item 11 reads LM 1.9

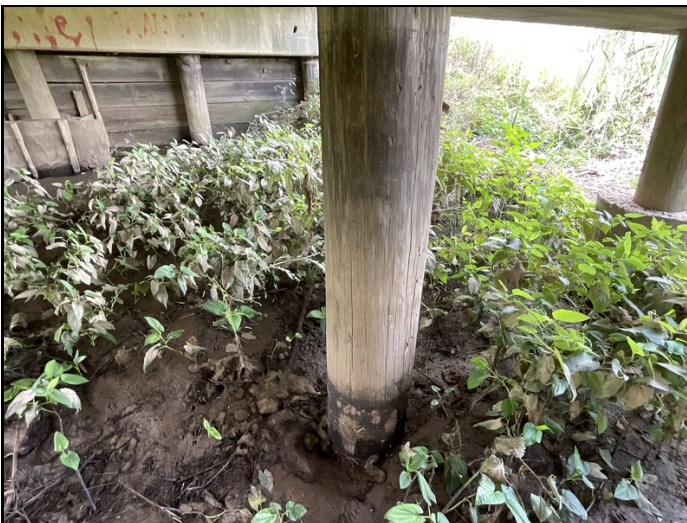
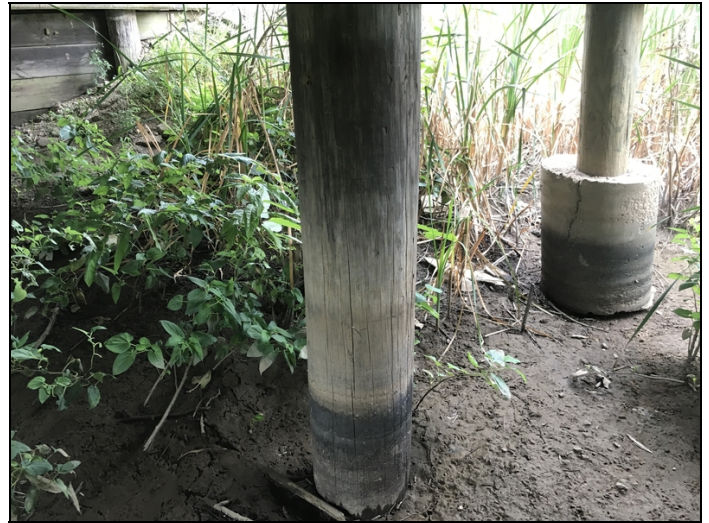
Bent 2 pile 4 is decayed and hollow.

this bridge scheduled for replacement on job 100955 WRONG
to Dist Bridge Crew for repair as schedule allows KAW 9/23/20

****Bridge 02139 is currently planned to be a HBM box replacement in the 2024 fiscal year. Email attached.

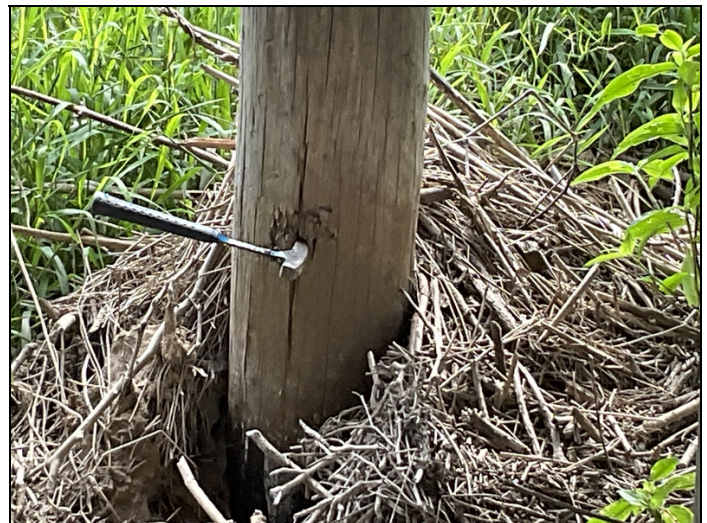
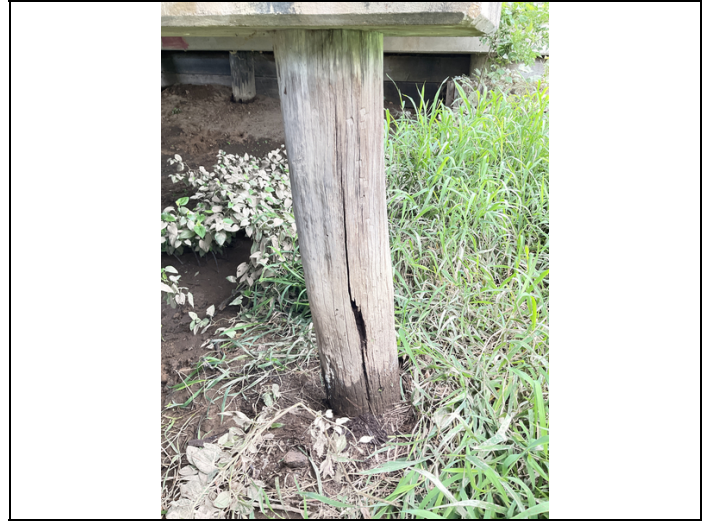
Bent 2 pile 1 is decayed and hollow. Soft core and partial outer shell remain.

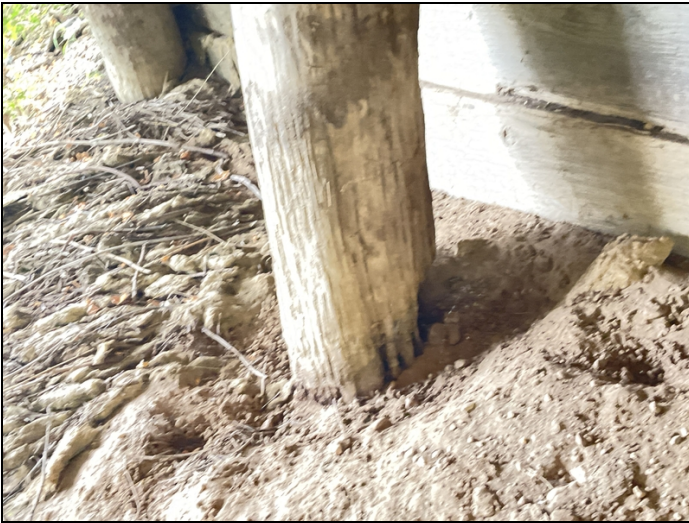
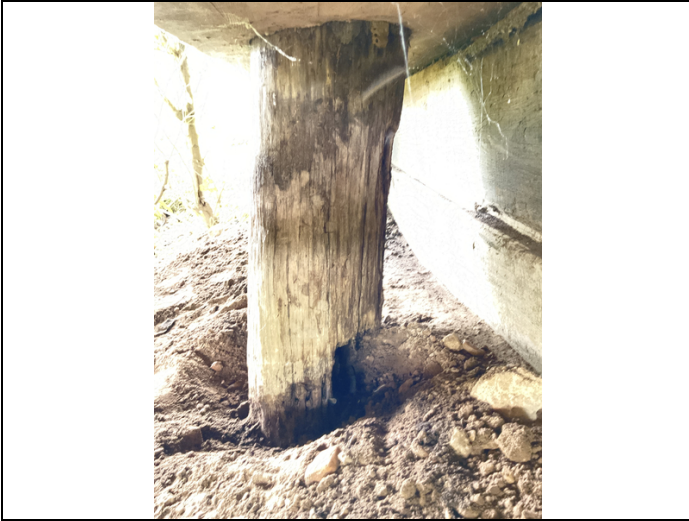
Bent 1 pile 4 is decayed and hollow. Partial outer shell and core remain.

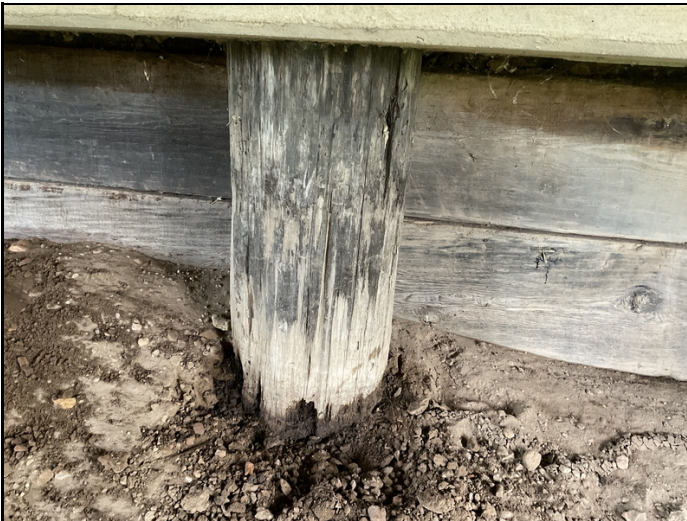
Bent 1 pile 3

Bent 1 piles 3 and 5 have up to 1" of outside decay and section loss at ground line.
