Asset #X0292(Routine)

SH 1-16- LM 0.41 over T LATERAL WATERWAY

Team Lead: Tim Myrick, Inspection Date: 11/01/2021

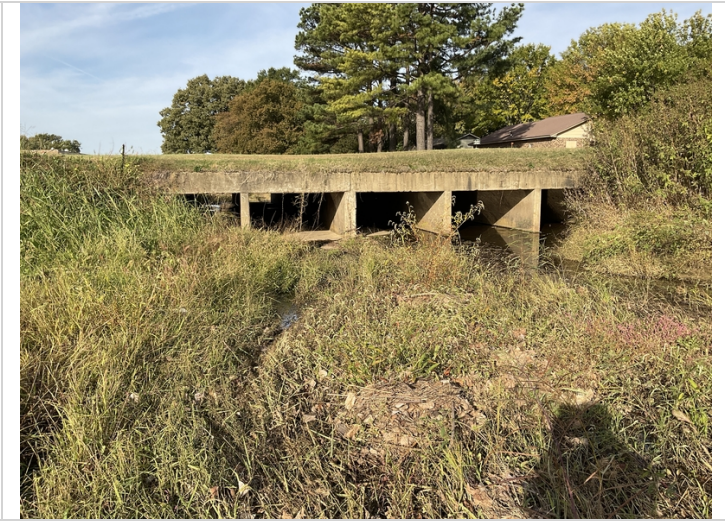
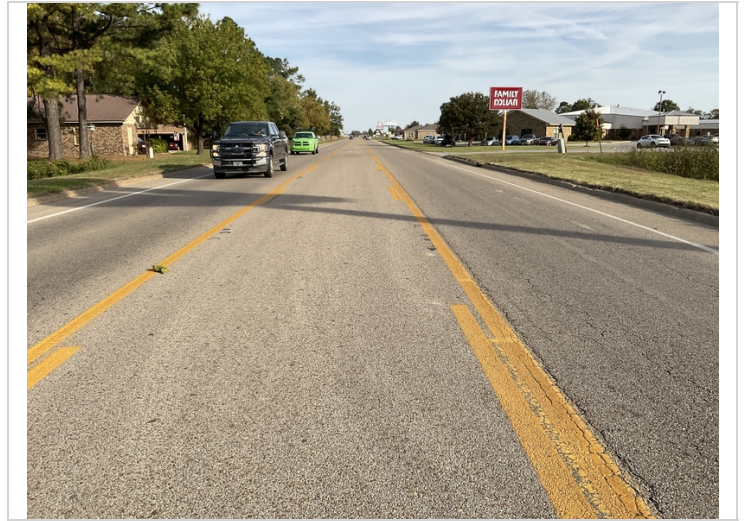
Left end side wall barrel 5 has a spalled area with exposed rebar, see 2017 photo.

Barrel 5 has some delamination and small spalls around drop inlet and drains.

Ends of division wall between barrels 3 & 4 has a open crack at connection of additional barrels.

1.5 ft. of scour on inlet end of barrels 1 thru 5.

2.5 ft. of scour at outlet end of barrels 1-5.

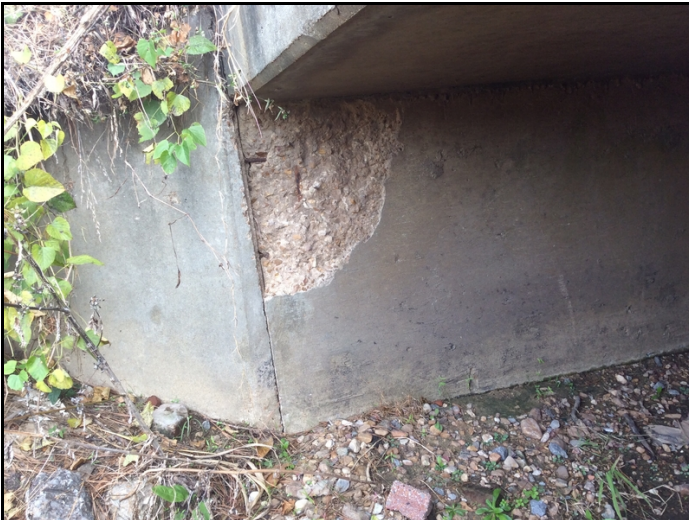
Left end side Wall Barrel 5 has a shelled out area with rebar exposed.
Barrel 5 has some delamination and small spalls around drop inlet and drains.

Type of Work: Repair (General)
