Asset #X0293(Routine)

SH 1-16- LM 2.29 over CREEK

Location: 2.29 MI N JCT SH 14

Team Lead: Richard Jones, Inspection Date: 05/15/2023

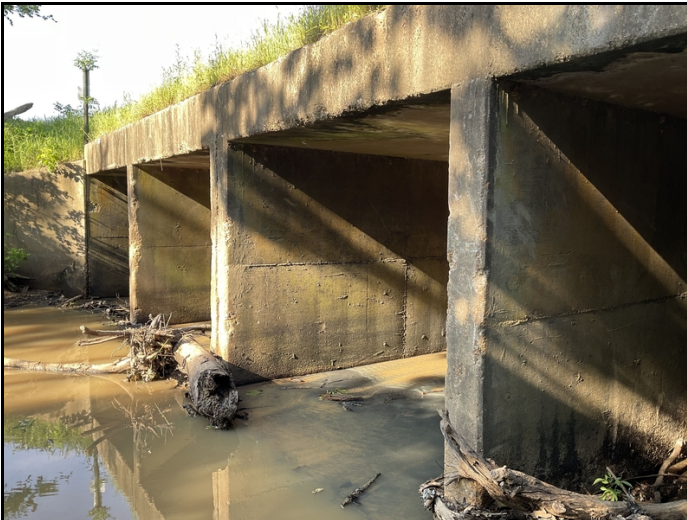
Large drift in channel at inlet of culvert.
Trees and brush outlet end is restricting water flow.

2023 Inlet end

copy to Poinsett crew
Drift has been removed 5/15/23 RRJ

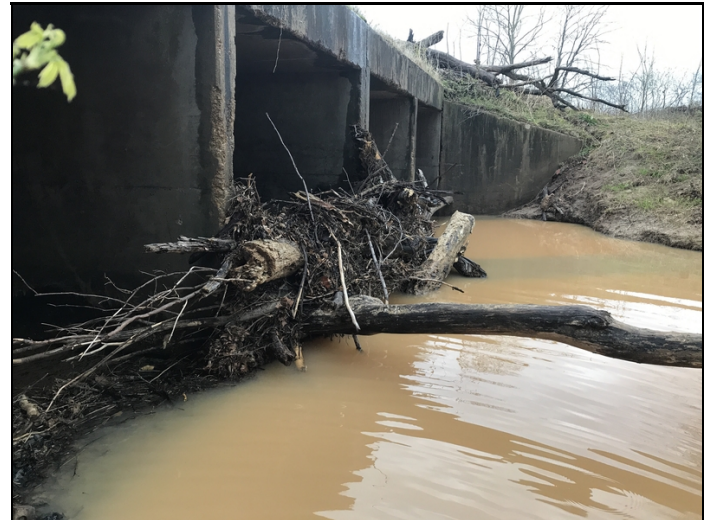
RT Side upstream debris

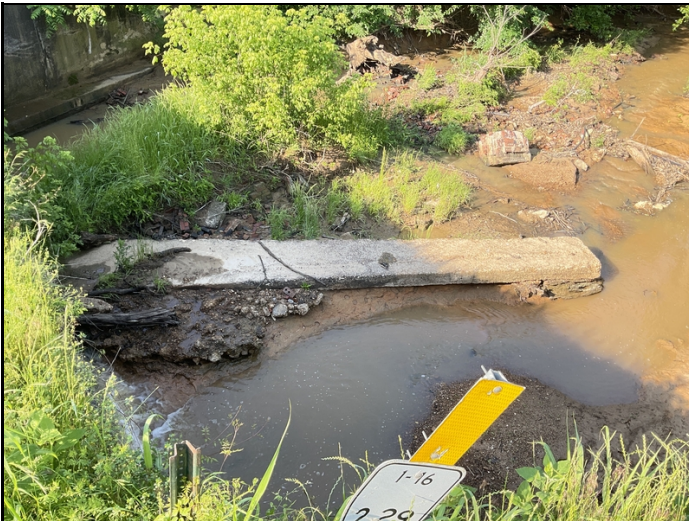
Channel has scour around old wing wall footing that was left in place on outlet end.

old wing wall footing left in place
