Asset #X0294(Routine)

SH 1-16- LM 4.95 over DRAINAGE DITCH

Location: 4.95 MI N JCT SH 14

Team Lead: Tim Myrick, Inspection Date: 11/01/2021

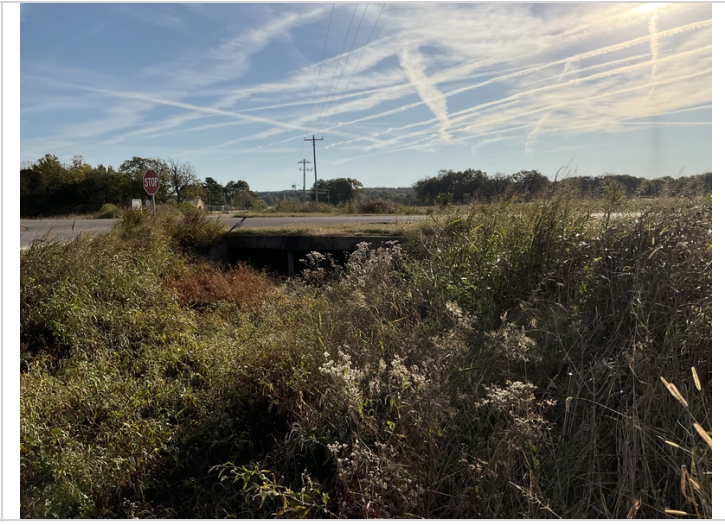
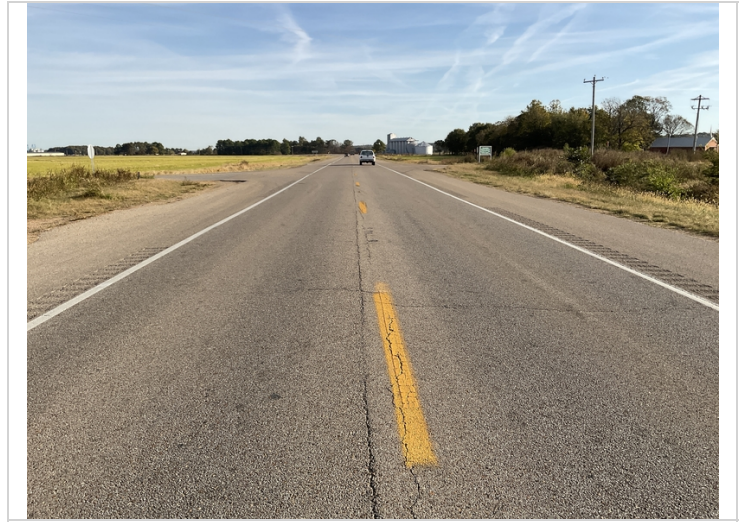
Comment: Several moderate width cracks thru top slab and walls with efflorescence.

SW wing wall separated from barrel with a 2 in. gap. 1.5 ft. of silt in Barrels 1 & 3.

1.5 ft. of erosion at outlet of barrel 2.

Old beaver dam across barrels 1-3 on right side upstream.
