Asset #X0295(Routine)

SH 1-16- LM 6.03 over DRAINAGE DITCH

Location: 6.03 MI N JCT SH 14

Team Lead: Richard Jones, Inspection Date: 05/15/2023

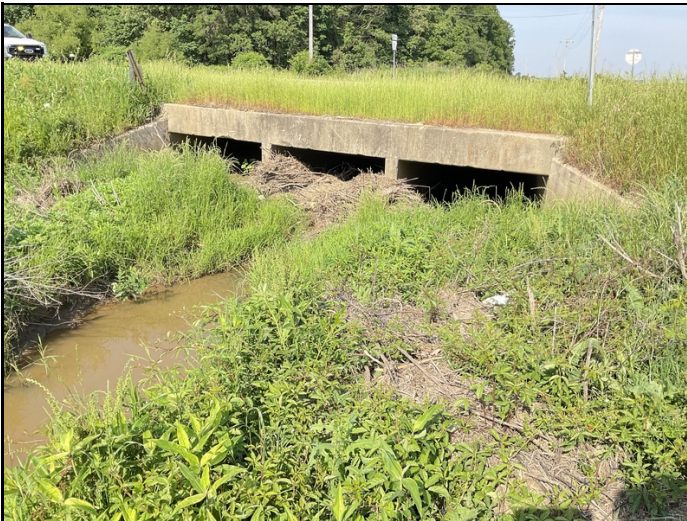
drift

Comment: Drift and sediment are built up at inlet end.

Drift and sediment are built up at inlet end.  
Barrel 1 has 2' of sediment buildup restricting flow.  
Barrel 2 has 1' of sediment buildup restricting flow.

**Type of Work:** Channel Work/Drift Removal
