Asset #X0337(Routine)

SH 1-16- LM 3.50 over DRAINAGE DITCH

Location: 3.5 MI N JCT SH 14

Team Lead: Richard Jones, Inspection Date: 05/15/2023

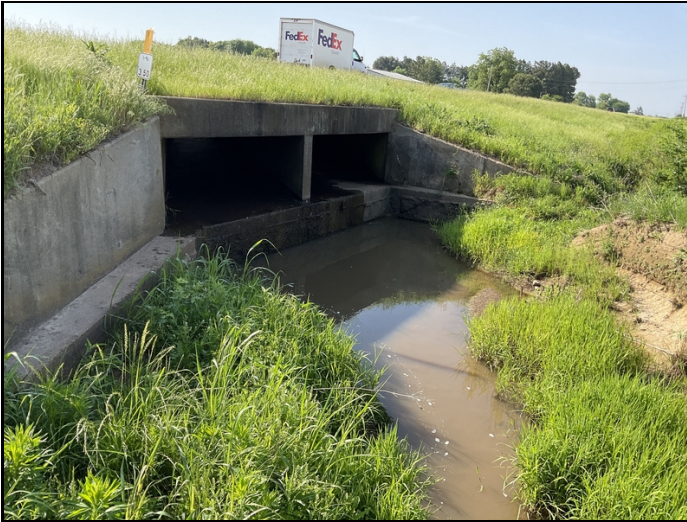
Comment: Channel is scoured 2' below flow line at outlet end. Scour is beginning to undermine toe wall.

Channel is scoured 2' below flow line at outlet end. Scour is beginning to undermine toe wall.

Outlet end scour

Type of Work: Channel Work/Drift Removal
