Arnold Road ID:61x34x2xA, Arnold Log mile:1.933

District 10, 121 - Randolph County

Asset #06531(Routine, Underwater type 2)
SH 34-02- LM 1.94 over BEAVER DAM DITCH
Location: S W LIMITS OF O'KEAN ARK
Team Lead: Richard Jones Inspection Date: 04/13/2023

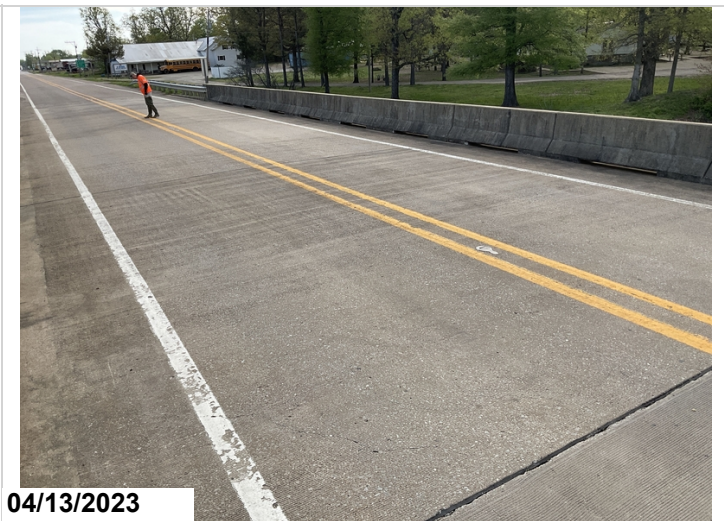
Deck

Top flange has a few minor cracks, and wide spread abrasion with a few popouts.

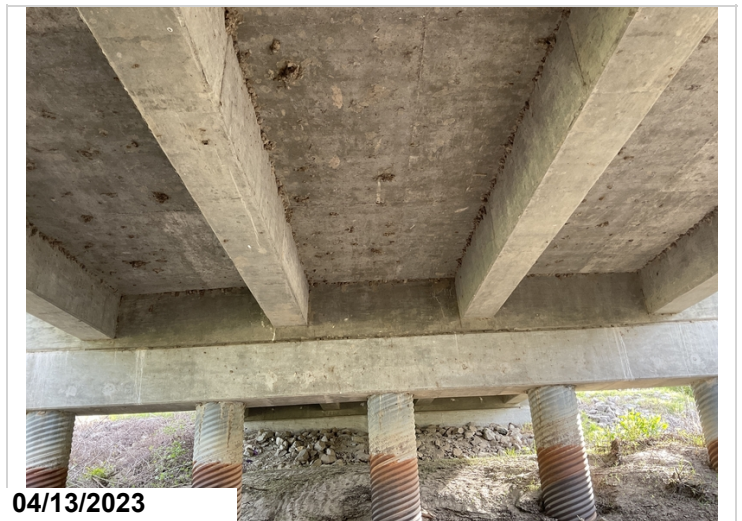
(16) Top flange has a few minor cracks. Top flange has wide spread abrasion with a few small pop outs. Soffit has a few minor cracks, some with light efflorescence. Span 1 bay 1 near bent 2 has a small spall with exposed rebar. Overhangs have a few small delaminated areas or spalls with rebar exposed.							
110	Reinforced Concrete Open Girder/Beam	LF	360	360	0	0	0

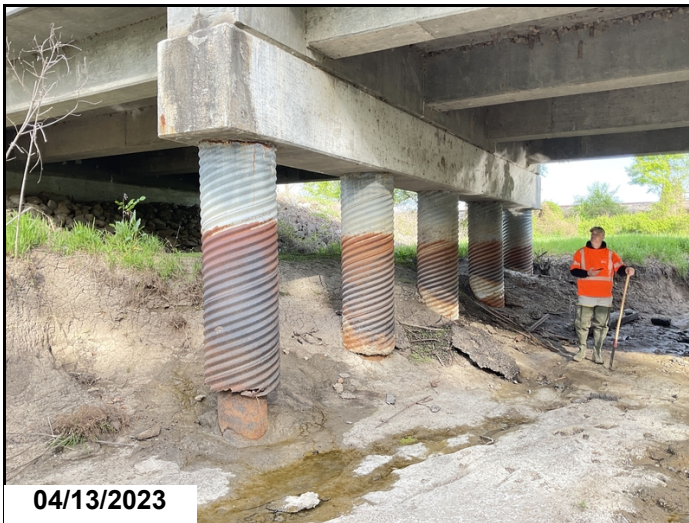
2023 - Bent 2

Sub is in overall good condition, but pile encasements are undermined, partially exposing piles 4 and 5 at bent 2.

Bent 2 pile encasements are undermined at piles 4 and 5, partially exposing steel shells. Exposed portion has flaking rust.

Type of Work: Substructure Repair

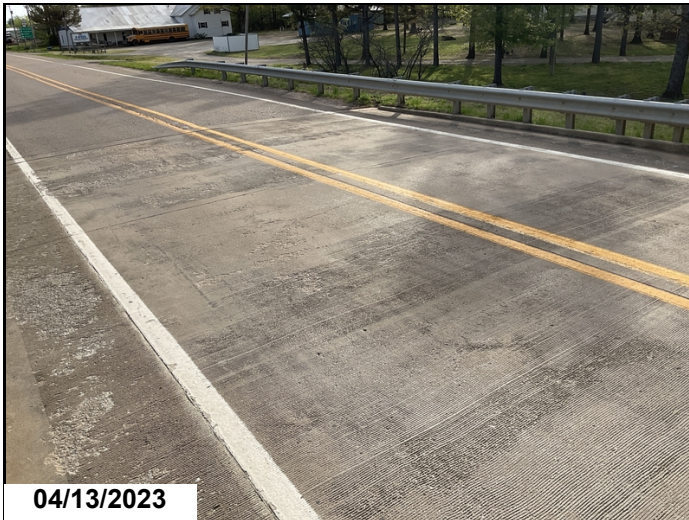
2023 - Bent 4 approach slab

Approach slabs have a few unsealed cracks.
Approach slab at bent 4 end has areas of moderate abrasion.

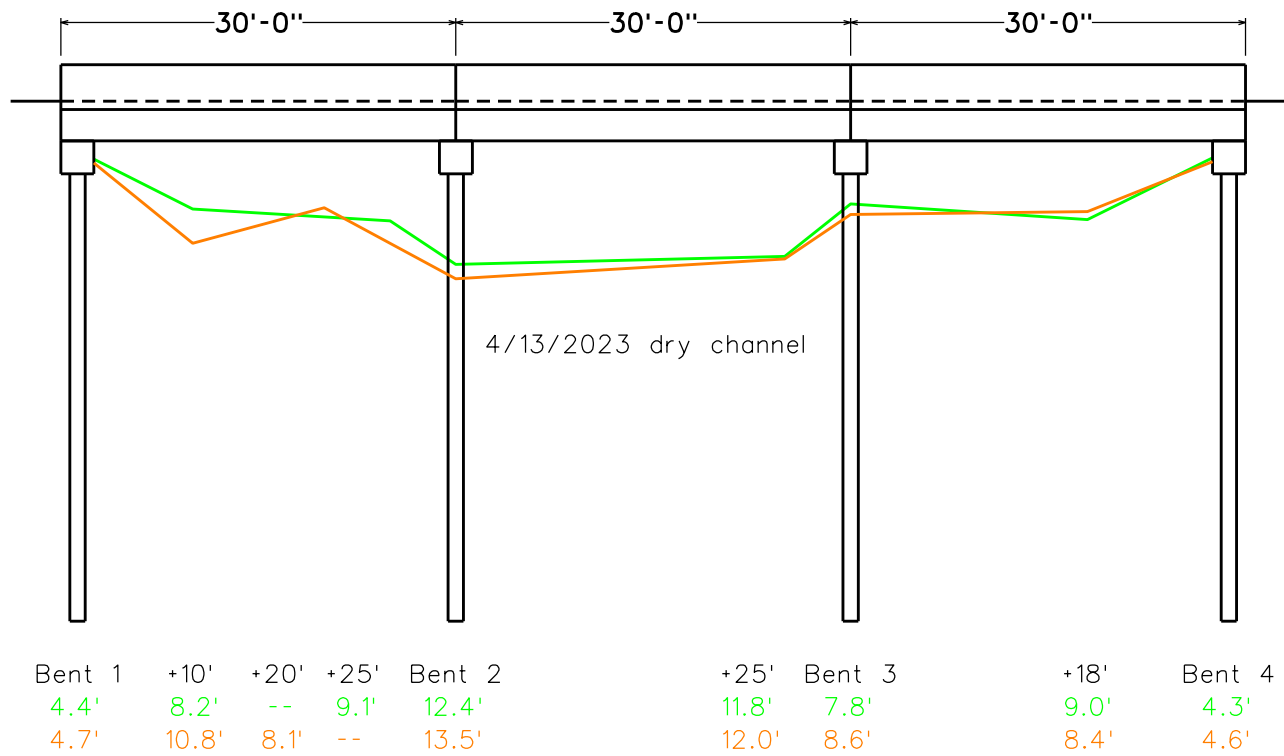
61 - Channel/Channel Protection (6 - Bank is beginning to slump. River control devices and embankment protection have widespread minor damage. There is minor stream bed movement evident. Debris is restricting the channel slightly.)
Steep bank cuts/lateral scour

Channel profiled from top of deck on Rt side (downstream side)

Green soundings taken on 4/1/2019

Orange soundings taken on 4/13/2023
