Asset #03014(Routine)
SH 18-04- LM 3.64 over TURTLE CREEK
Location: .50MI E JCT OF US 49

Team Lead: James Adams Inspection Date: 02/15/2022

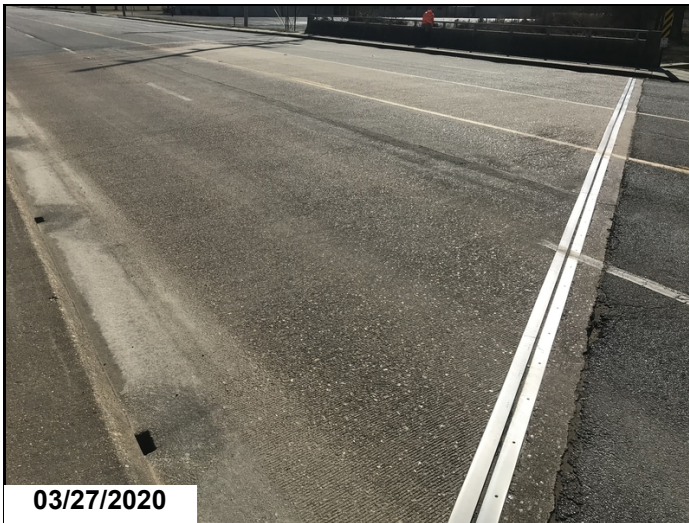
Joint seals are losing adhesion and allowing leakage onto abutments.

Type of Work: Replace (General)
