Asset #X1211(Routine)

SH 18-04-LM 5.90 over Moore Ditch

Location: 2 MI E of Jonesboro Ar.

Team Lead: Brandon Sutton Inspection Date: 07/08/2024

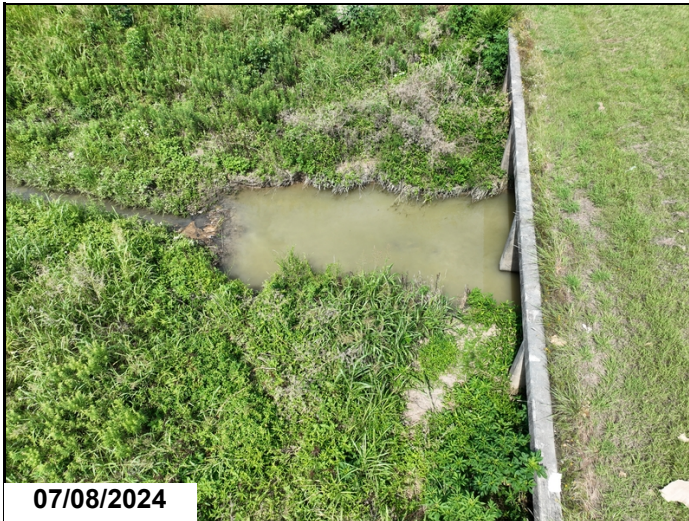
07/08/2024

Barrels 1, 2 and 5 have up to 2' of sediment buildup.
Channel on left end has drift buildup on division walls.
Channel on right side has sediment and vegetation buildup and small beaver dam.

Channel right side sediment and vegetation buildup and small beaver dam

Type of Work: Channel Work/Drift Removal

Status: Monitor

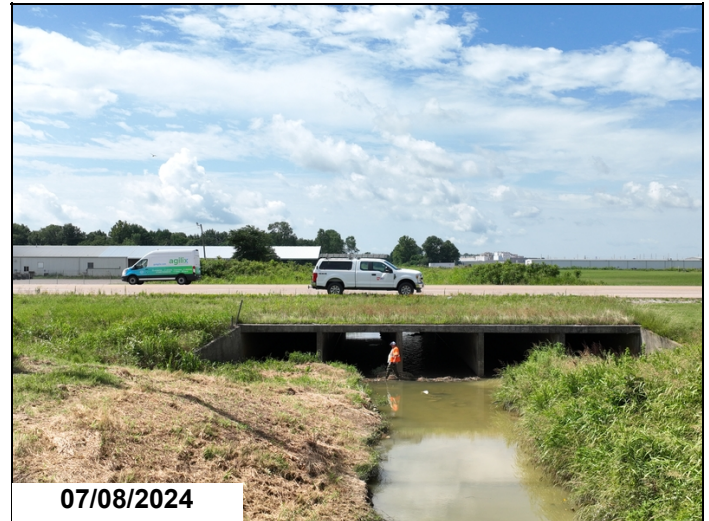
07/08/2024

Barrels 3 and 4 minor beaver dam buildup
