Asset #05266(Routine)

US 412-09- LM 0.83 over EIGHT MILE CREEK

Location: 1.8 Mi E Jct US 49

Team Lead: Richard Jones Inspection Date: 09/13/2023

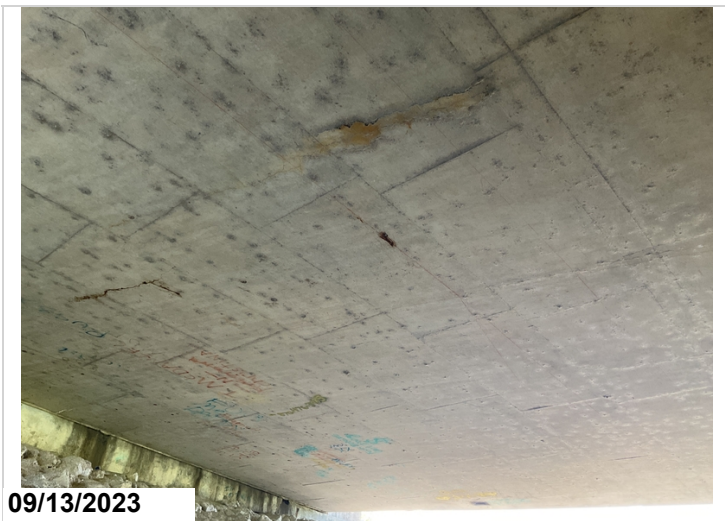
Span 3 soffit

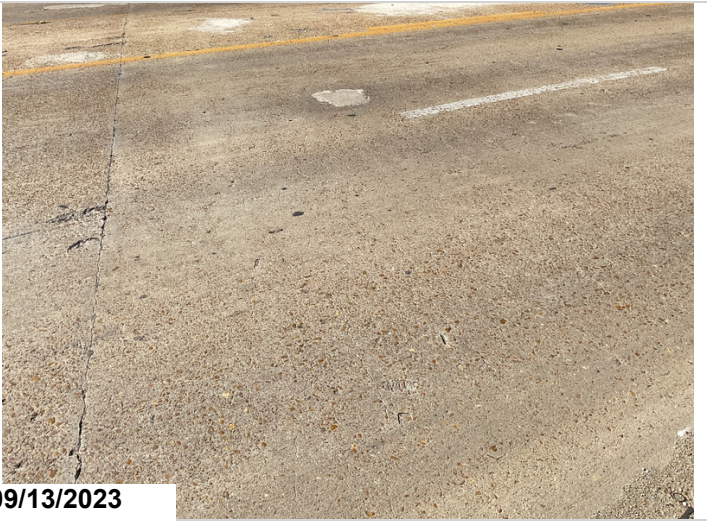
Span 1 cracks

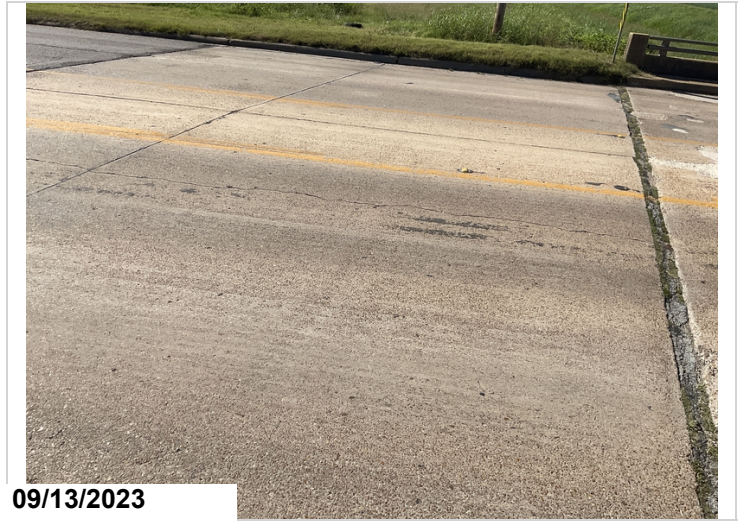
Approach slab at end

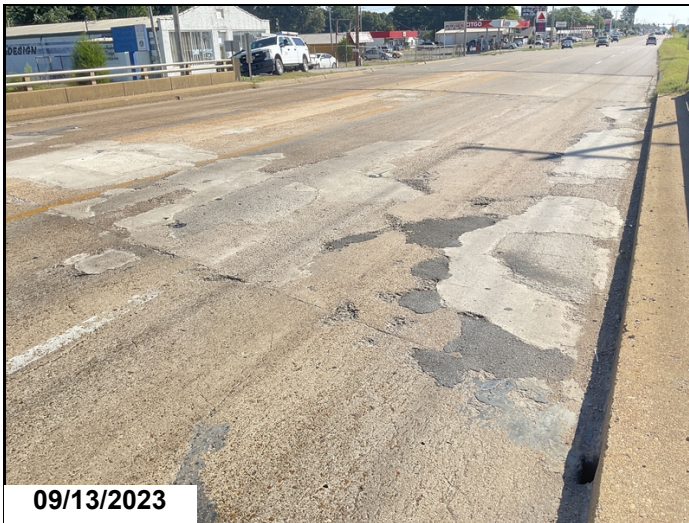
Span 3 Rt

Slabs have a few spalls or delaminated areas. Span 3 has some rebar exposed.

Type of Work: Deck Repair

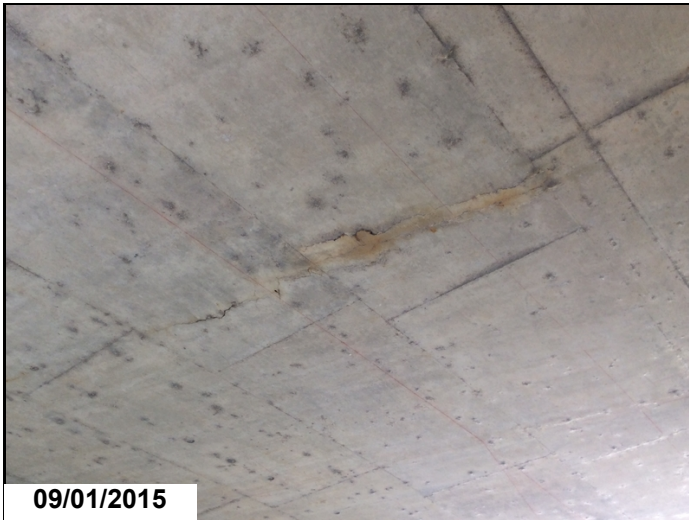
Slab soffits have longitudinal cracks with some efflorescence or rust stains. Slabs have a few spalls or delaminated areas along cracks. Slabs have cracked or delaminated areas near drain openings.

soffit

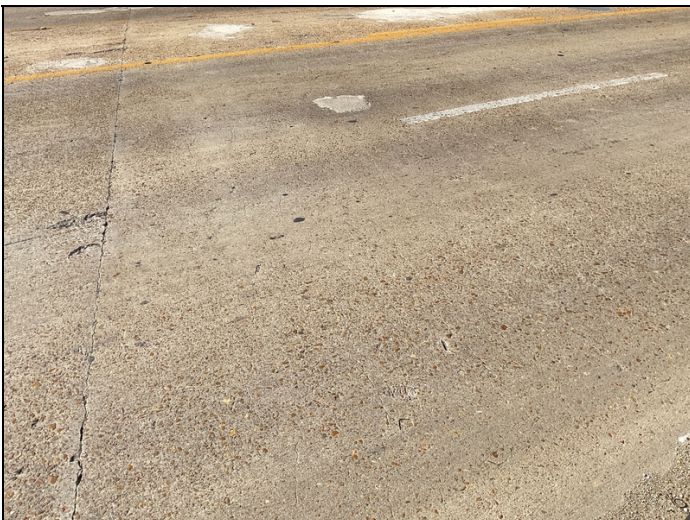
Span 1 cracks

A-54 - Sealable Deck Cracks (Yes)
