Asset #06087(Routine)

US 412-09- LM 0.06 over 2ND ST &SLSW RR

Location: .95 MI E Jct US 49

Team Lead: Richard Jones Inspection Date: 10/28/2024

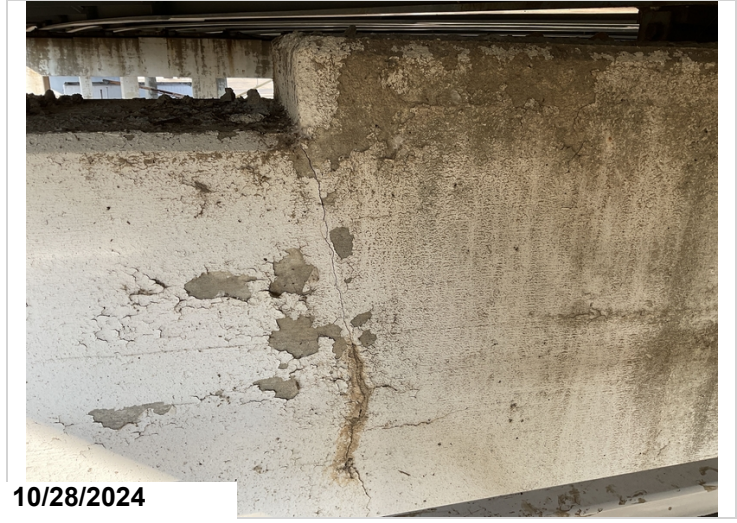
Bent 6 ahead Rt crack CS3

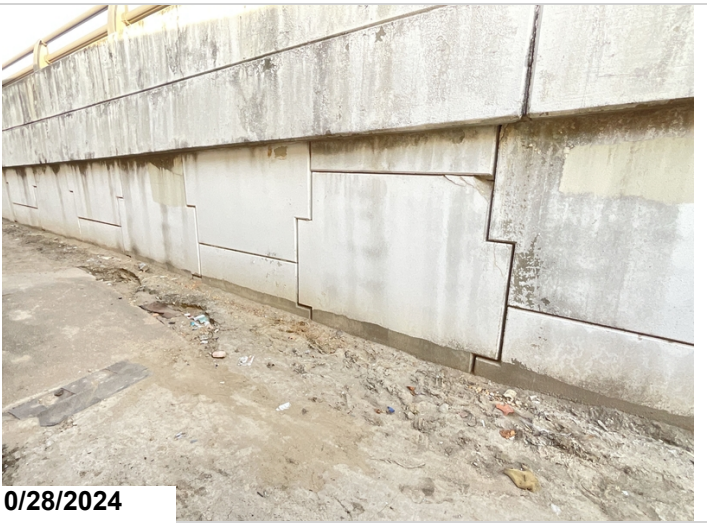
Bent 1 Rt starting 22 units back from 90° cracks and corner spalls

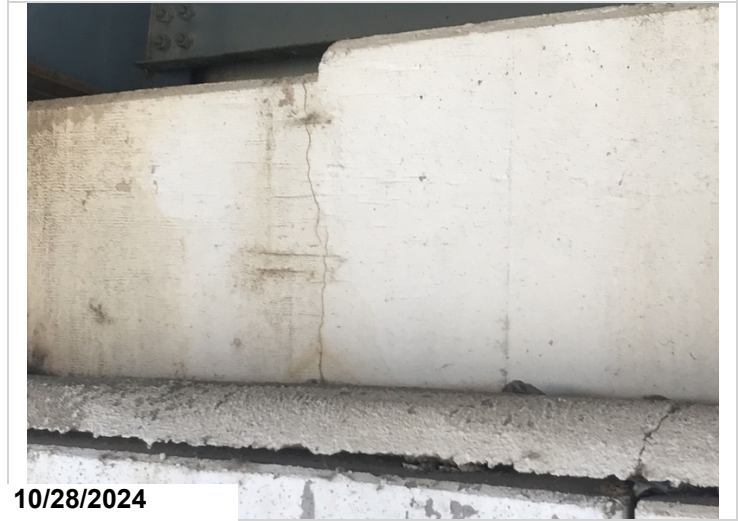
Bent 10 abutment has 16' of cracks CS2

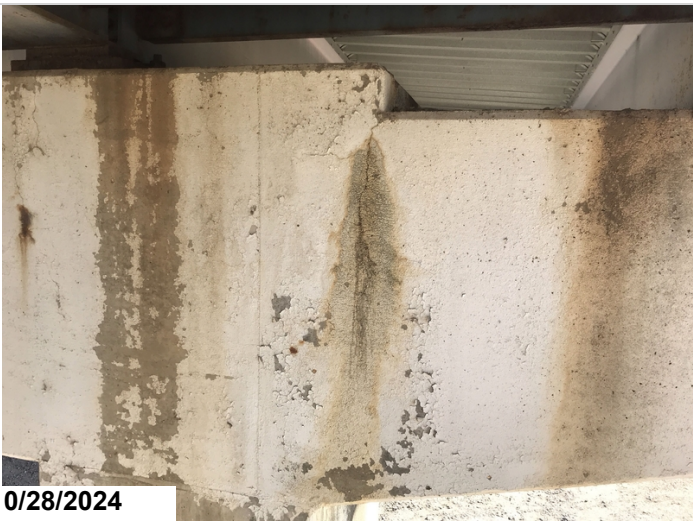
Bent 9 cap has 1' of cracking with rust stains CS3 and 1' of cracking CS2

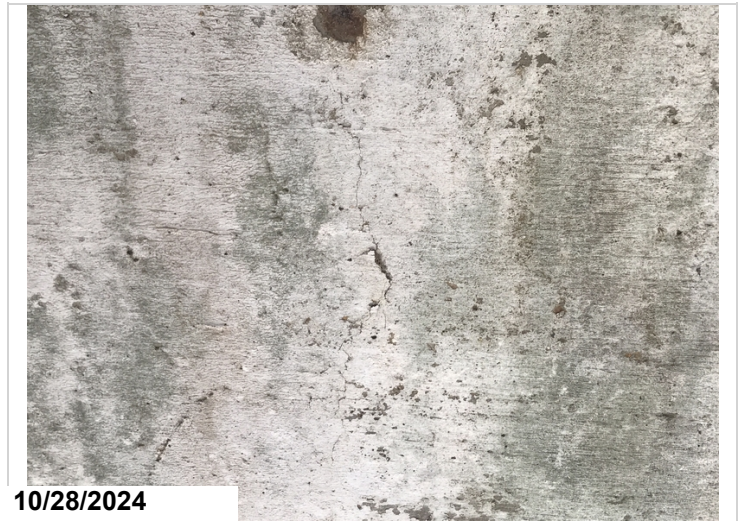
Bent 7 cap has 2' cracking CS2 and 1' delamination CS2

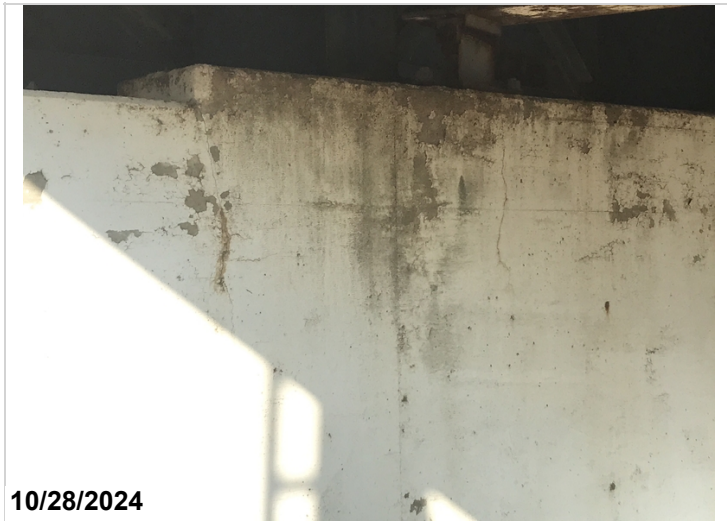
Bent 6 cap has 4' of vertical cracks CS2

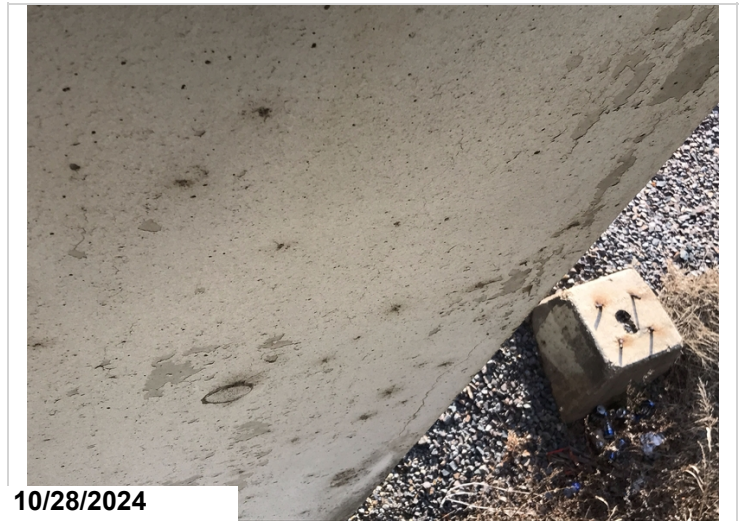
Bent 5 column 3 back has a 2' vertical crack 3' from bottom of cap CS2

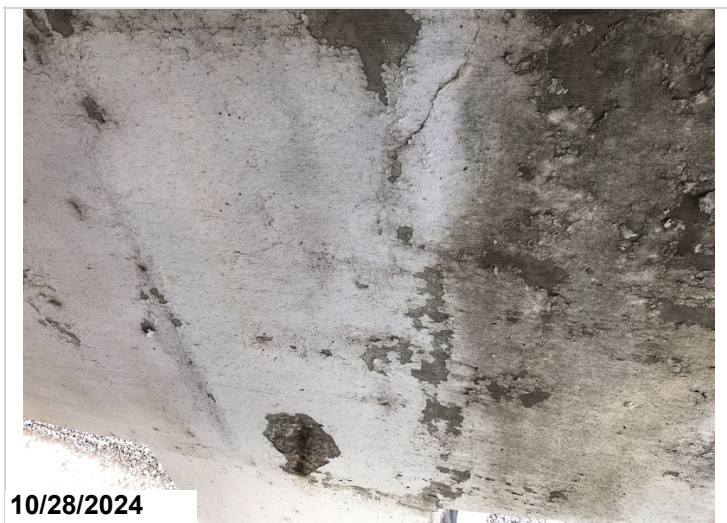
Bent 5 cap has 1' spall with exposed rebar CS2 and 1' of cracking CS2

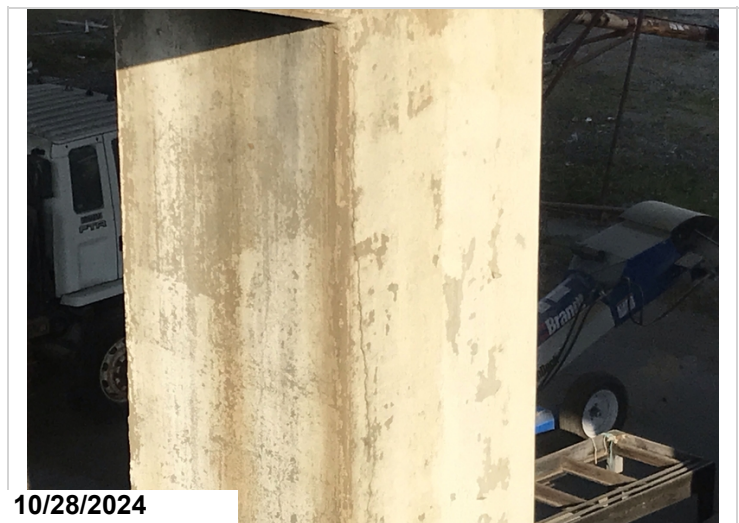
Bent 4 column 3 ahead has a vertical crack CS3

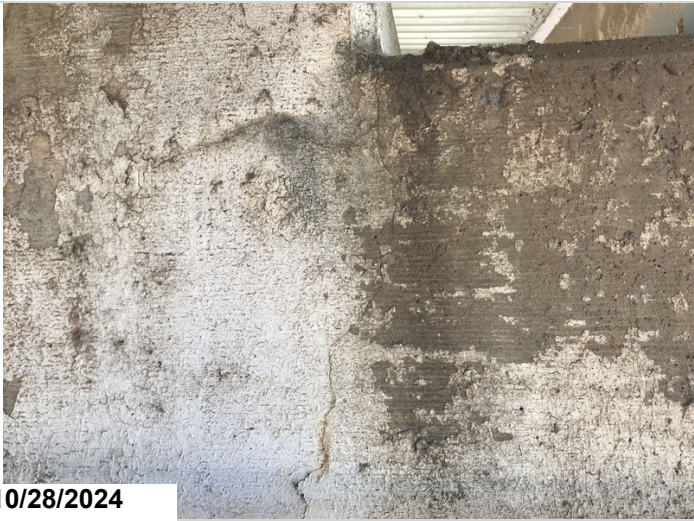
Bent 4 cap has 1' of cracking CS2

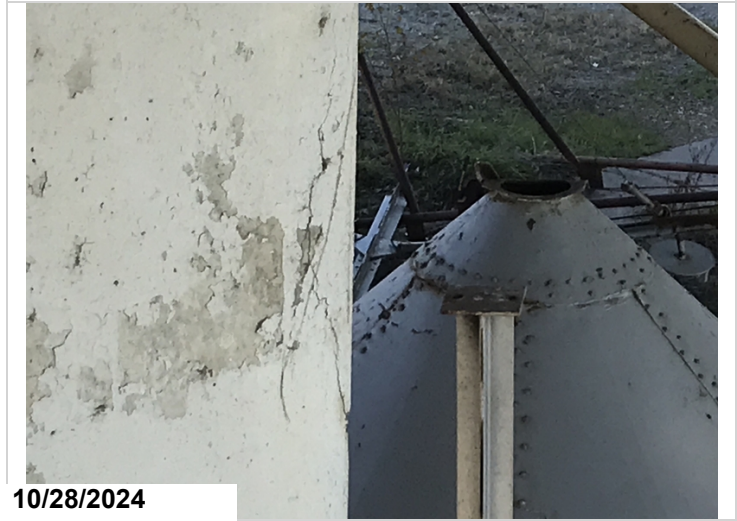
Bent 3 column 2 ahead has a 3' vertical crack under cap CS3

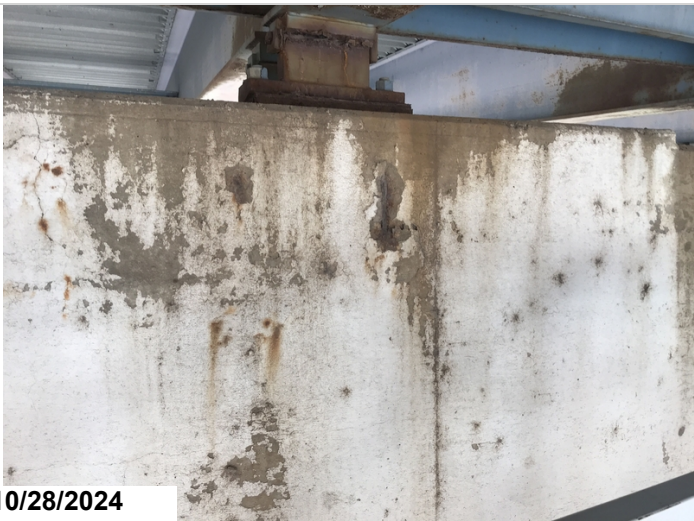
Bent 3 cap has 3' of delamination CS2 and 2' of spall with exposed rebar CS2 and 2' of cracking CS2

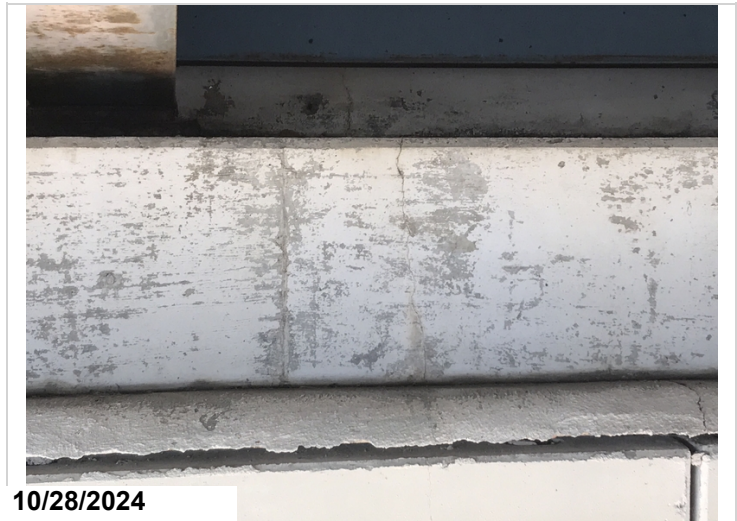
Bent 1 abutment has 15' of cracking CS2

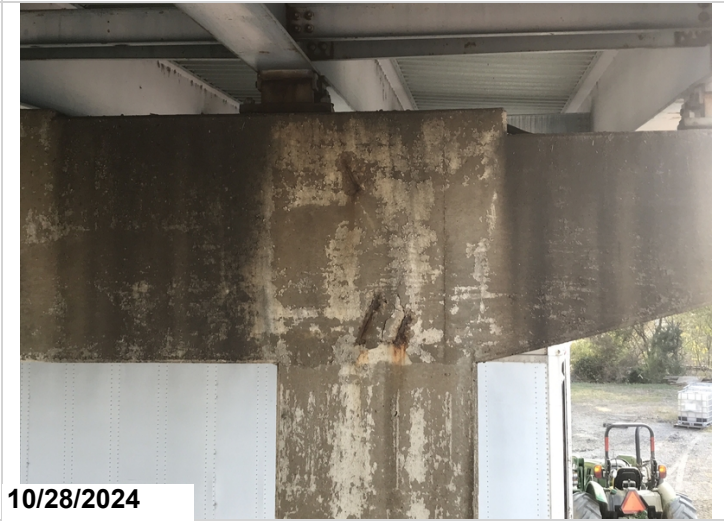
Bent 2 cap has 1' spall with exposed rebar CS2 and 1' cracking CS2

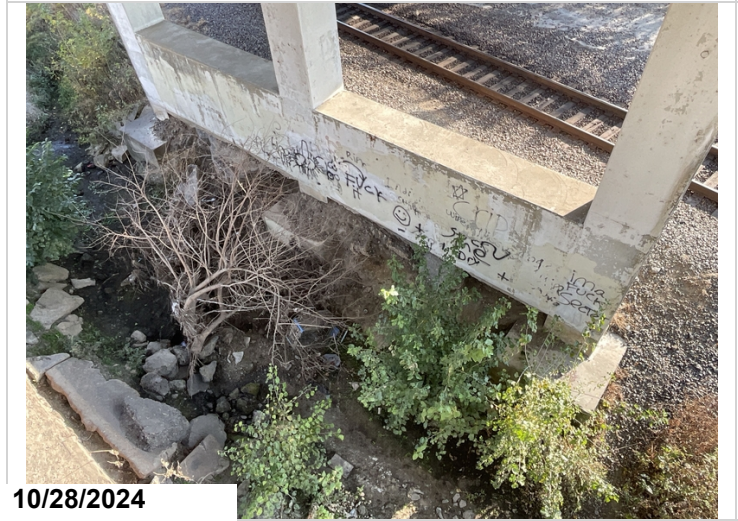
Bent 5 back footings exposed

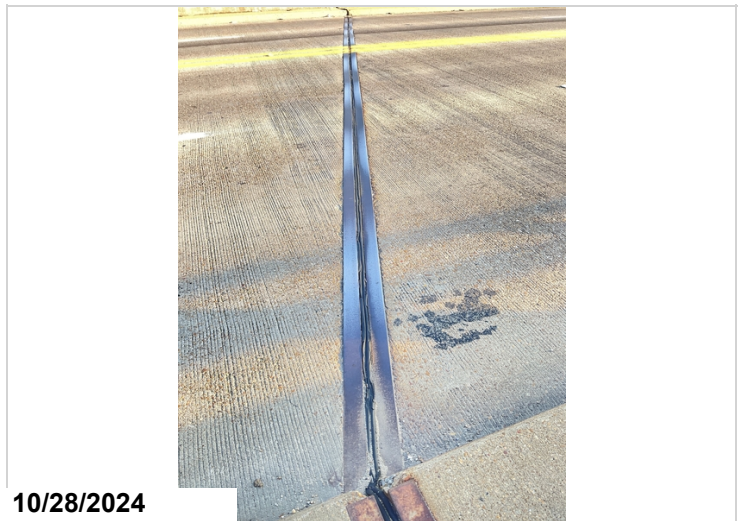
Bent 6 1/2 torn/ adhesion 2

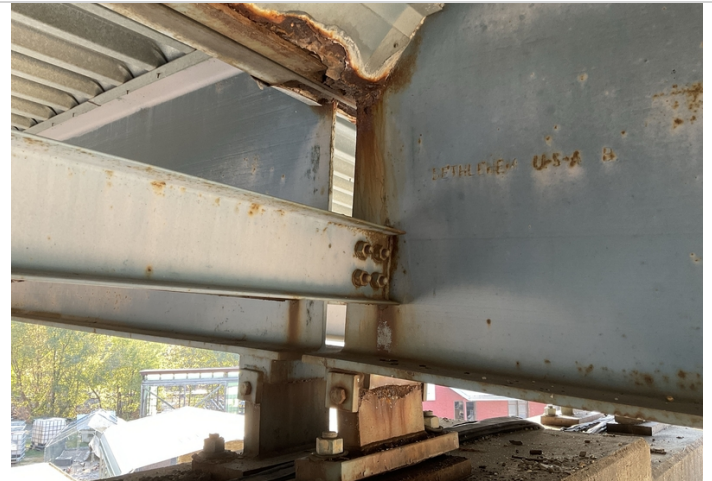
Typ corrosion at ends

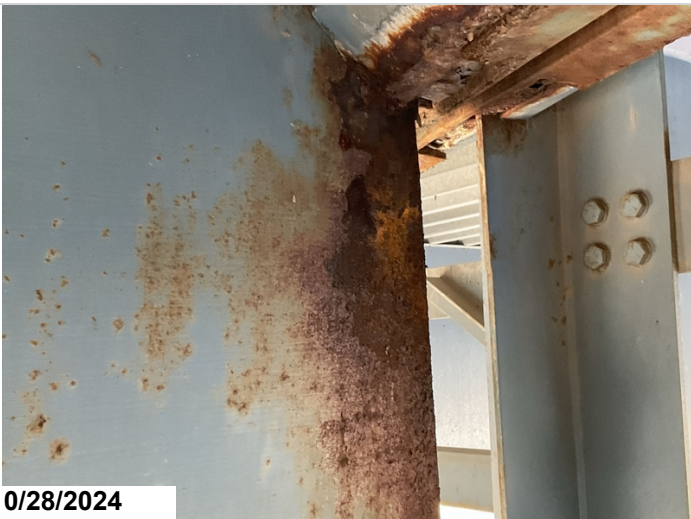
Span 6 bent 6 girder 5 has some minor flaking rust in web below haunch

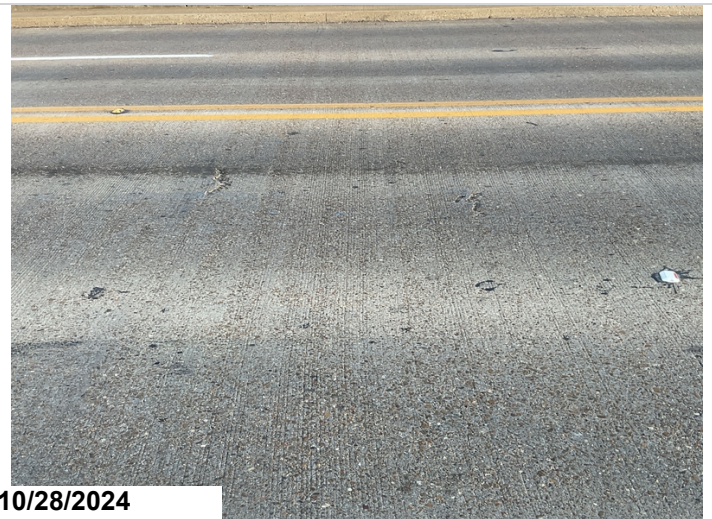
Span 2 East bound delam/shallow spalls

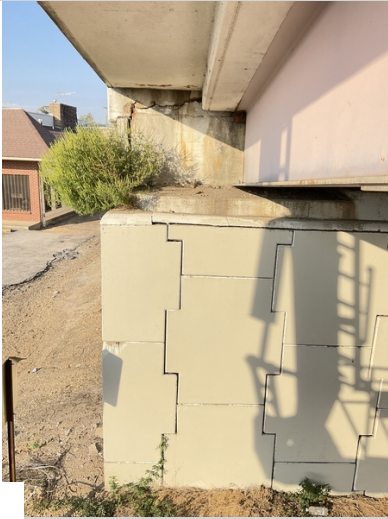
Bent 1 Rt vegetation

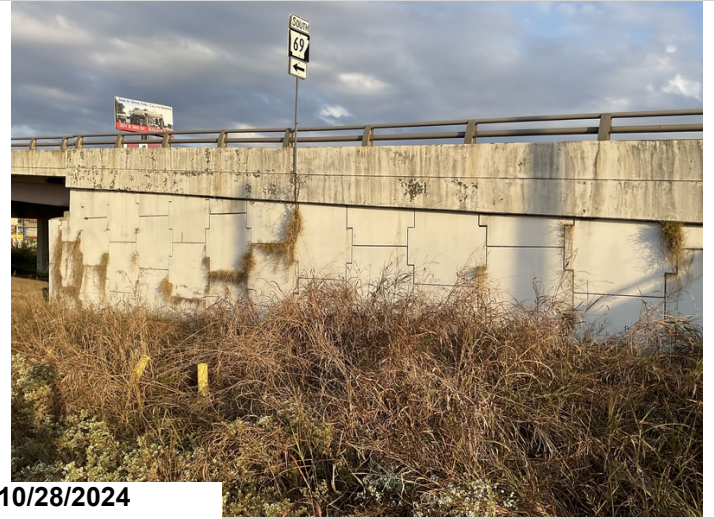
Bent 10 Rt vegetation in mse joints

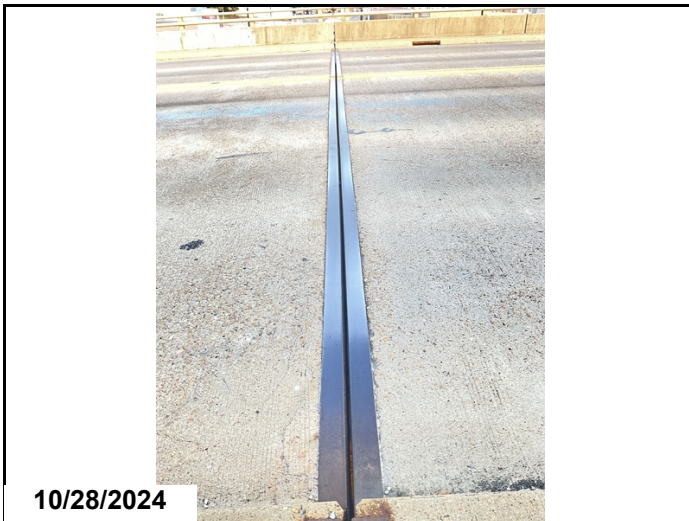
Compression seals are torn and losing adhesion. Seals over bents 2 and 5 are missing.

Bent 2, 5 seal missing

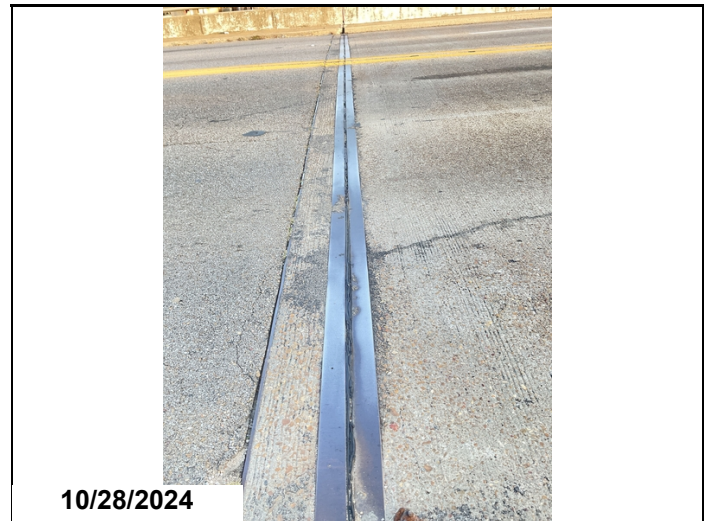
Bent 1, 3, 4, 8, 9, 10 joint torn

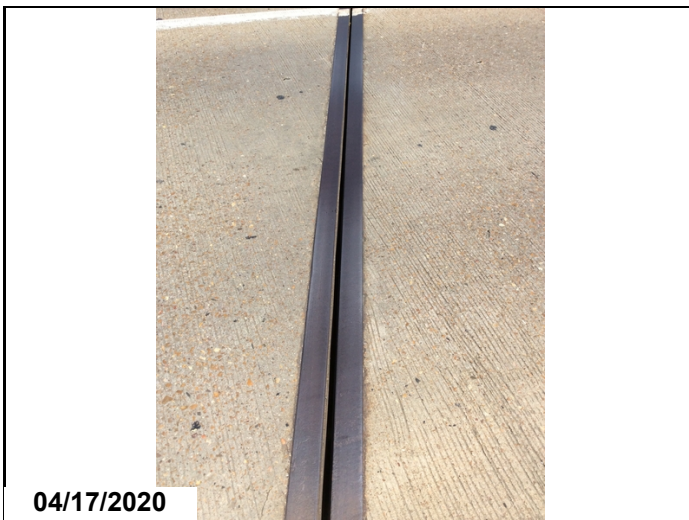
missing seal

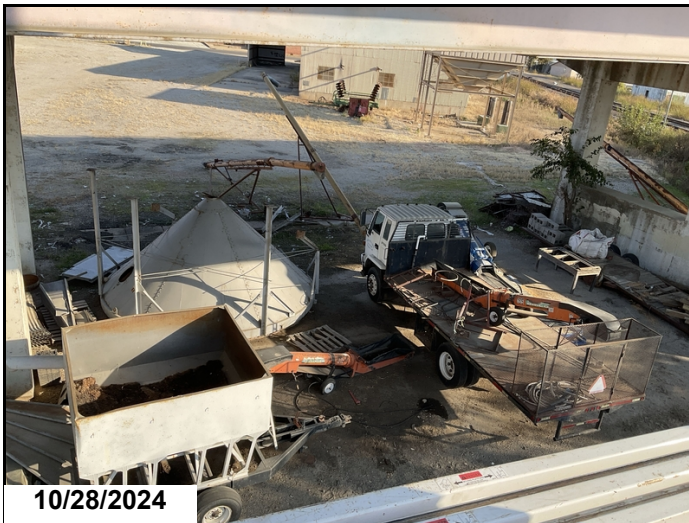
Several items are parked/stored under spans 2 and 3.

Span 3 under bridge storage

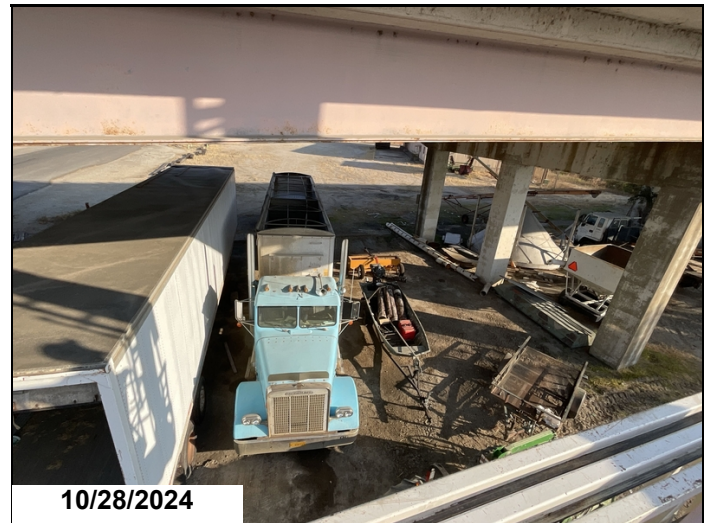
Span 2 under bridge storage

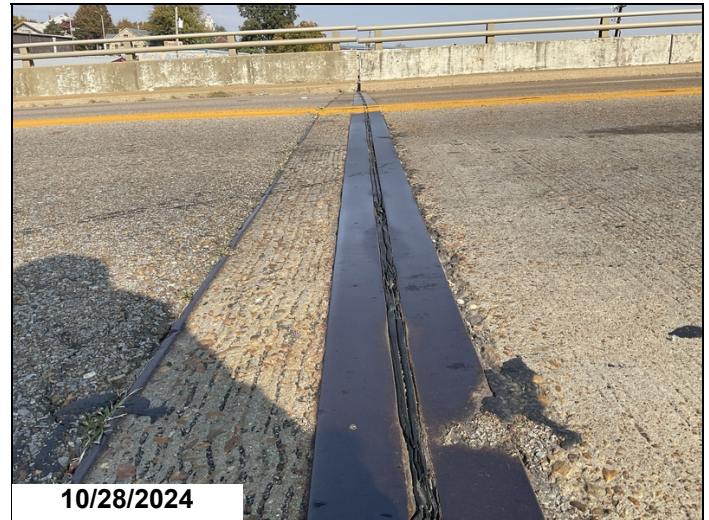
Approach roadways at bents 1 and 10 have some settlement.
Sidewalks have settlement at bents 1 and 10.

Bent 1 at centerline

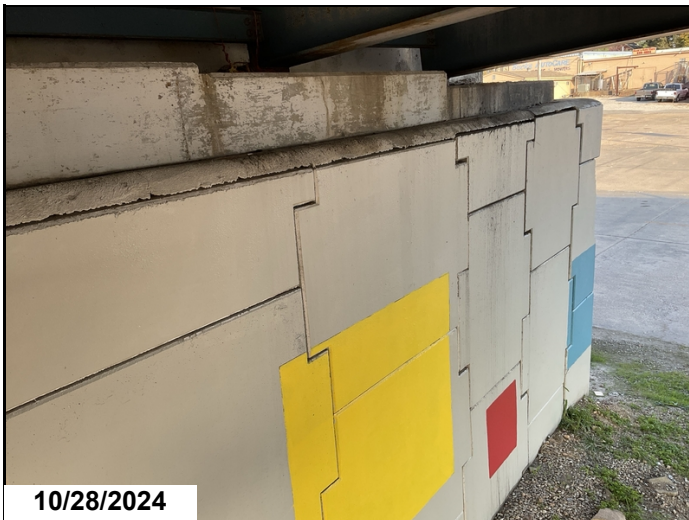
Bent 1 Lt – top corner block has settled/rotated away from bridge. Corner block beneath top block is spalled along corner, and has 2 minor cracks on Lt side.

Bent 1 Lt MSE wall settlement at top corner

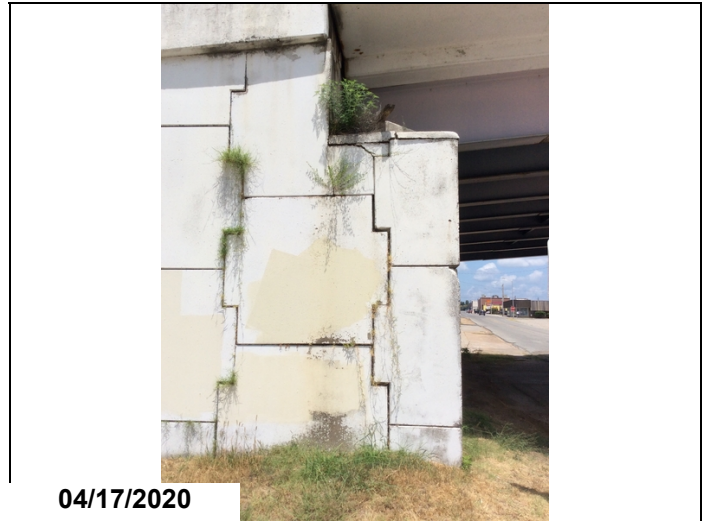
bent 1 Rt

Bent 1 Rt – top 2 corner blocks have some settlement/misalignment. 1st panel perpendicular to abutment at top is cracked/spalled.

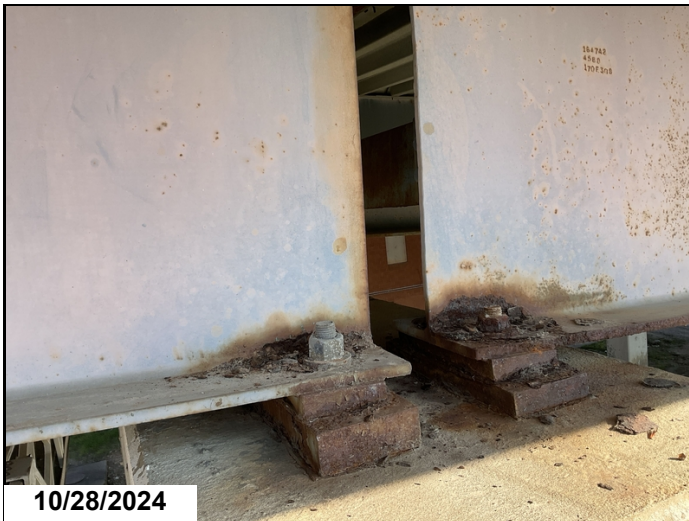
Span 7 bent 8 girder 8 and Span 8 bent 8 girder 8 have 6" areas of 1/8" section loss at bottom of web over bearings. CS3

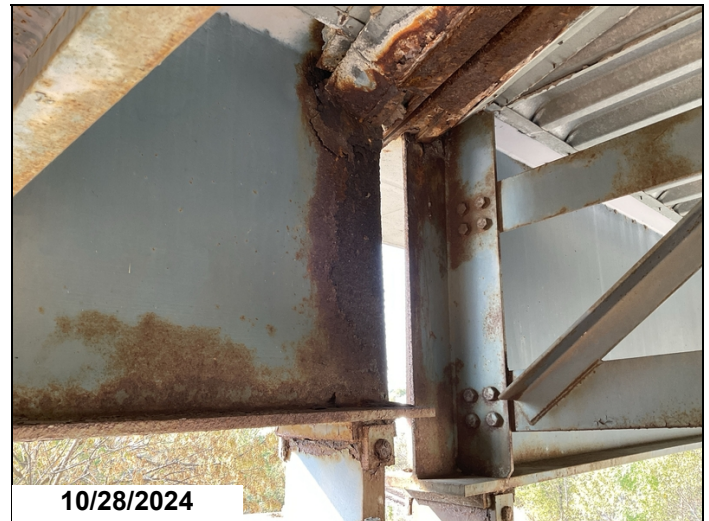
Span 6 bent 6 girder 8 CS3

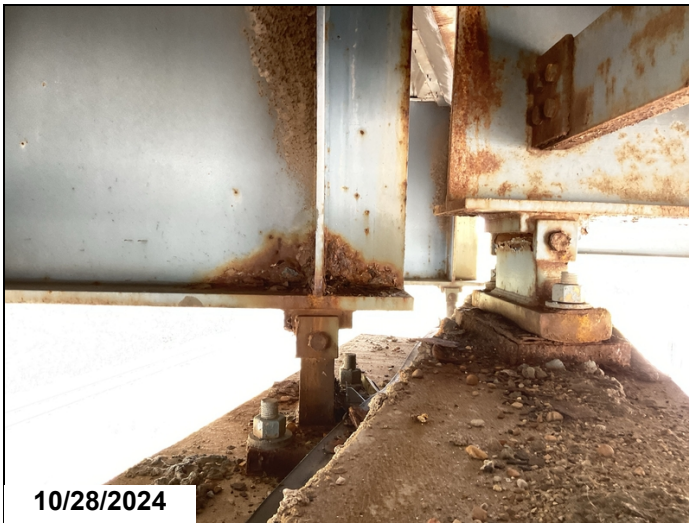
span 5 bent 5 girder 7 CS3

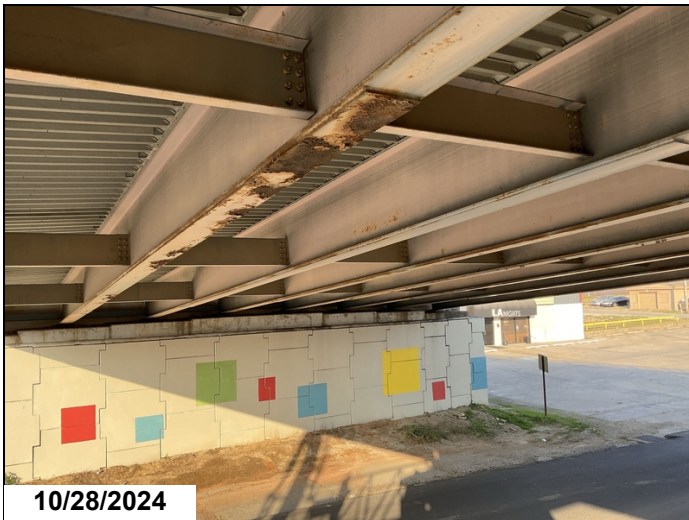
Span 1 girder 7 has rust with areas initial section loss at bottom flange cover plate.

Span 1 girder 7 corrosion with minor section loss CS3

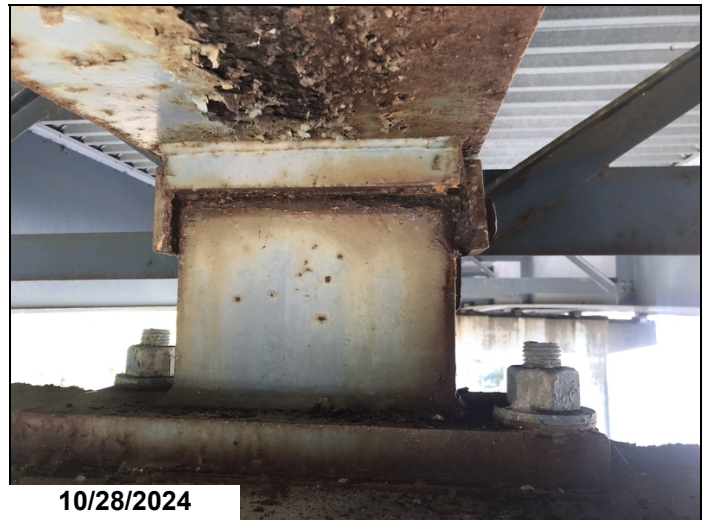
Span 6 bent 6 bearing 5 retainer is bowed from pack rust at cap screw. CS3

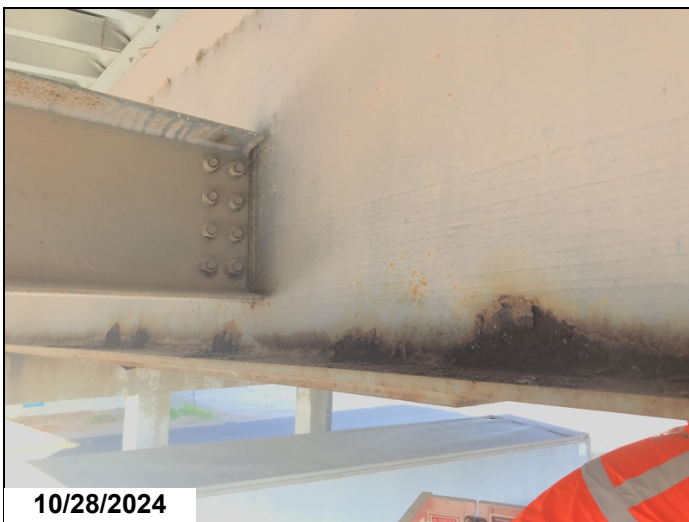
Span 2 girder 7 Rt side corrosion

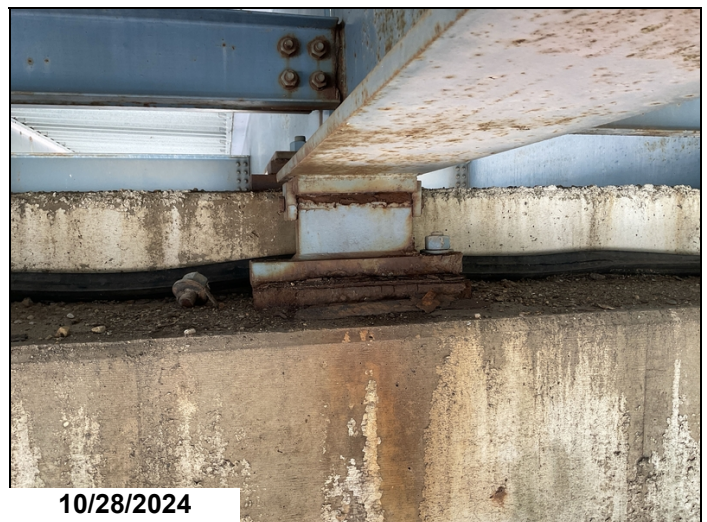
Span 6 bent 7 bearing 6 has 1 anchor bolt sheared off

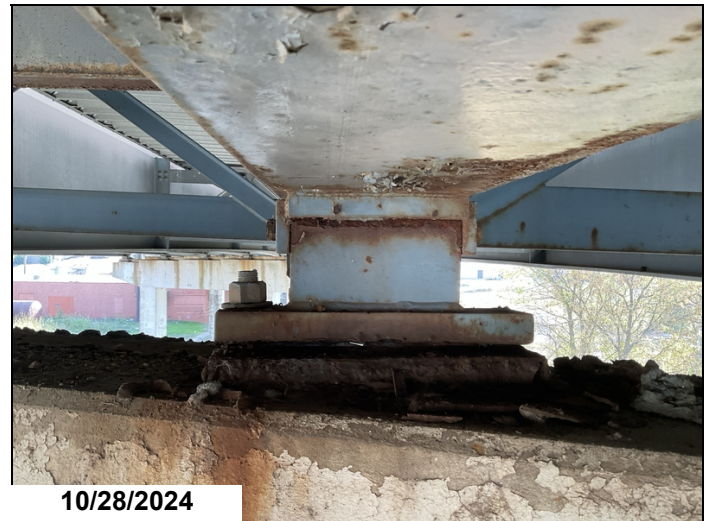
Span 4 bent 5 bearing 6 has 1 anchor bolt sheared off

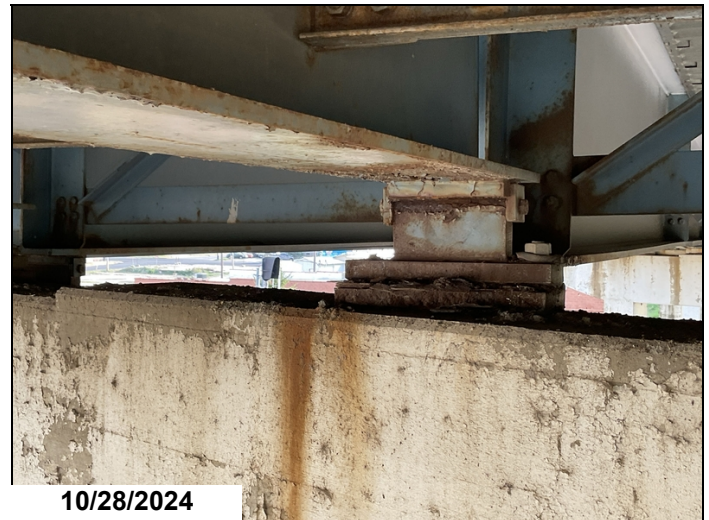
Span 4 bent 5 bearing 3 has 1 anchor bolt sheared off

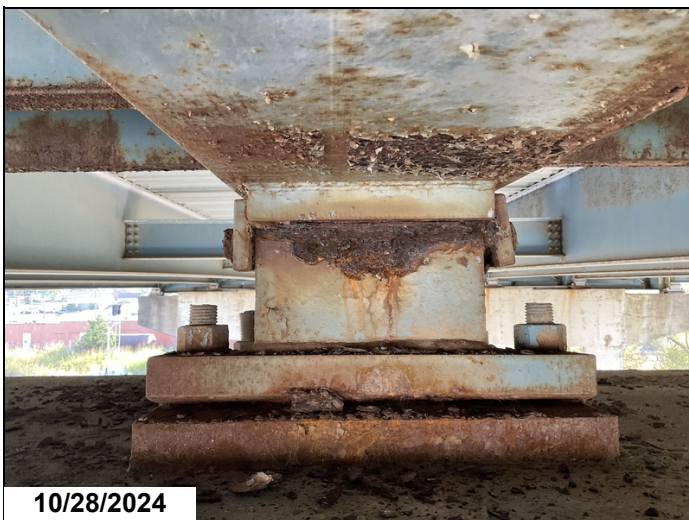
Span 3 bent 4 bearing 4 retainer is bowed from pack rust at cap screw. CS3

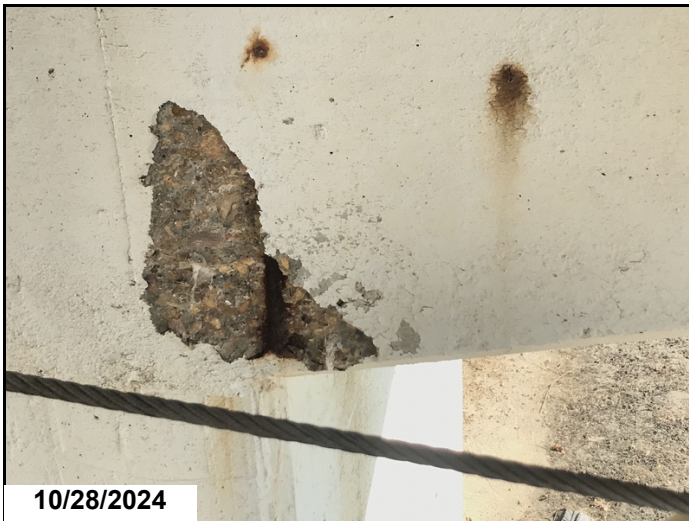
Bent 8 cap has 2' cracking CS2 and 1' spall with exposed rebar CS2 and 1' of delamination

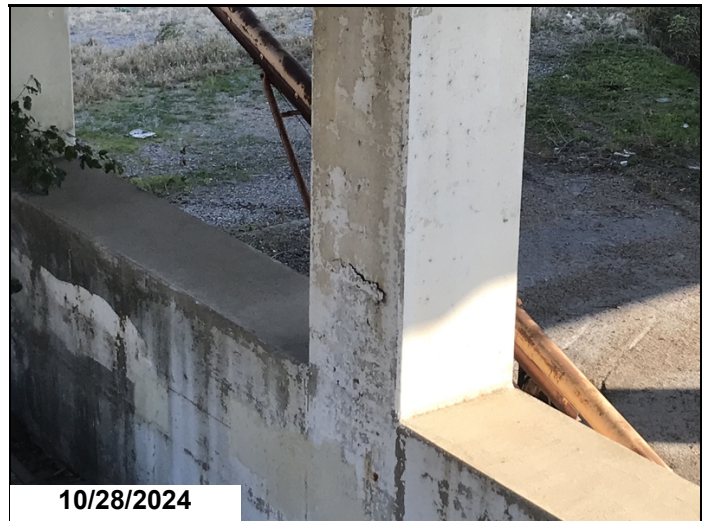
Bent 4 column 2 back has a 2' delamination CS3

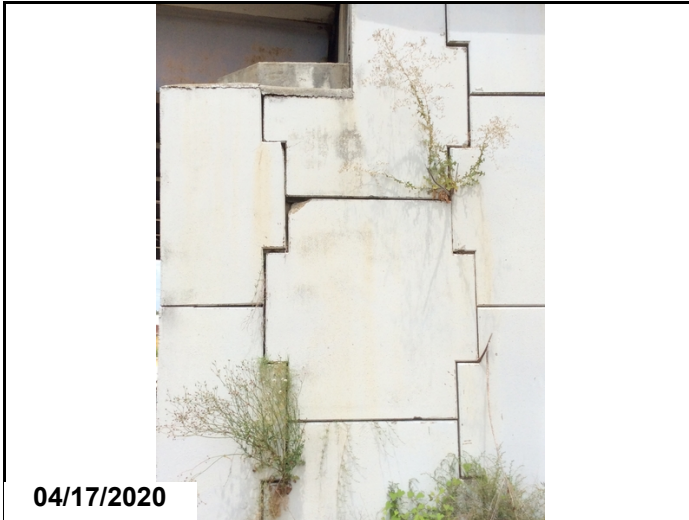
MSE walls have leakage and staining at a few joints. Several joints have vegetation growing between panels.

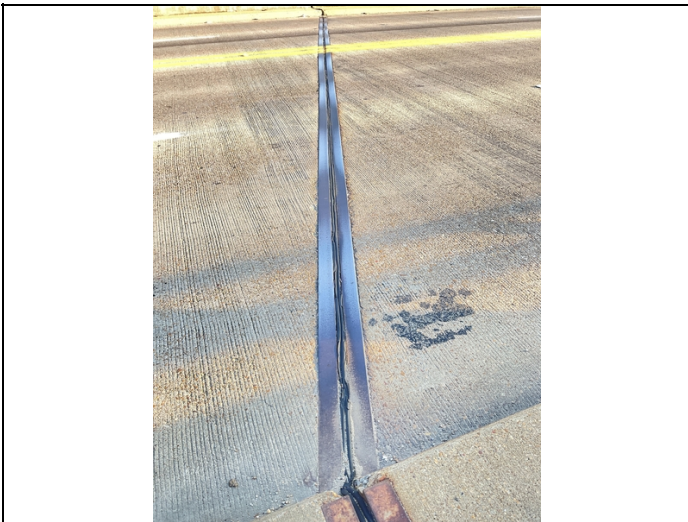
Bent 6 1/2 torn/ adhesion 2

A-59 - Joint Repair Needed (Yes)

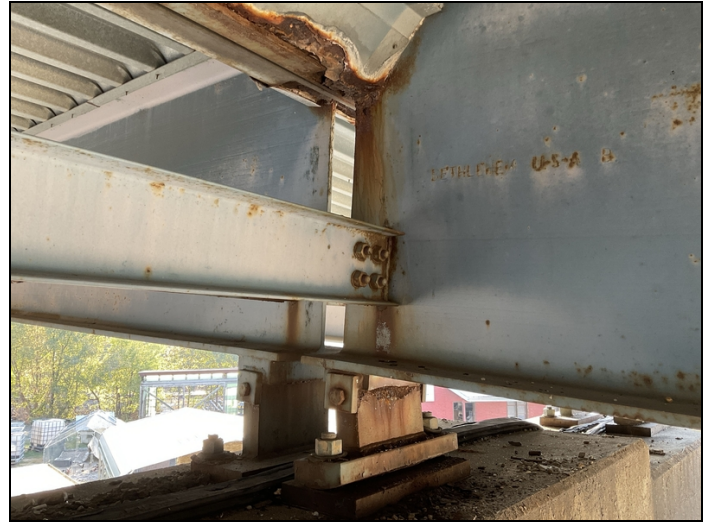
Typ corrosion at ends

A-60 - Full Girder Painting Needed (Yes)

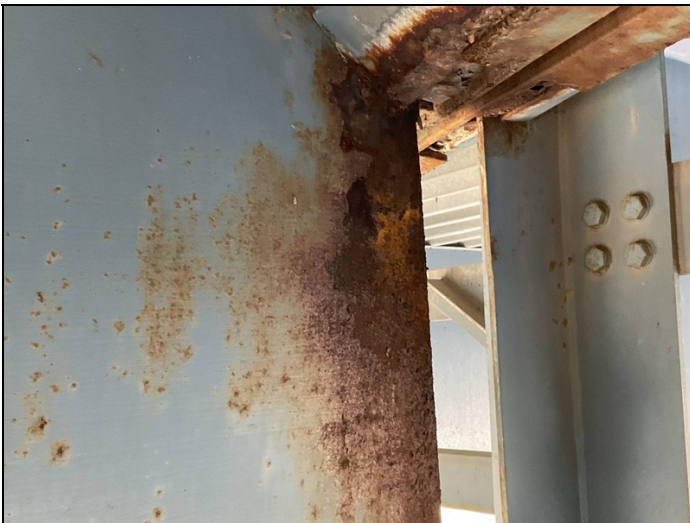
Span 6 bent 6 girder 5 has some minor flaking rust in web below haunch

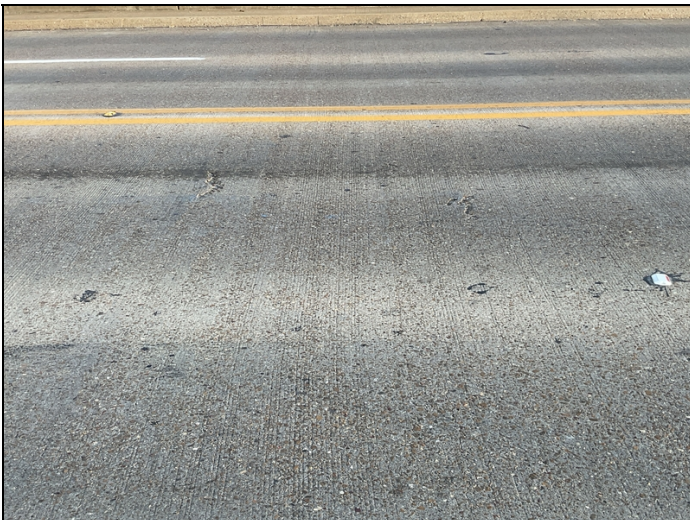
Span 2 East bound delam/shallow spalls

A-61 - Polymer Overlay Advised (Yes)

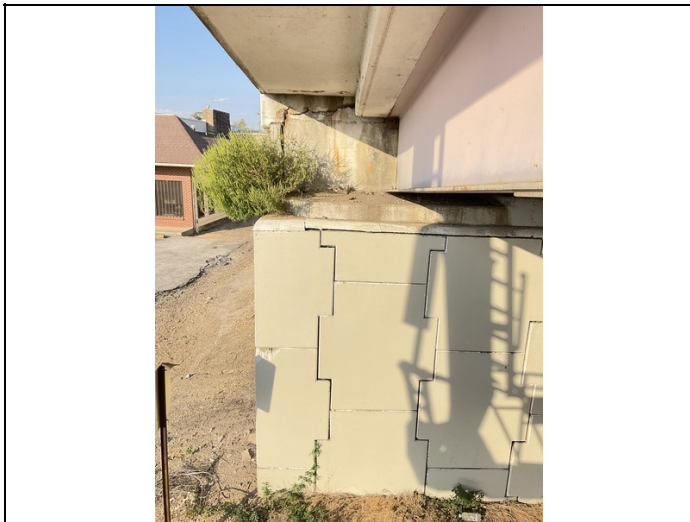
Bent 1 Rt vegetation

A-64 - Vegetation Removal Requested (Yes)

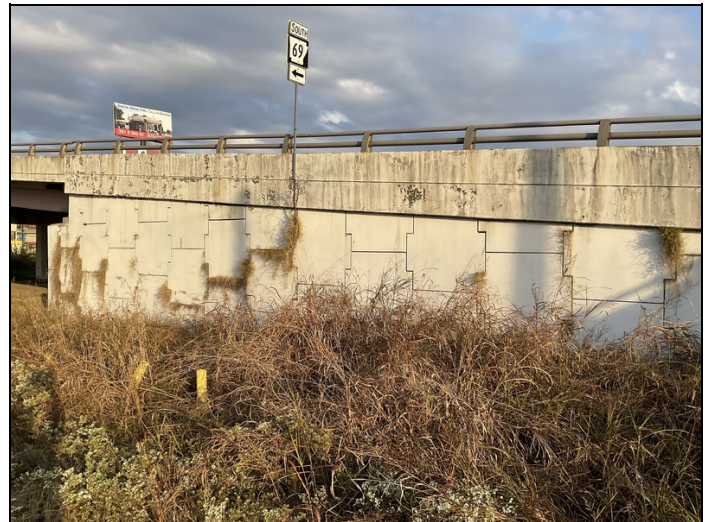
Bent 10 Rt vegetation in mse joints
