Asset #M3982(Other Special Recurring)

SH 358-01- LM 4.39 over VILLAGE CREEK

Team Lead: Richard Jones Inspection Date: 05/08/2024

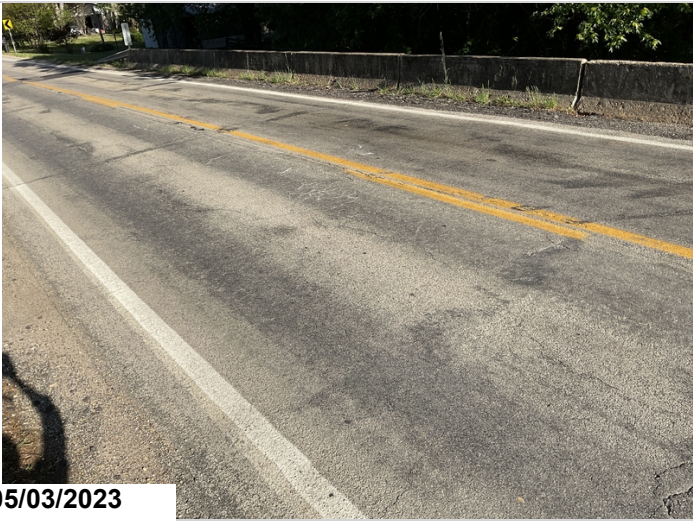
Asphalt wearing surface has map cracks with efflorescence pumping through cracks.

Wearing surface

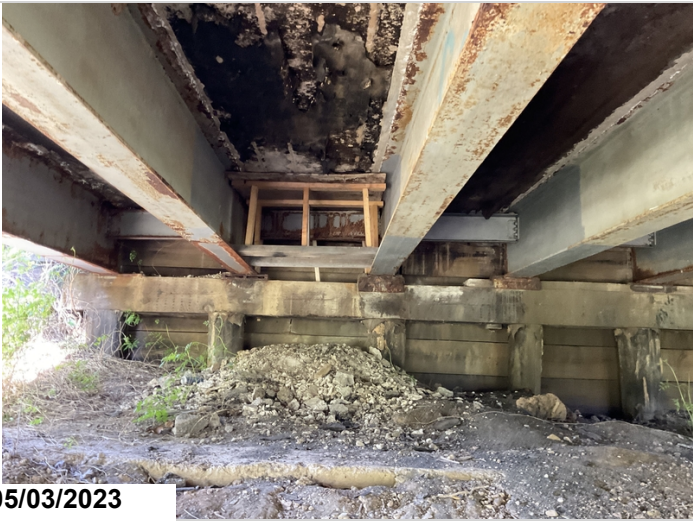
Span 3 has full depth patches.

Span 3 bay 2 fdp

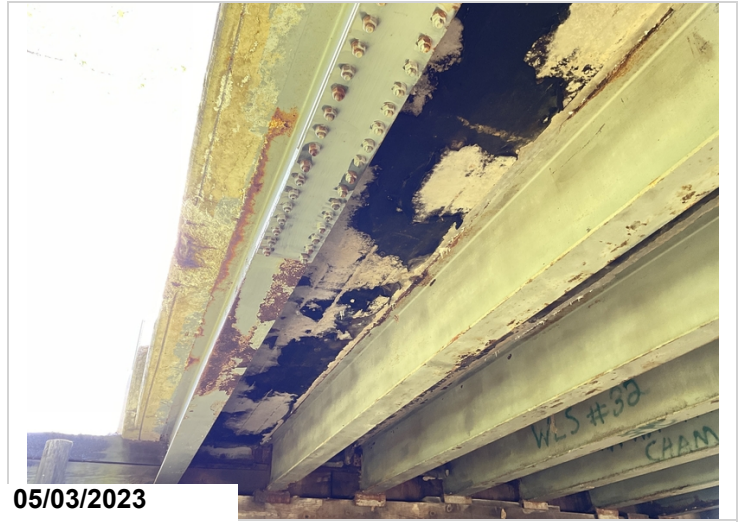
Span 1 Rt overhang

Deck has areas of concrete disintegration along joints and overhangs.

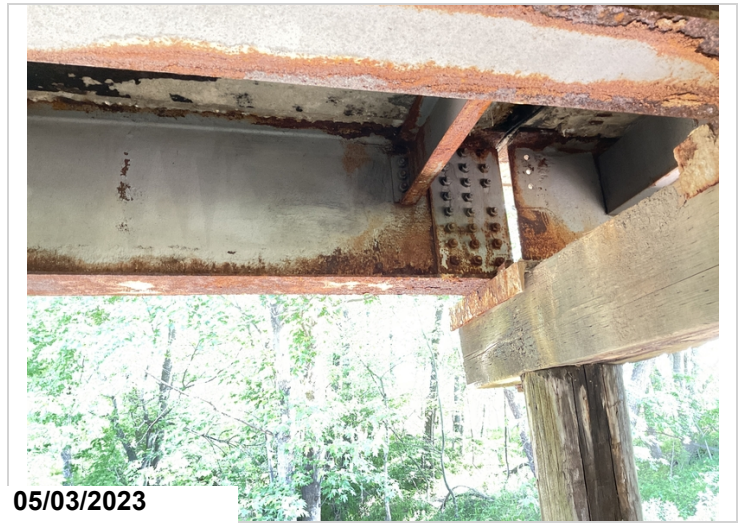
ELEMENTS	DESCRIPTION	UNITS	TOTAL	CS1	CS2	CS3	CS4
Span 2 bent 3 girder 8 was repaired with a T-Splice and bolted plate along bottom flange.							
Span 3 bent 3 girder 1 was t-spliced sometime in the past Span 3 bent 3 girder 2 was cleaned and painted in 2019, but has some active corrosion. Span 3 bent 3 girder 3 was t-spliced sometime in the past Span 3 bent 3 girder 4 was t-spliced sometime in the past Span 3 bent 3 girder 5 was t-spliced sometime in the past Span 3 bent 3 girder 6 was t-spliced sometime in the past Span 3 bent 3 girder 7 was t-spliced sometime in the past Span 3 bent 3 girder 8 has a bolted web plate at end of girder.							
Span 3 bent 4 girder 1 was t-spliced sometime in the past. Span 3 bent 4 girder 2 was t-spliced sometime in the past. Span 3 bent 4 girders 3 and 4 were cleaned and painted in 2019. Span 3 bent 4 girder 5 was t-spliced sometime in the past. Span 3 bent 4 girder 6 was t-spliced sometime in the past. Span 3 bent 4 girder 7 was t-spliced sometime in the past. Span 3 bent 4 girder 8 was t-spliced sometime in the past.

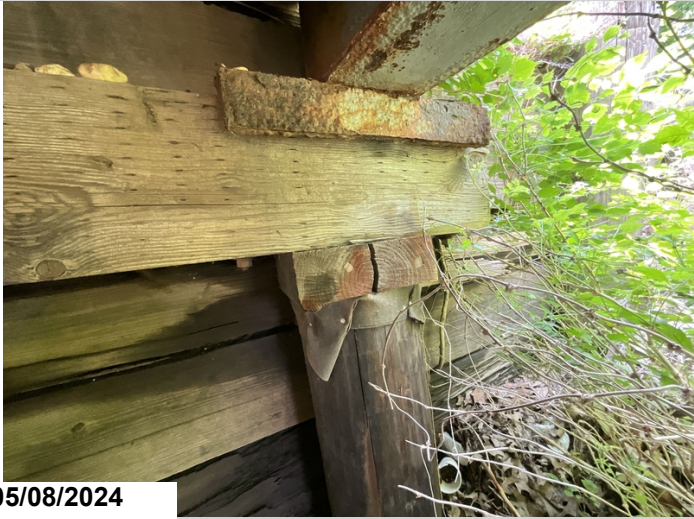
(228) Piles have checks and some outside decay near ground level. Bent 1 pile spacer blocks have splits and some crushing. Bent 2 pile 1 was spliced in 2019. Concrete collar is cracked/broken on back side. Bent 2 piles 2 and 3 have a concrete mass pressed against them on back side. Piles have delaminated areas on ahead side and are bowed. Pile 3 is possibly broken. Bent 2 pile 8 is decayed and hollow at ground line. Pile appears to be swelling or broken on ahead side.							
235	Timber Pier Cap	LF	123	61	46	4	12
1140	Decay/Section Loss	LF	32	0	16	4	12
1150	Check/Shake	LF	30	0	30	0	0

Bent 1, Pile 1: spacer block split

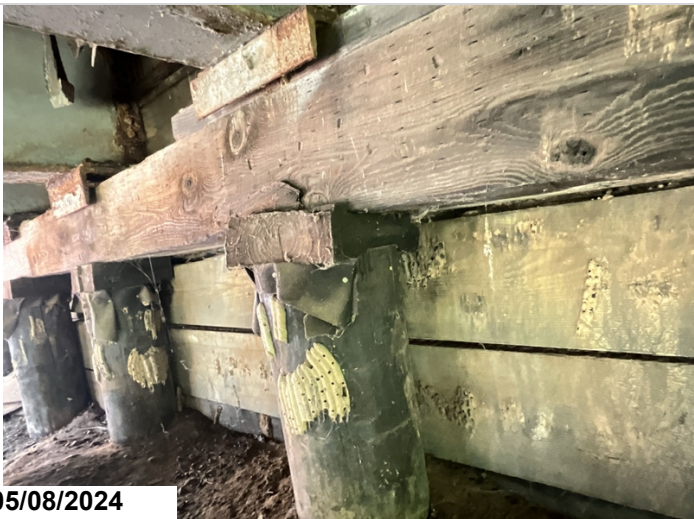
Bent 1, Pile 5: spacer block is decay and crushing

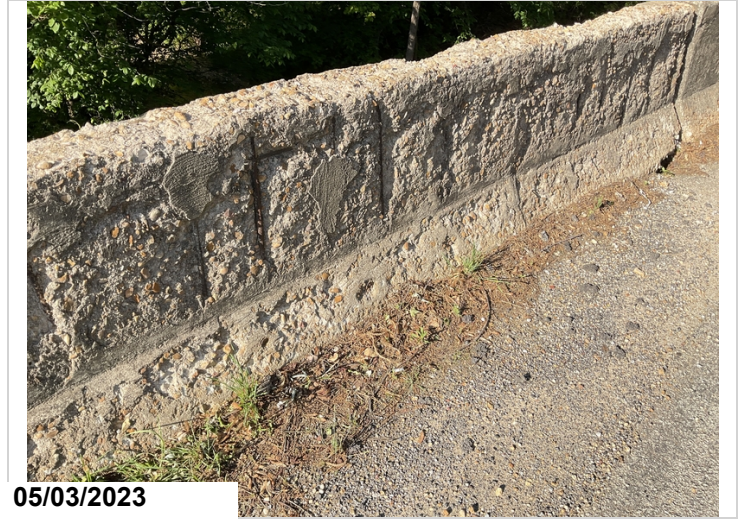
Span 1 Lt rail

(331) Concrete rails have several minor spalls with exposed rebar from lack of coverage. Rails have moderate to advanced abrasion, especially at span 1 Lt.

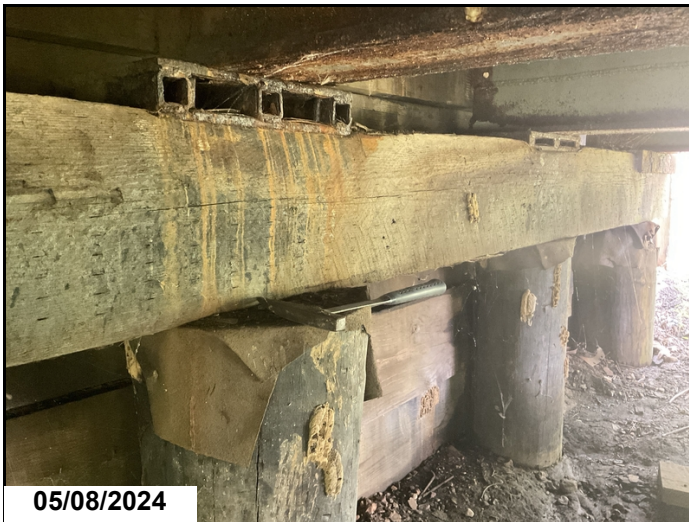
Bent 4 Rt

Bent 4 cap has 12' of top decay on Rt end. Cap is hollow up to 8" deep with some crushing/swelling under girders 6 and 7.

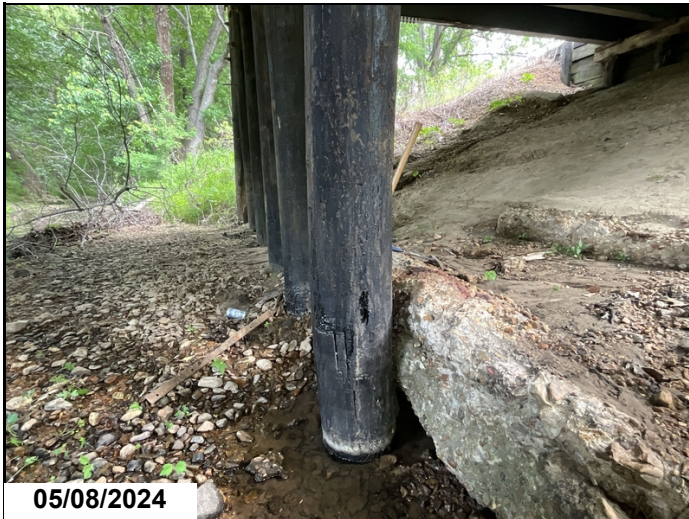
Bent 2 piles 2 and 3 have a concrete mass pressed against them on back side. Piles have delaminated areas on ahead side and are bowed. Pile 3 is possibly broken.

Bent 2, Pile 3: concrete slid against pile. Pile has some outer split and delam on ahead side

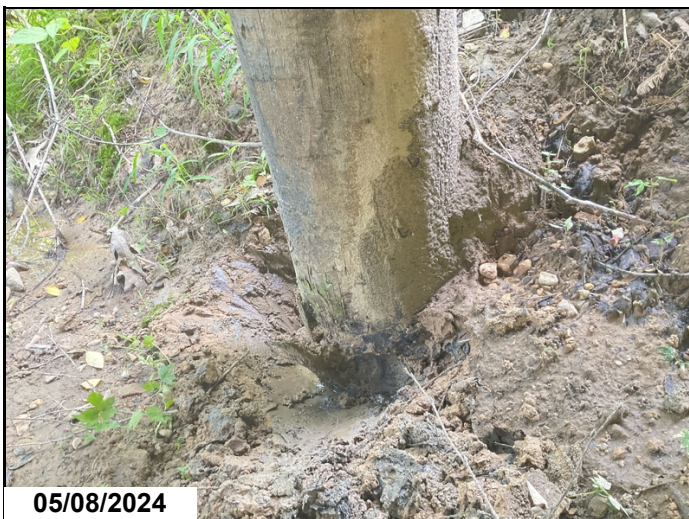
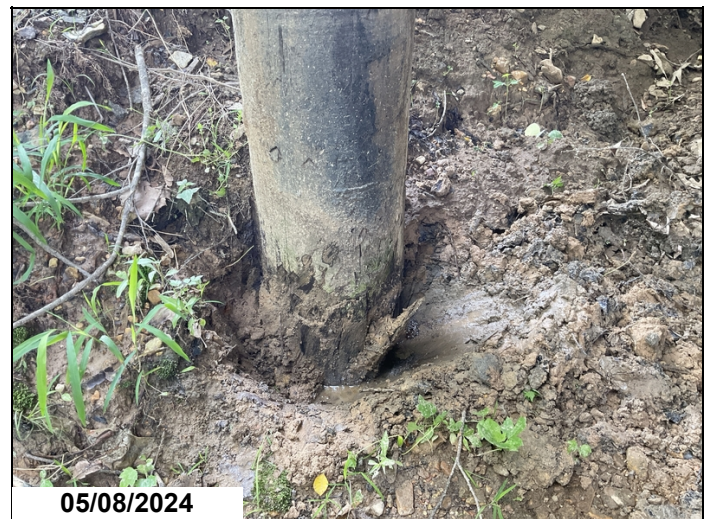
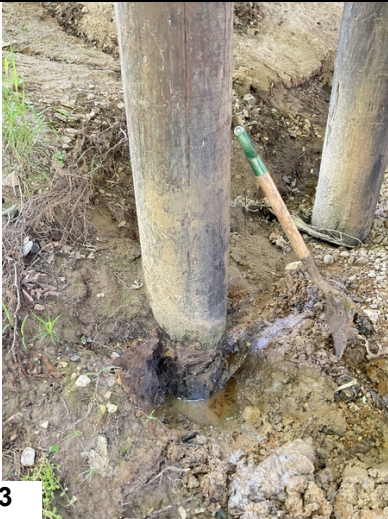
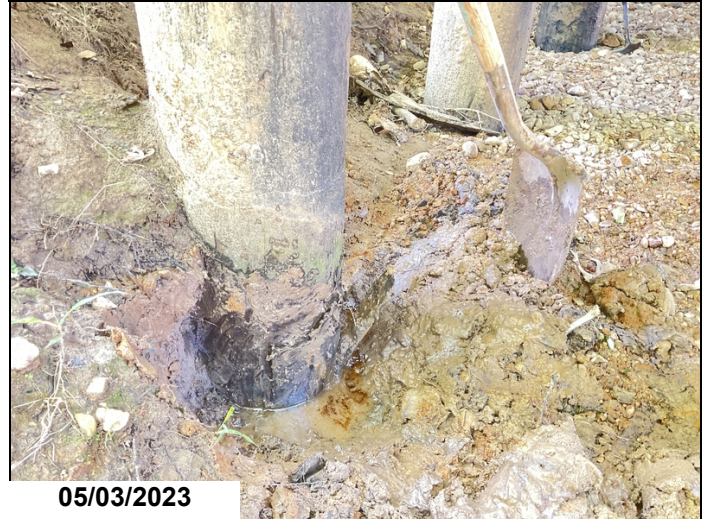
Bent 2 pile 8 is decayed and hollow at ground line. Pile appears to be swelling or broken on ahead side.

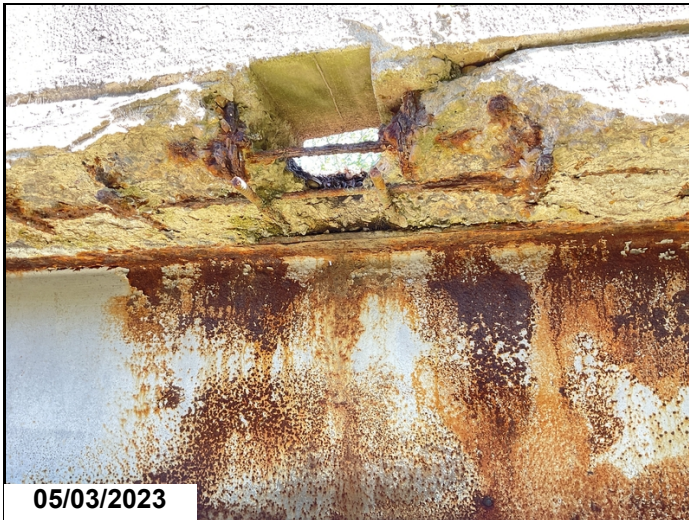
Span 3 Lt

Deck has areas of concrete disintegration along joints and overhangs. Overhangs have rebar exposed near joints and drain openings.

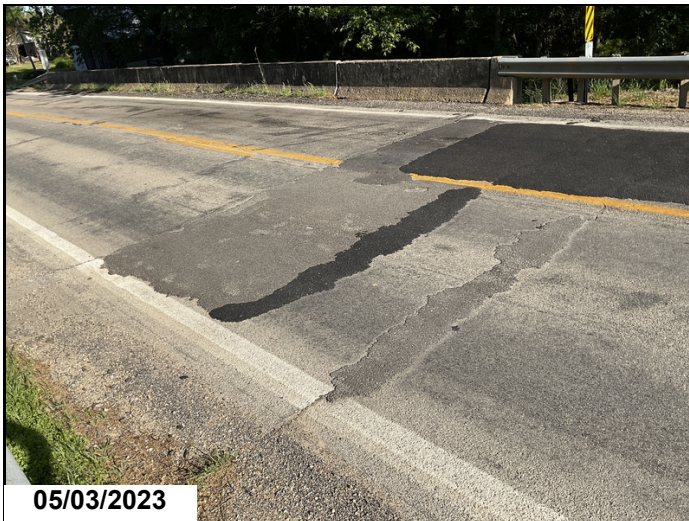
Bent 1 approach

Approach roadways have some settlement and patched areas at each bridge end.

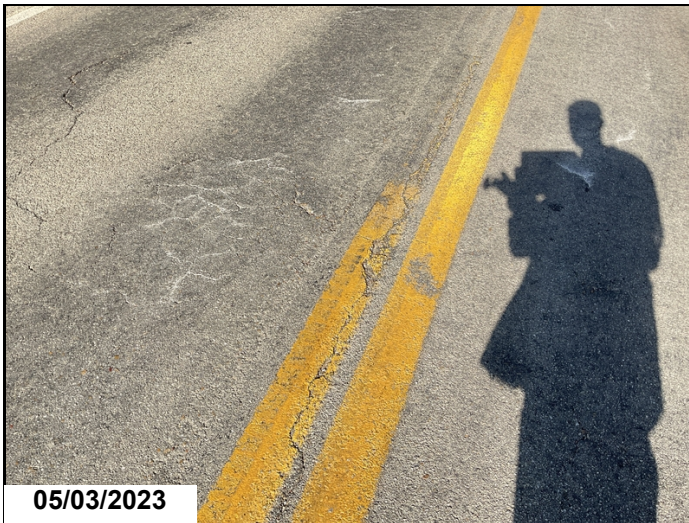
Span 1

Asphalt wearing surface has map cracks with efflorescence pumping through cracks. Asphalt has a few spalls/potholes.

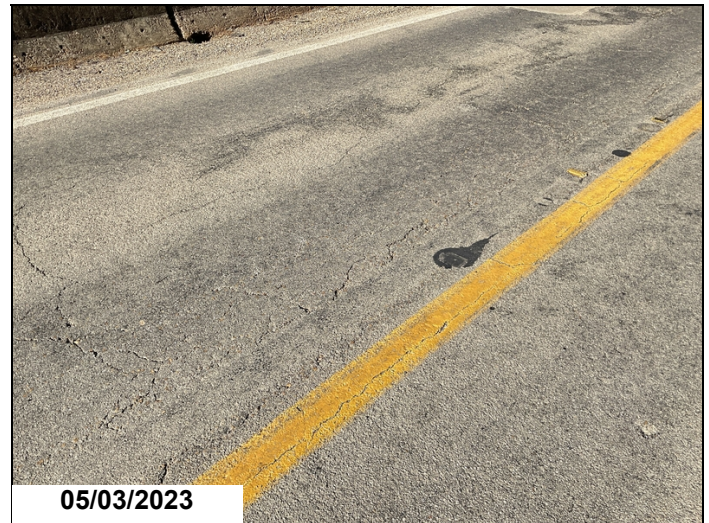
Map cracks
