Asset #05728(Routine, Underwater type 2)

US 412-06B-LM 4.41 over VILLAGE CREEK

Location: WALNUT RIDGE

Team Lead: Richard Jones Inspection Date: 09/18/2023

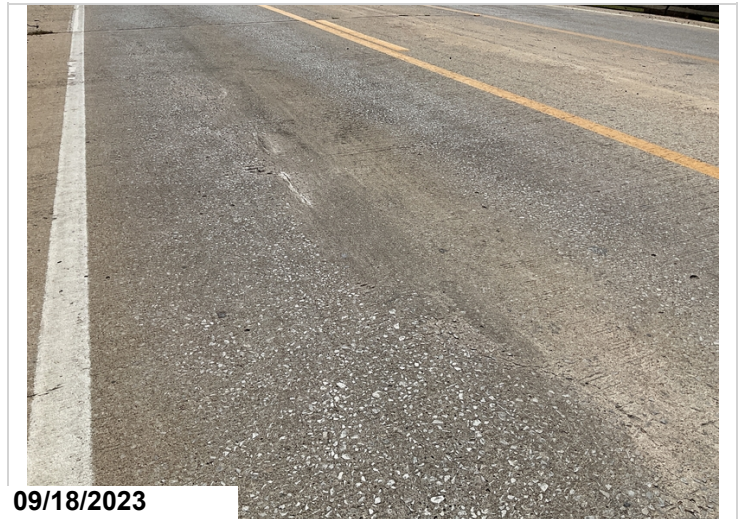
Abrasion

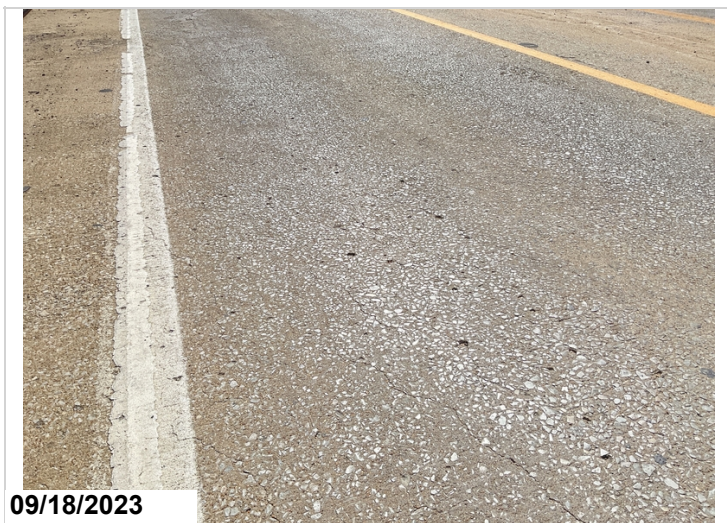
Slabs have unsealed cracks and moderate abrasion.

cracks/abrasion with pop outs

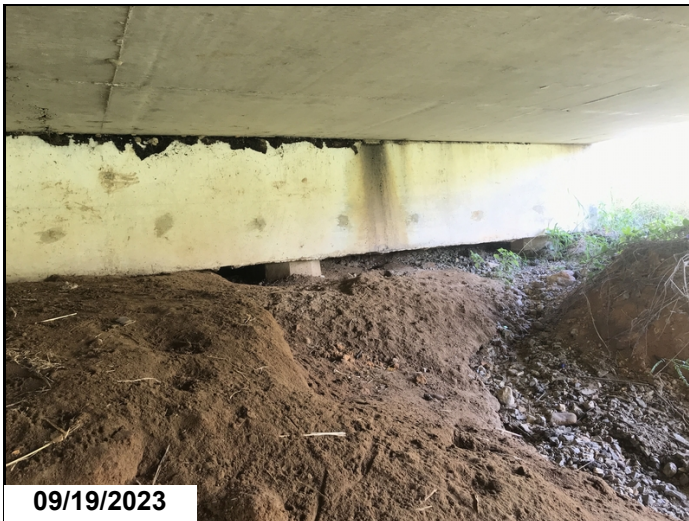
2023 - Bent 1 left side

Bent 1 is undermined for 9' on Lt end and 3' on Rt end up to 2' below and 2' back under. Concrete repairs were made on Rt end in the past, but erosion has progressed adjacent to repair.

Lawrence and Bridge crew reviewed recently to determine best way to repair

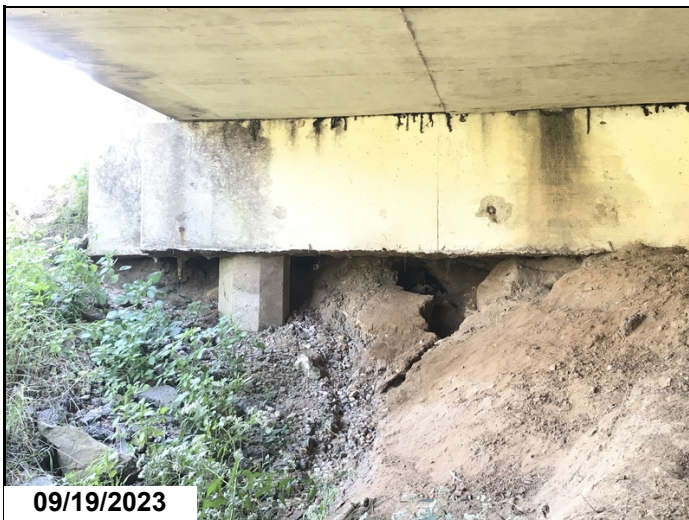
2023 - Bent 4 left side

Bent 4 abutment has a concrete scour repair on Rt end. Embankment is continuing to wash out adjacent to repair. Lt end is undermined for 9' up to 2' below and 2.5' back under.

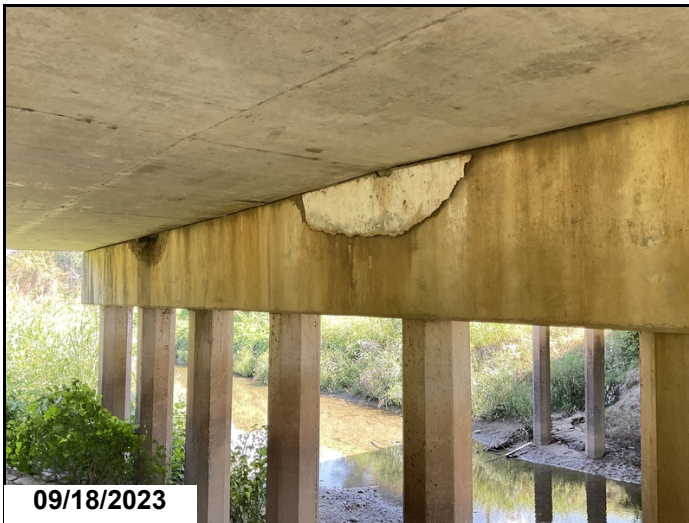
Bent 2

Bents 2 and 3 caps have spalls and delaminated areas near keyways.

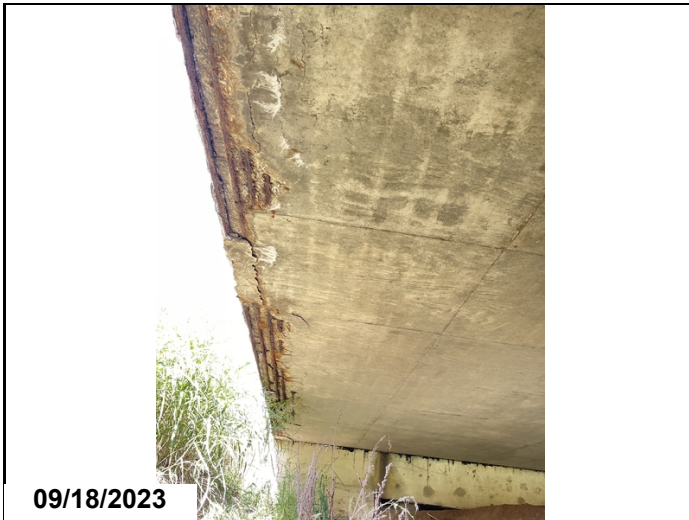
2023 - Span 1 Rt

Span 1 has a large spall with exposed rebar along Rt edge. Exposed rebar has some section loss and loss of embedment.

Span 1 has a large spall with exposed rebar along Rt edge. Exposed rebar has some section loss and loss of embedment. Span 2 has a spall with rebar exposed along edge.

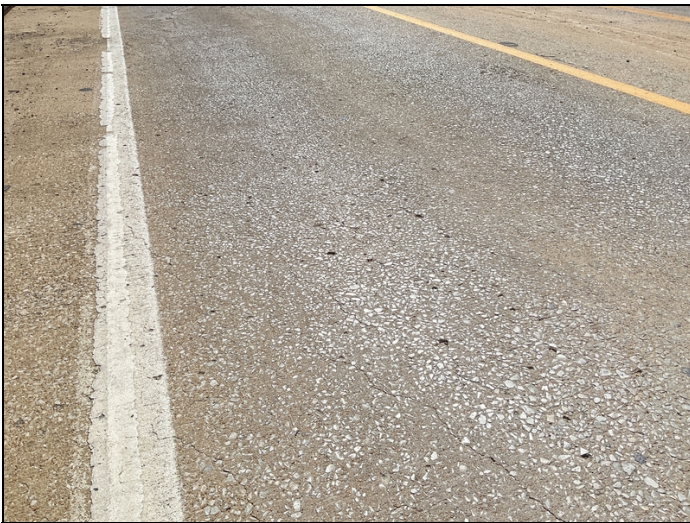
cracks/abrasion with pop outs

**A-61 - Polymer Overlay Advised (Yes)**

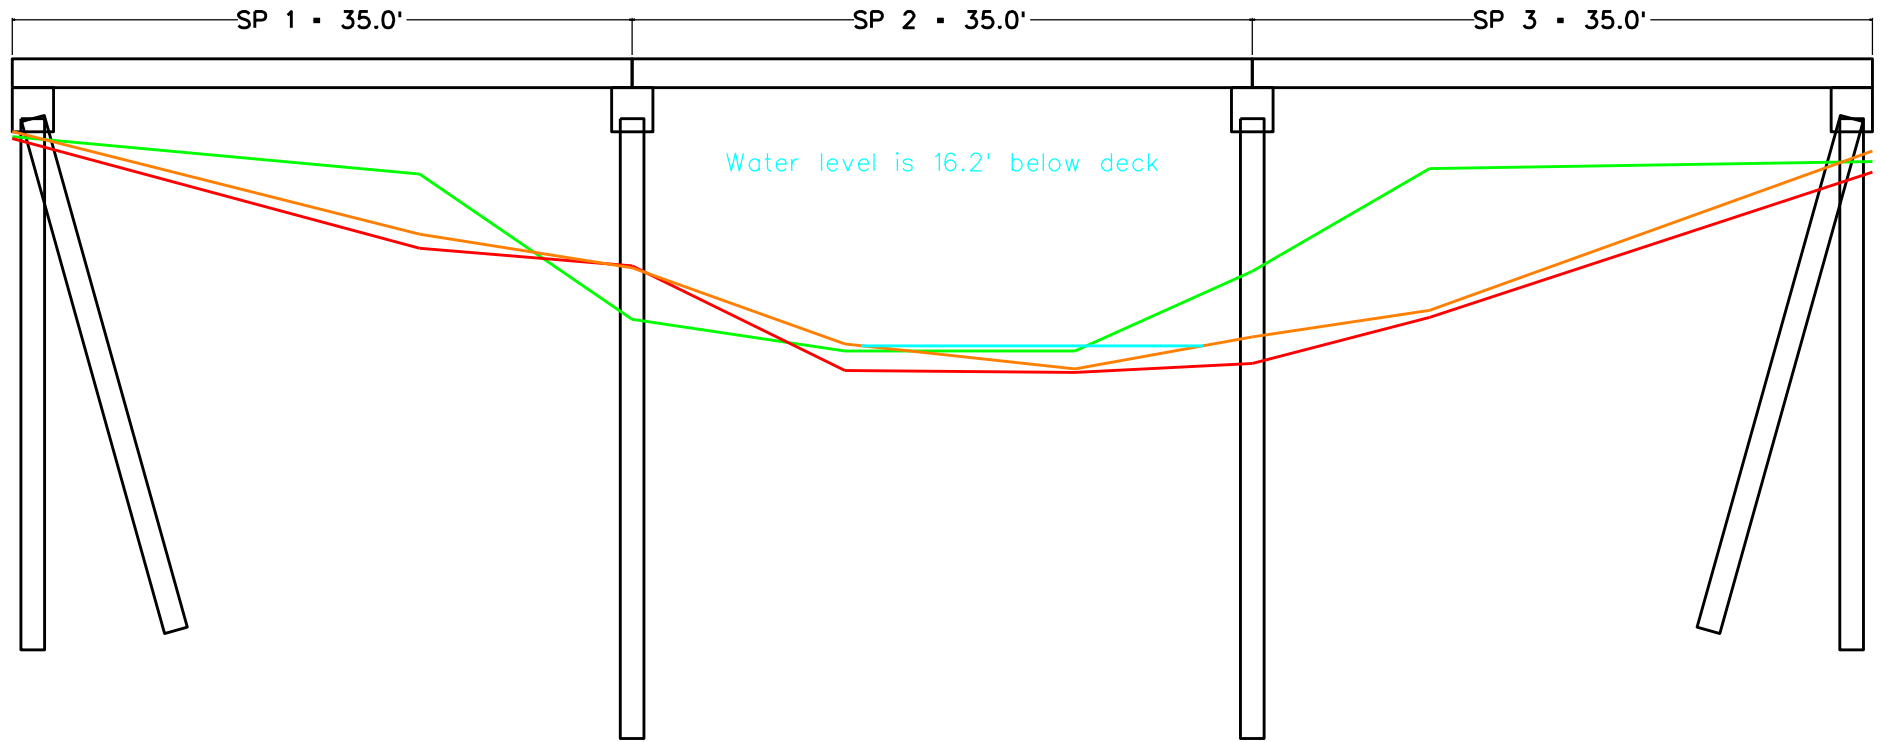
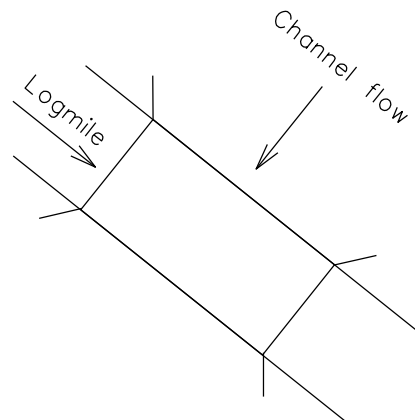
Channel sounded from top of deck, LEFT SIDE  
 Green soundings taken on 8-22-1990  
 Red soundings taken on 9-4-2019  
 Orange soundings taken on 9-18-2023
