Arnold Road ID:61x328x1xA, Arnold Log mile:8.808

District 10, 121 - Randolph County

Asset #05734(Routine, Underwater type 2)
SH 328-01-LM 8.83 over CURRENT RIVER RELIEF
Location: 8.83 MI E MAYNARD
Team Lead: James Adams Inspection Date: 02/15/2023

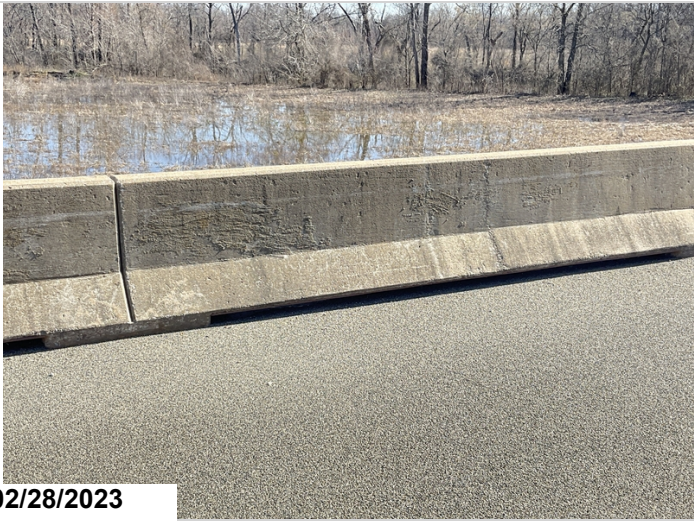
Bridge rails have several minor cracks with some efflorescence, areas of abrasion, and spalls with rebar exposed, mostly from lack of coverage. Some areas have been grouted.

Parapet example

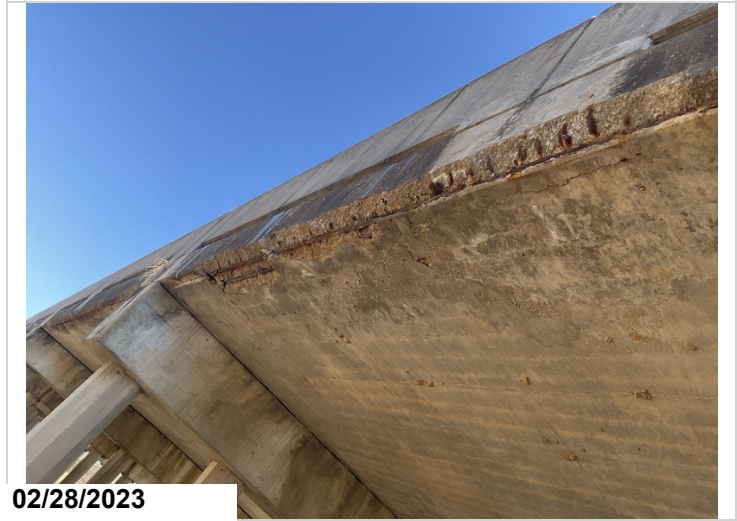
Span 11 right

Span 11 Left side = 15 ft. x 1.0 ft. wide exposed rebar with 27.0 ft. of delamination, Right side= 15 ft. x 1.0 ft. wide exposed rebar and 20.0' delamination.

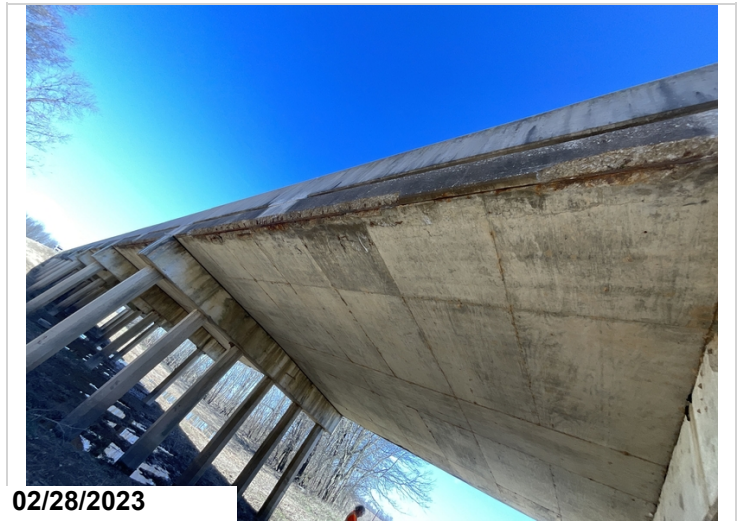
Span 10 right

Span 10 Left side = 3.0 ft. x 12.0 ft. wide exposed rebar, 8.0 ft. x 1.0 ft. wide spalling. Right side = 20.0 ft. x 1.0 ft. wide exposed rebar and 10.0' delamination.

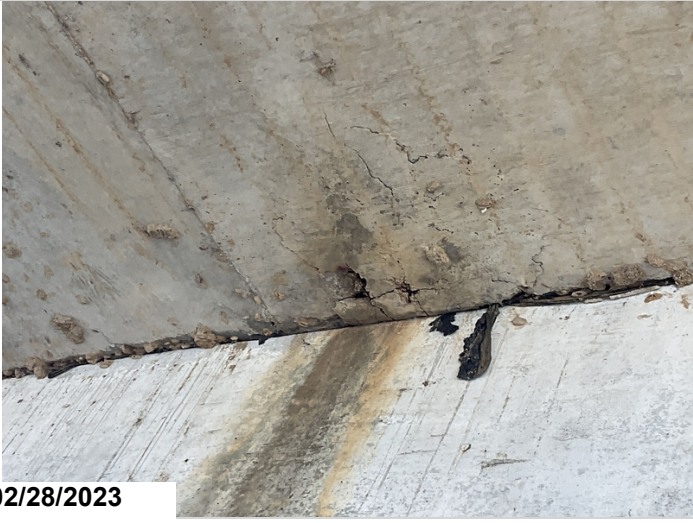
Span 9 near bent 10 2-28-2023

Span 9 Left & Right side = 30.0 ft. x 1.0 ft. exposed rebar each side.

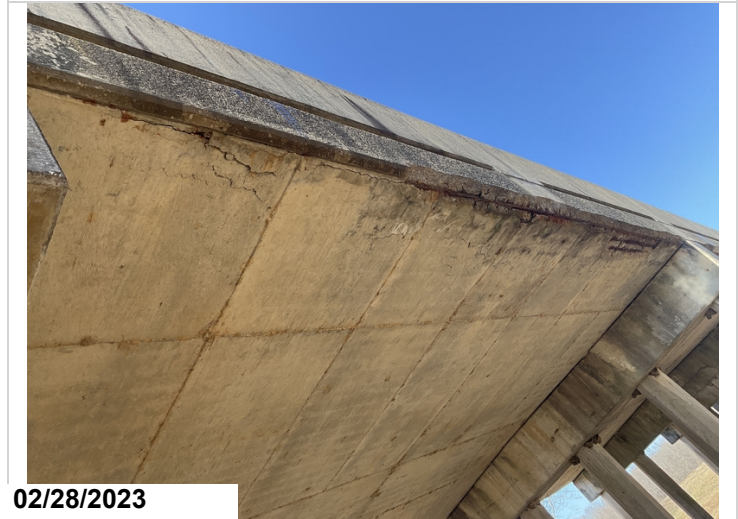
Span 8 left

Span 8 Left side = 20.0 ft. x 2.0 ft. wide exposed rebar, Right side 3.0 ft. x 1.0 ft. wide exposed rebar with 27.0 ft. of cracking with efflorescence.

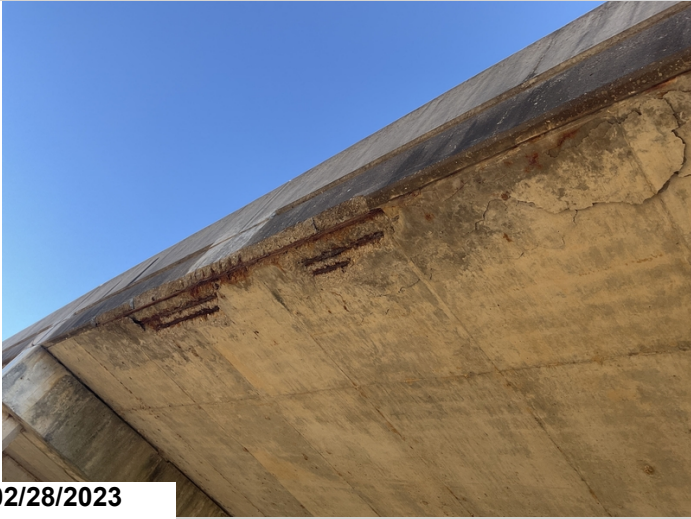
Span 7 right

Span 7 Left side = 30.0 ft. x 2.0 ft. wide exposed rebar & delamination, Right side = 14.0 ft. x 2.0 ft. wide exposed rebar with 18.0 ft. of delamination with efflorescence.

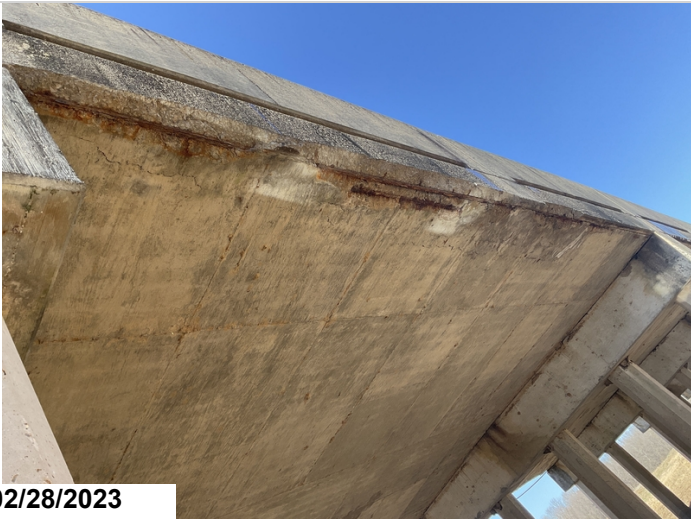
Span 6 left

Span 6 Left side = 20.0 ft. x 2.0 ft. wide exposed rebar, Right side = 14.0 ft. x 2.0 ft. wide exposed rebar with 8.0 ft. of cracking with rust staining.

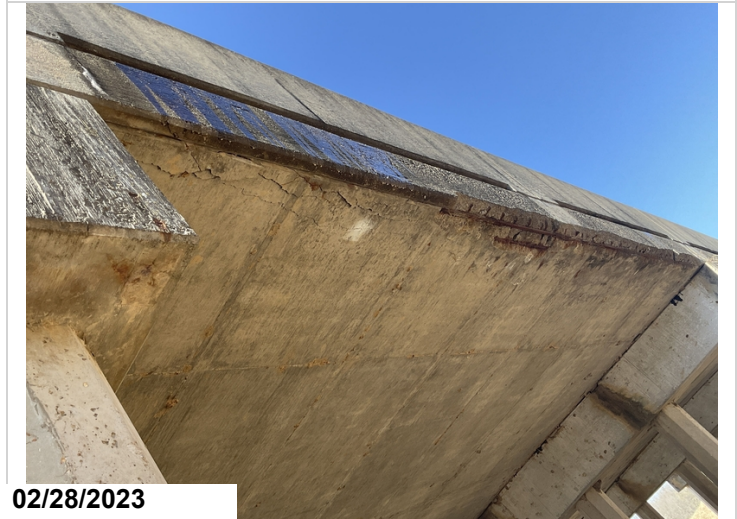
Span 5 left

Span 5 Left side = 20.0 ft. x 1.0 ft. wide exposed rebar & 10.0 ft. delaminated Right side = 30.0 ft. x 1.0 ft. exposed rebar with 1.0 ft. additional exposed rebar. Rebar is detached from slab (see photo).

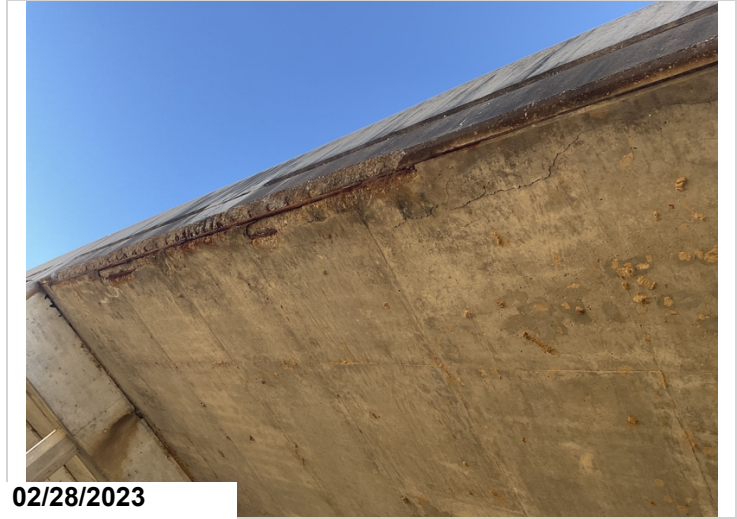
Span 4 right

Span 4 Left side = 20.0 ft. x 2.5 ft. wide exposed rebar & 8.0 ft. x 1.0 ft. wide delaminated, Right side = 20.0 ft. x 1.0 ft. wide exposed rebar and 6.0ft. X 1.0ft. of delamination.

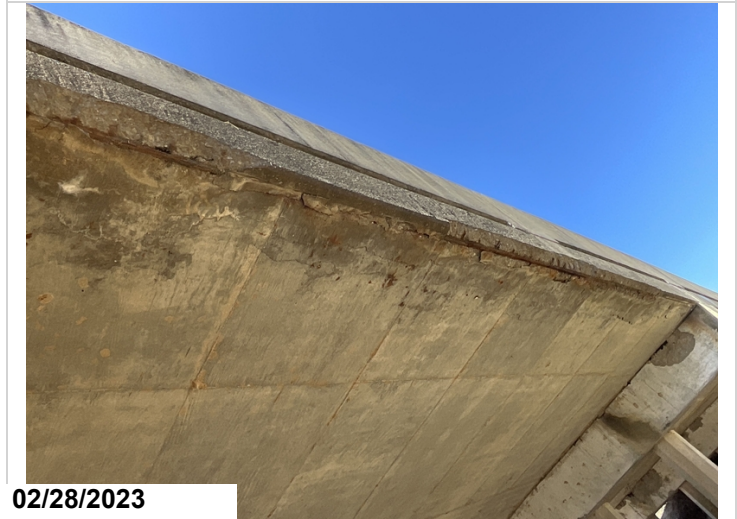
Span 3 left

Span 3 Left side = 30.0 ft. x 2.0 ft. wide exposed rebar, Right side = 1.0 ft. exposed rebar, 30 ft. delamination with some efflorescence.

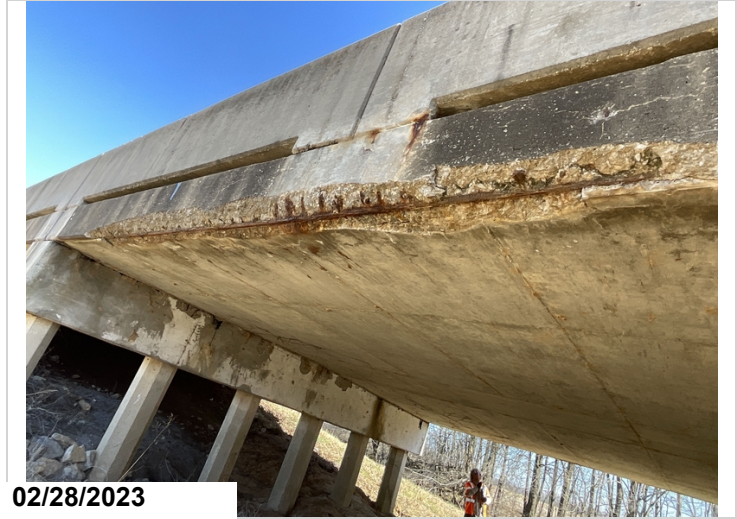
Span 2 right

Span 2 Left side = 6 ft. of cracking with rust staining, 1ft. of exposed rebar, Right side = 12.0 ft. x 1.0 ft. wide exposed rebar & 4.0 ft. of cracking with efflorescence & 9ft. of delamination.

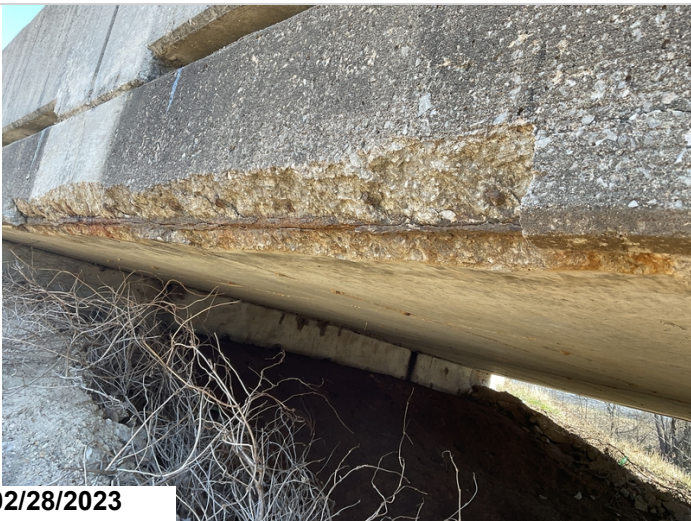
Span 1 right

Span 1 Left side = 9ft. x2.0 ft. cracking, Right side = 8.0 ft. of exposed rebar.

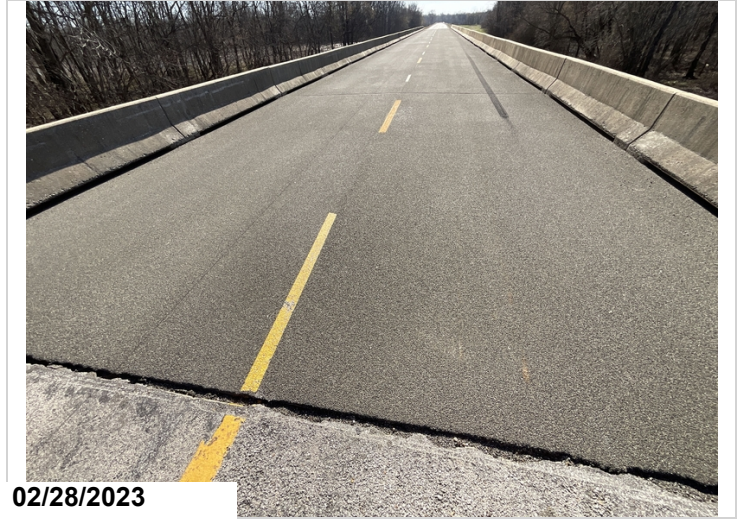
Deck has recieved a epoxy overlay by HBM.

Polymer deck observed repair by statewide crews 2-28-2023

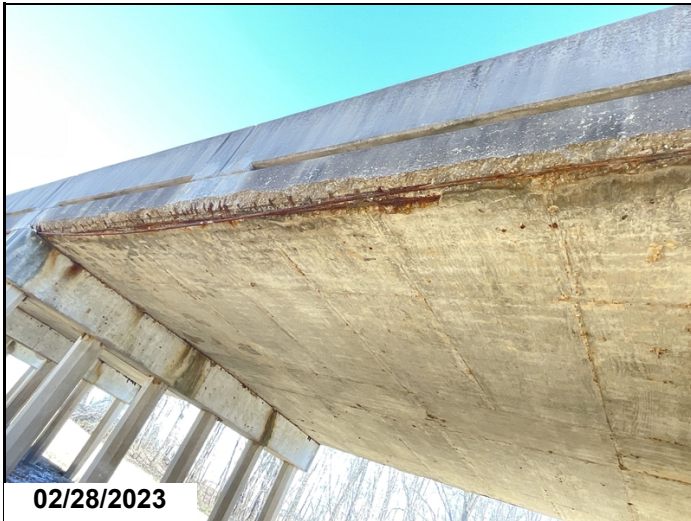
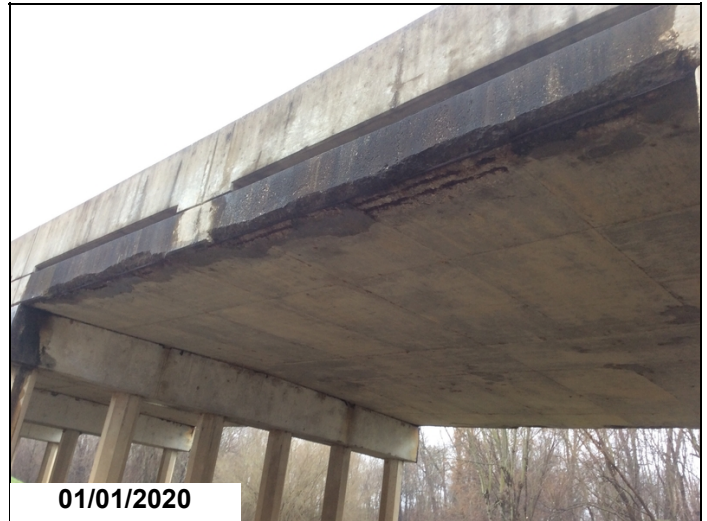
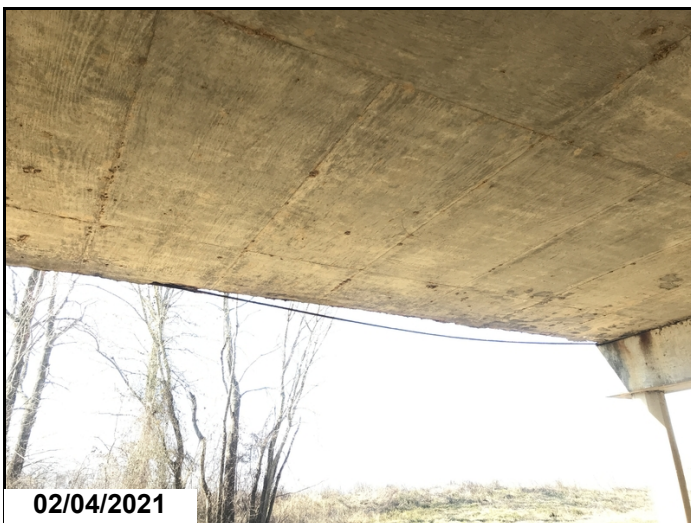
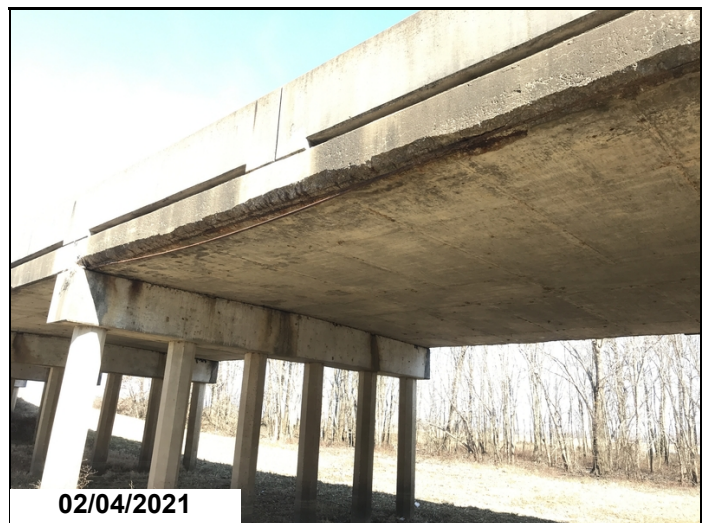
Span 5 right 2-28-2023

Span 5 right has approximately 15ft. where concrete has completely spalled away from 1 exterior longitudinal rebar. Rebar is sagging down away from slab.

Lt and Rt edges of slabs are cracked, delaminated, and have spalls with exposed rebar. Span 5 Rt has approximately 15' where concrete has completely spalled away from 1 exterior longitudinal rebar. Rebar is sagging down away from slab.

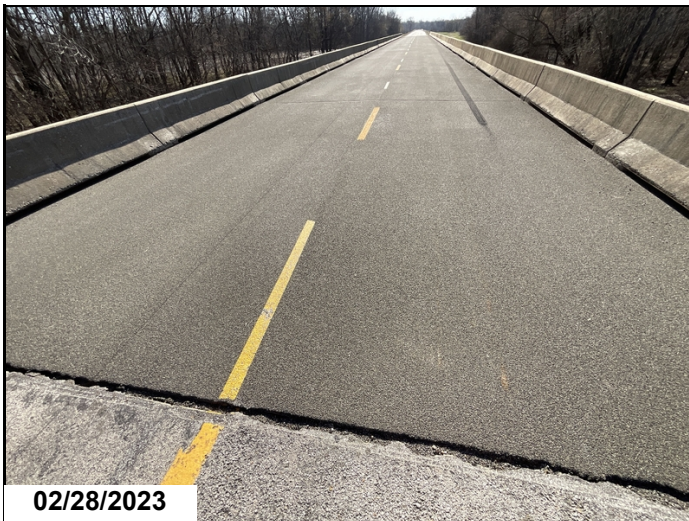
***Top of slabs have several areas of abrasion and a few small pop outs. Slabs have areas of map cracking, especially in wheel paths. Slabs have a few unsealed moderate width cracks. Observed polymer deck repair by statewide crews 2-28-2023.

Polymer deck observed repair by statewide crews 2-28-2023

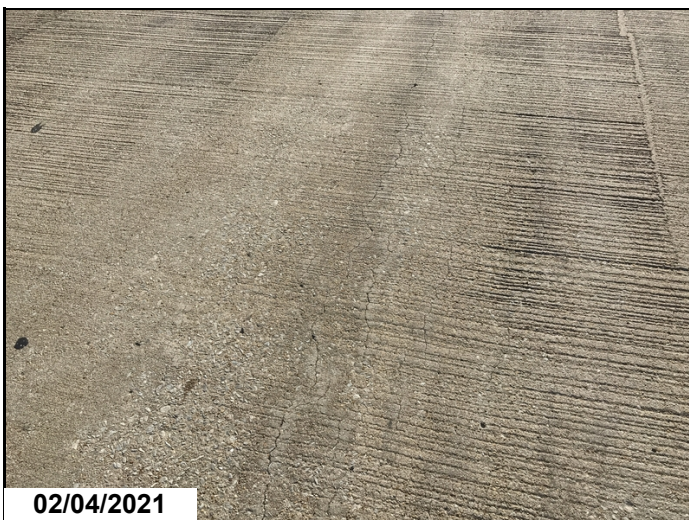
Top of slabs have several areas of abrasion and a few small pop outs. Slabs have areas of map cracking, especially in wheel paths. Slabs have a few unsealed moderate width cracks.

Map cracks in wheel path

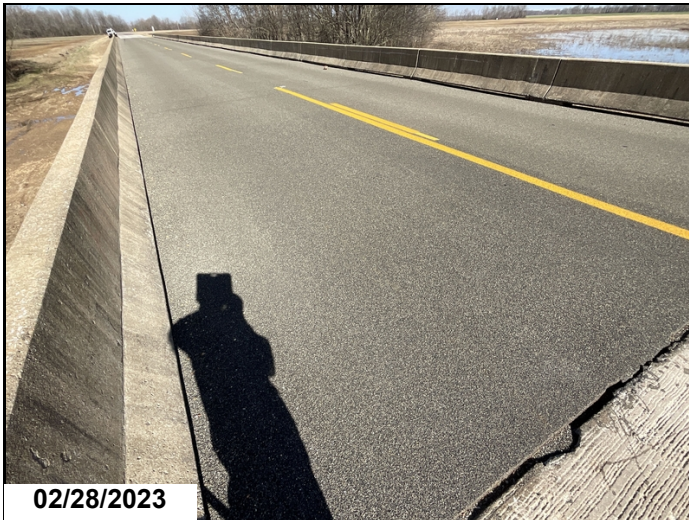
**Poured joint material has lost adhesion and has some sections missing. Observed polymer deck repair by statewide crews 2-28-2023.

Polymer deck observed repair by statewide crews 2-28-2023

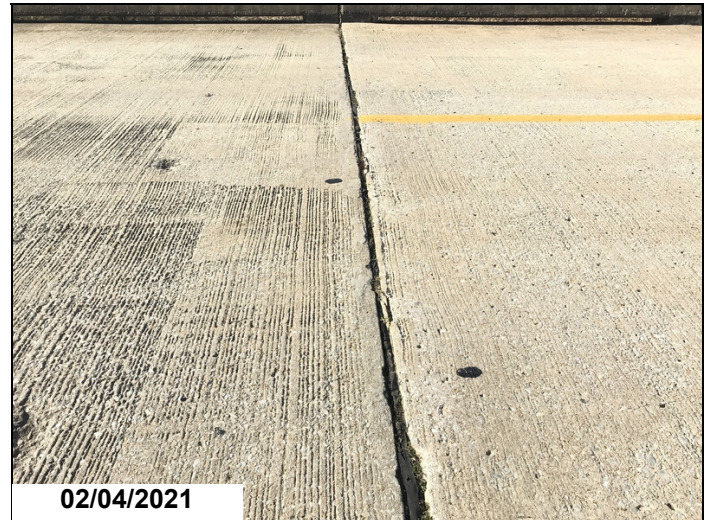
typical joint

Poured joint material has been replaced by HBM.

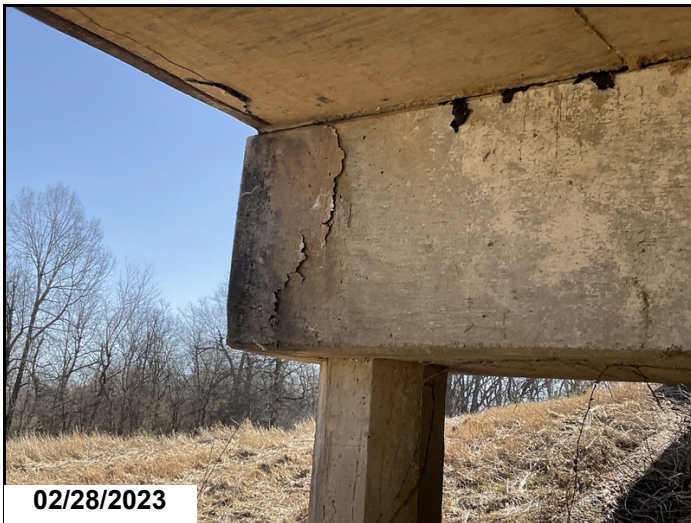
Bent 12 left

Caps have several minor cracks, spalls, and delaminated areas. Some spalls have exposed rebar.

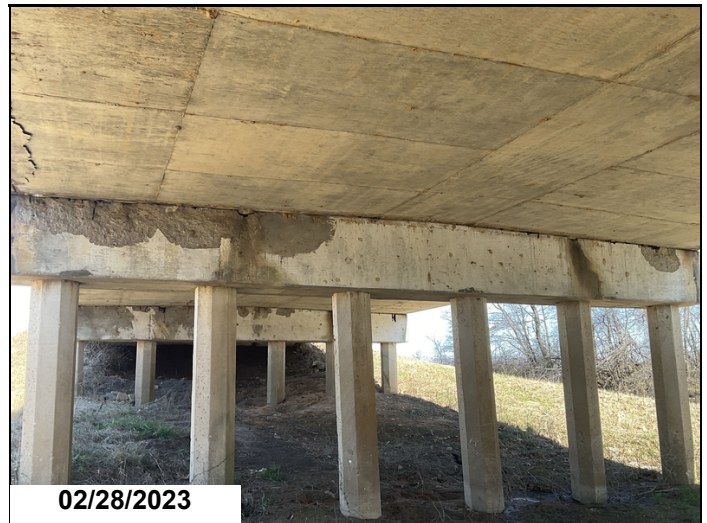
Bent 3 cap on span 3 side side has several large spalls.
