Asset #05735(Routine)

SH 328-01- LM 9.07 over CURRENT RIVER

Location: 9.07 MI E MAYNARD

Team Lead: Brandon Sutton Inspection Date: 05/08/2023

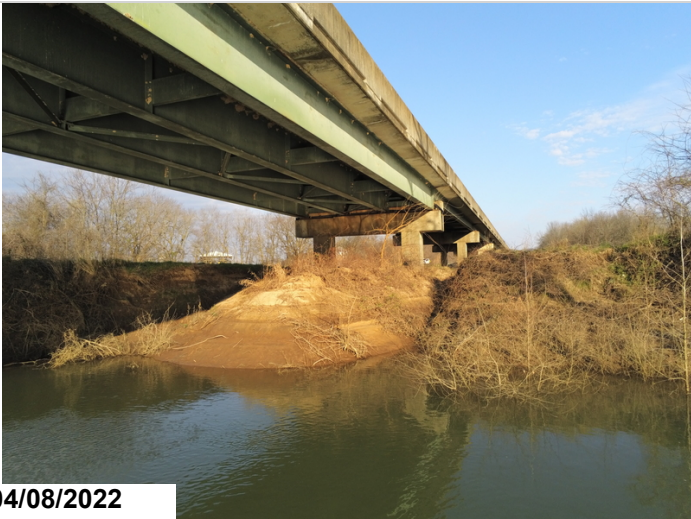
Overall, the channel is in good condition. The upstream channel is well aligned with the substructure units. There is minor timber debris on the upstream nose of Bent 8, however it is not adversely affecting flow through the channel. The banks upstream and downstream of the bridge are stable and well vegetated. The east bank under the bridge is stable and protected with rip rap. The west bank under the bridge is partially vegetated with an areas of runoff erosion.

RUNOFF EROSION ON THE WEST BANK UNDER THE BRIDGE

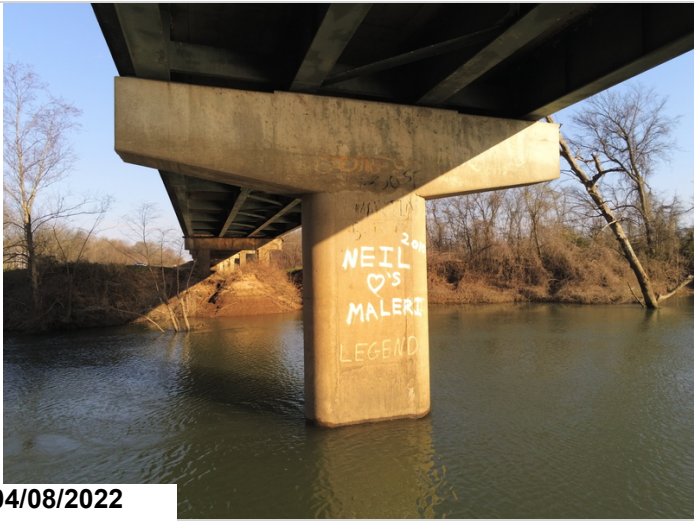
PIER 8

Overall the substructure units are in satisfactory condition with minor defects located on the footing of Pier 8. These defects include minor edge spalls and footing exposure up to 4'H. All defects are quantified in the element level portion of this report.

According to the available bridge drawings (DWG. NO 21532) dated June 17, 1977, Piers 8 and 9 are supported by piles and a concrete footing. A comparison of inspection findings to these drawings indicates that approximately 8' of scour has occurred since construction exposing the upstream (north) nose, east face, and west face of the Pier 8 footing for a distance of 10.5'. The maximum height of vertical exposure is 4' and no undermining of the footing was found.

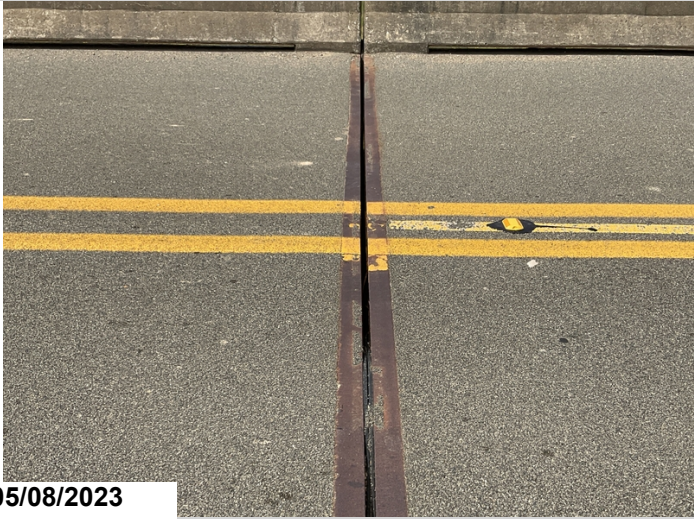
compression seals are torn, missing, or falling down

Bent 6 joint seal

A-59 - Joint Repair Needed (Yes)
compression seals are torn, missing, or falling down

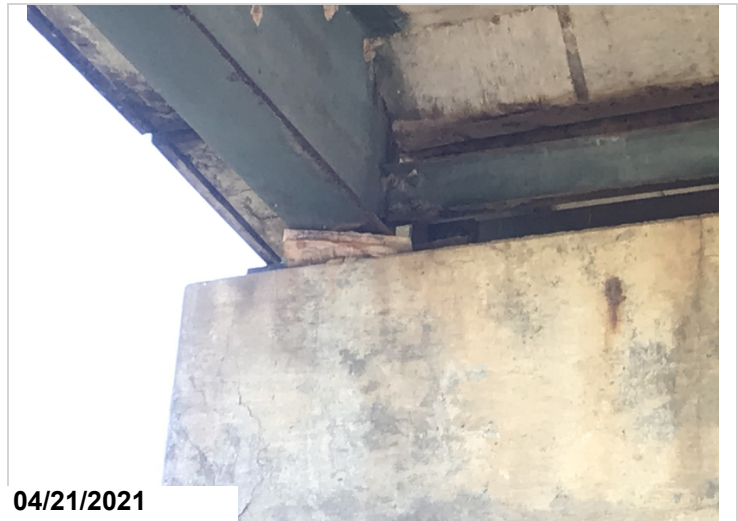
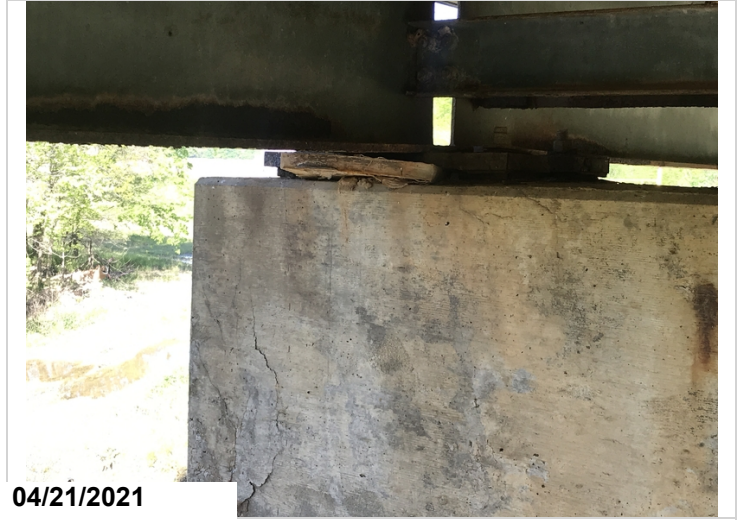
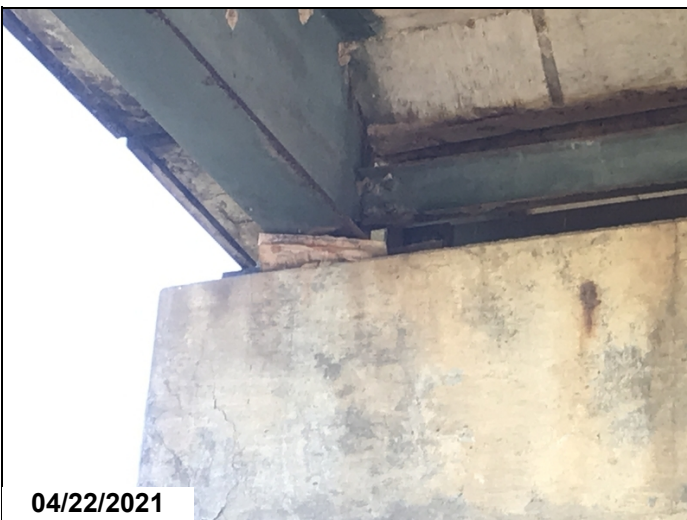
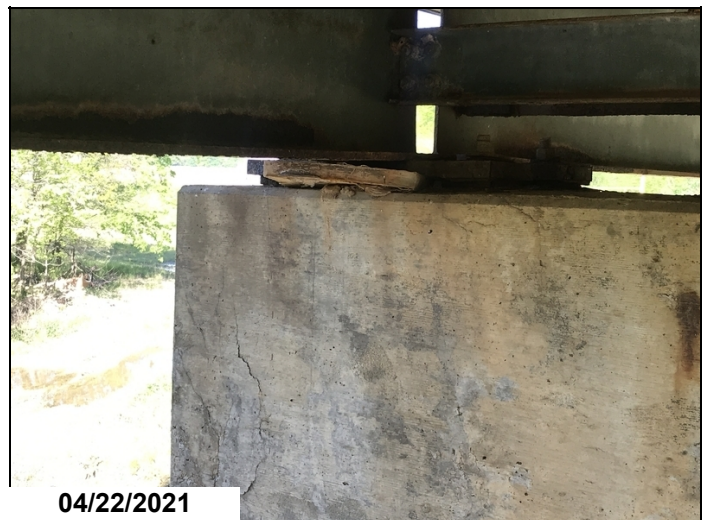
Span 4 bent 4 bearing 4 (pic 1)

Span 4 bent 4 girder 4 bearing pad is sliding out from under girder. Approximately 20% of pad is still under girder.

Type of Work: Bearing Repair/Replacement

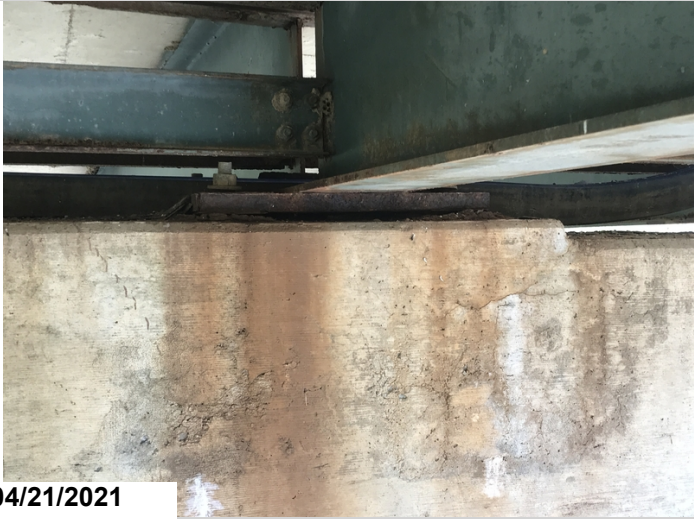
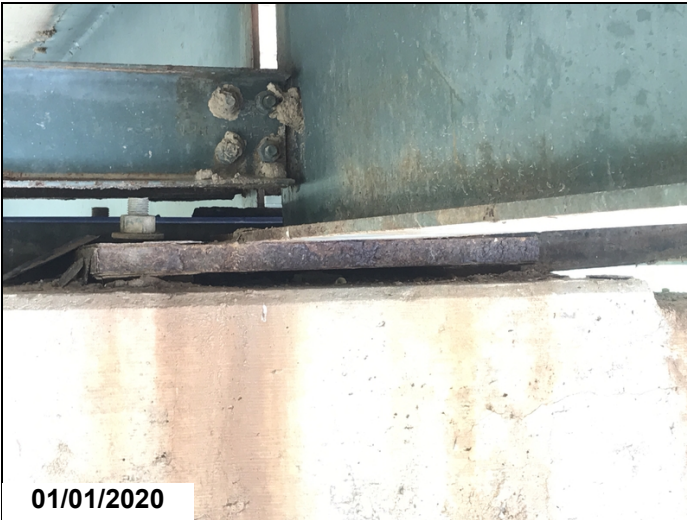
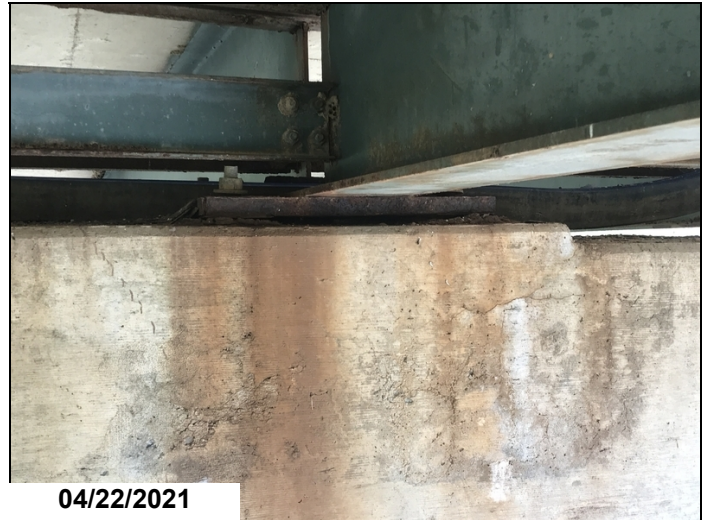
Span 4 bent 4 bearing 2

Span 4 bent 4 girder 2 bearing pad is missing.

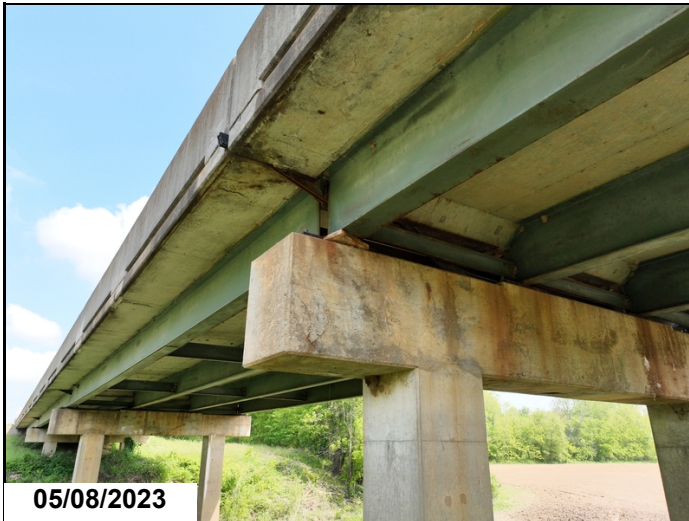
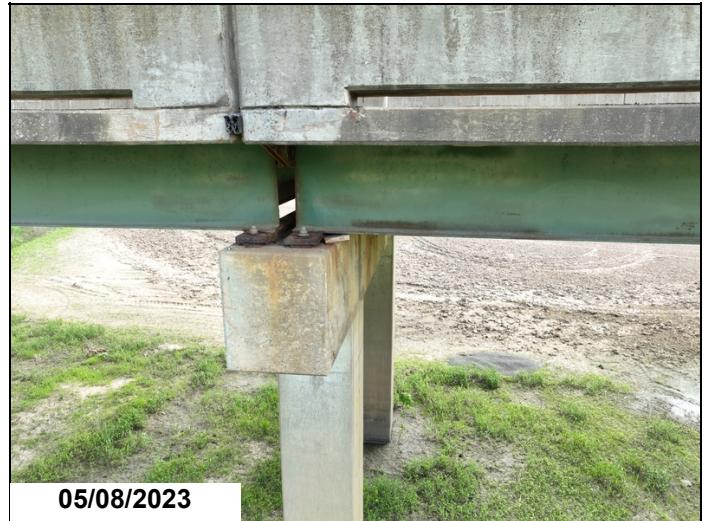
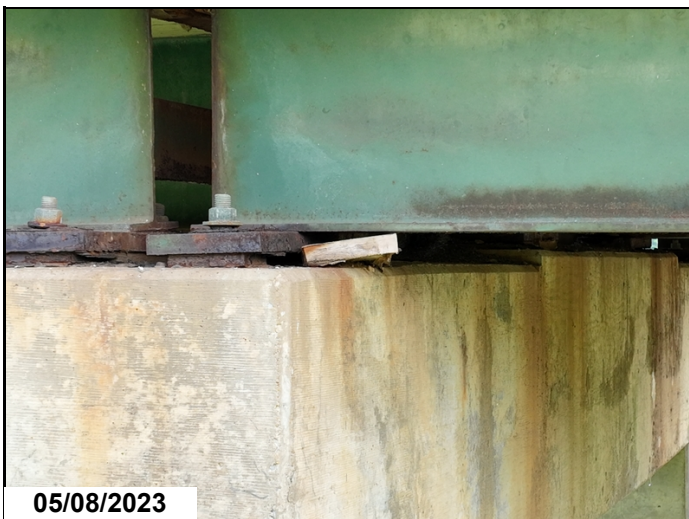
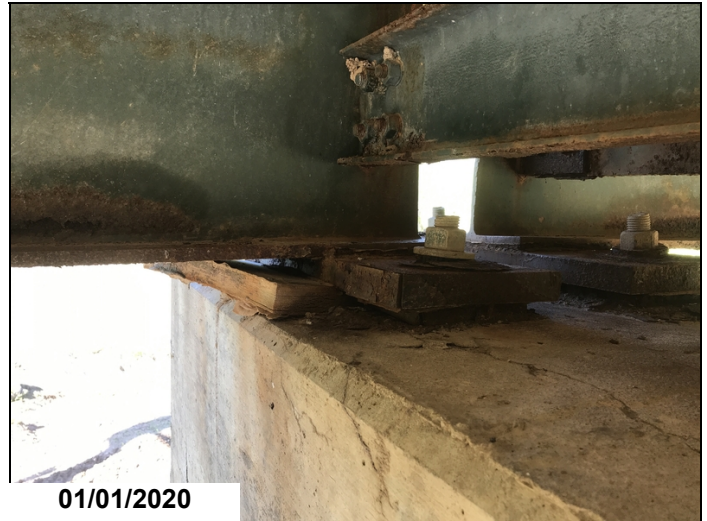
Span 4 bent 4 girder 4 elastomeric bearing pad < 20% remaining in place.

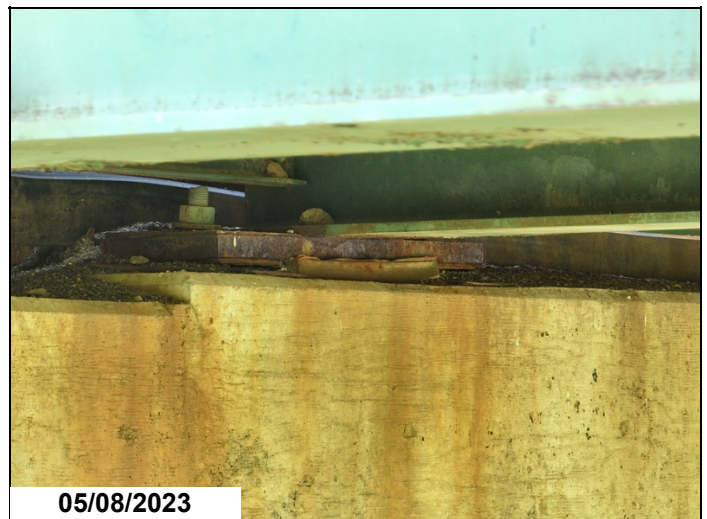
Span 4 bent 4 girder 3 bearing pad is beginning to slide out from under girder.

Span 4 bent 4 girder 3 elastomeric bearing pad moving

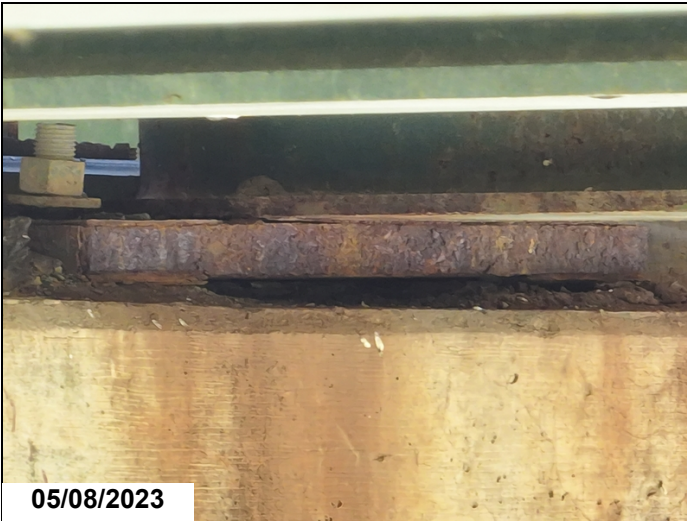
Span 4 bent 4 girder 2 elastomeric bearing pad missing

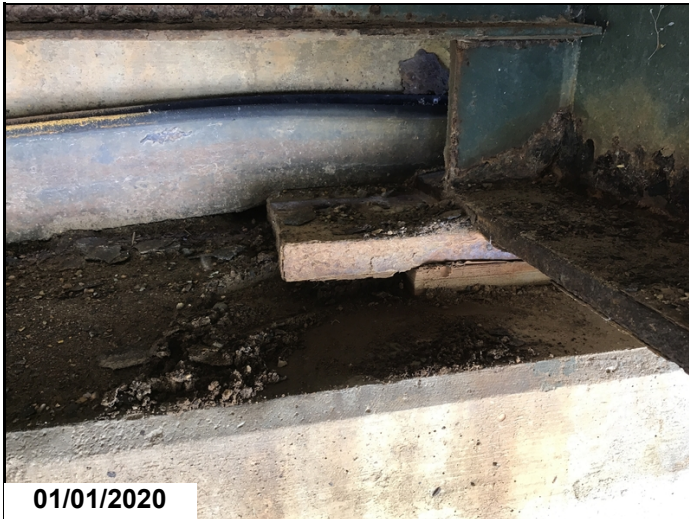
Span 7 bent 7 girder 2 has 2 anchor bolts missing. Bearing pad has shifted approximately ½".

Span 7 Bent 7 Girder 2 missing anchor bolt

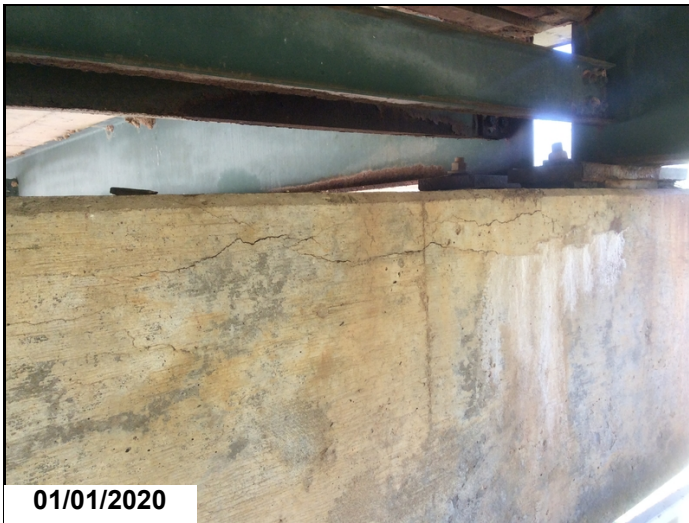
Concrete caps have several cracks, delaminated areas, and spalls with rebar exposed.

Typical cap cracking and bearings

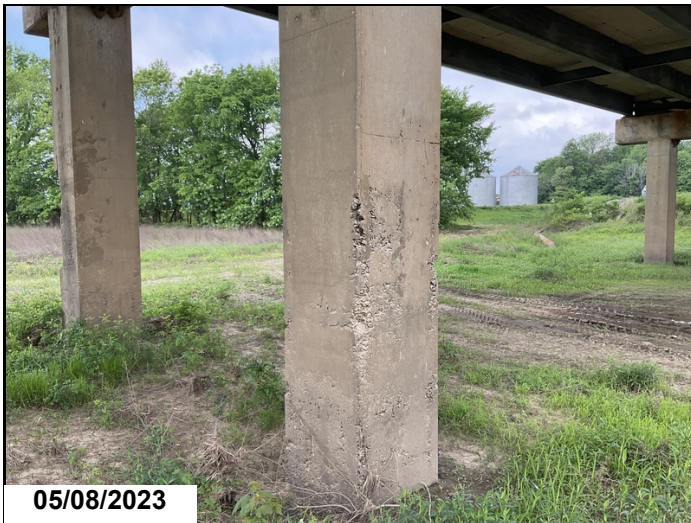
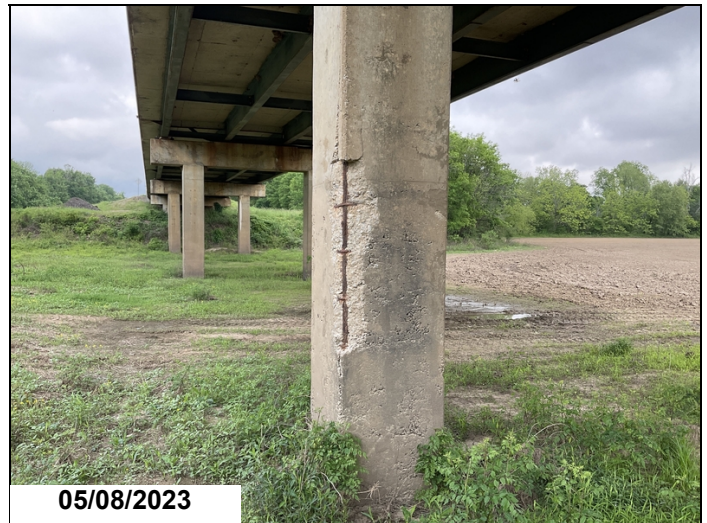
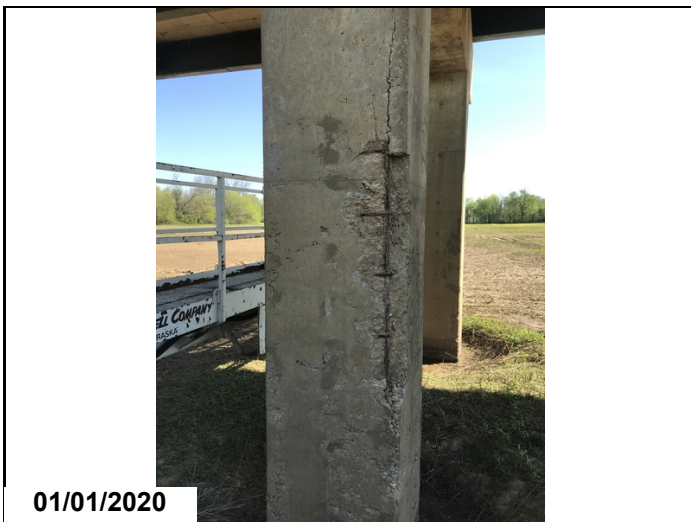
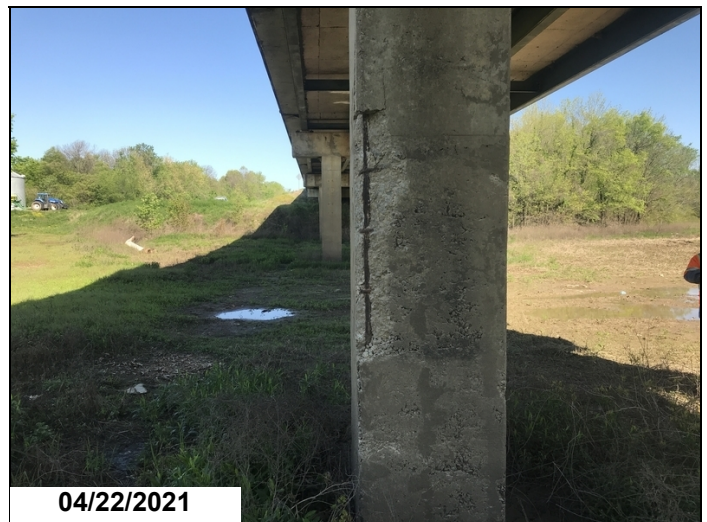
Bent 5 column 1

A few concrete columns have honeycombed areas, cracks, delaminated areas, and spalls with rebar exposed.
