Route:328 Section:01 Log:9.3

Arnold Road ID:61x328x1xA, Arnold Log mile:9.272

Asset #05736(Routine, Underwater type 2)
SH 328-01-LM 9.30 over CURRENT RIVER RELIEF
Location: 9.3 MI E MAYNARD
Team Lead: James Adams Inspection Date: 02/15/2023

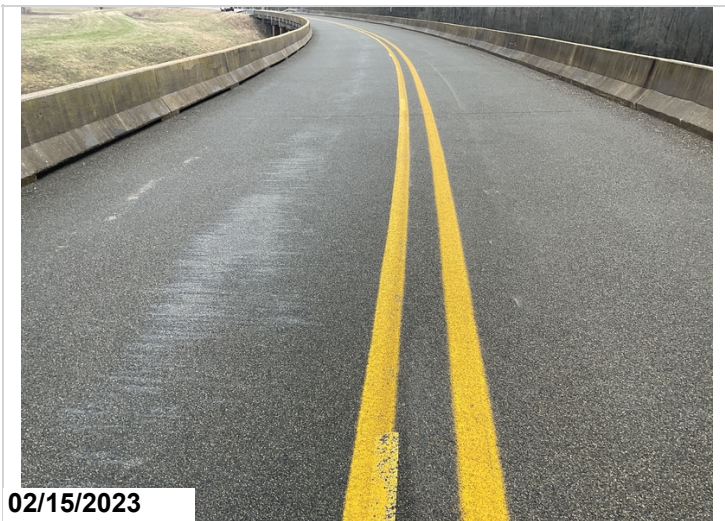
Deck HBM Polymer observed 2-15-2023

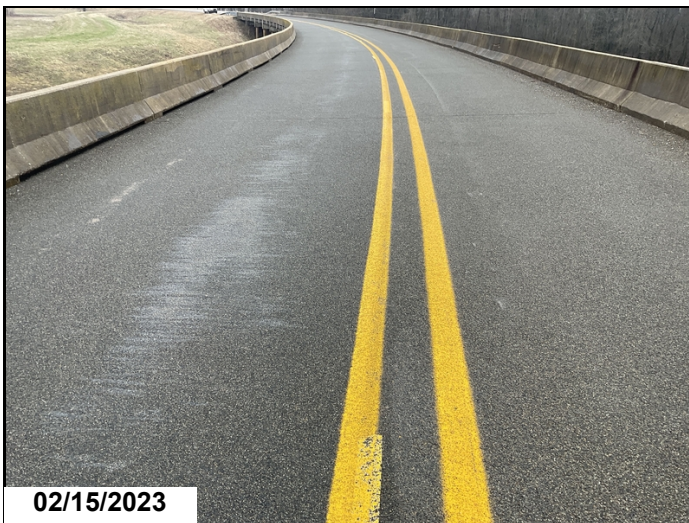
Top of slabs have several areas of abrasion and a few small pop outs. Slabs have areas of map cracking, especially in wheel paths. Slabs have a few unsealed moderate width cracks

HBM applied protective coating since previous inspection. Observed 02-15-2023 JFA/CWS

Deck HBM Polymer observed 2-15-2023

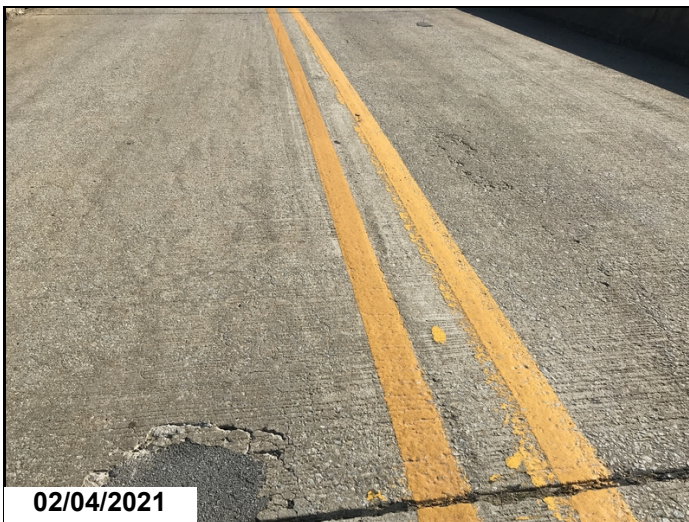
cracks, spalls, abrasion

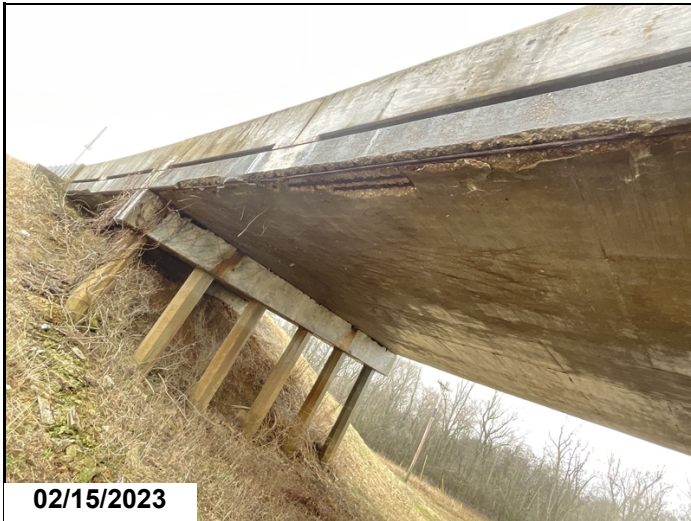
Span 13&14 left

Lt edge of slabs are cracked, delaminated, and have spalls with exposed rebar. Spans 2, 3, 4, 6, 7, 9, and 11 have areas along Lt edge where concrete has spalled completely away from 1 longitudinal bar.

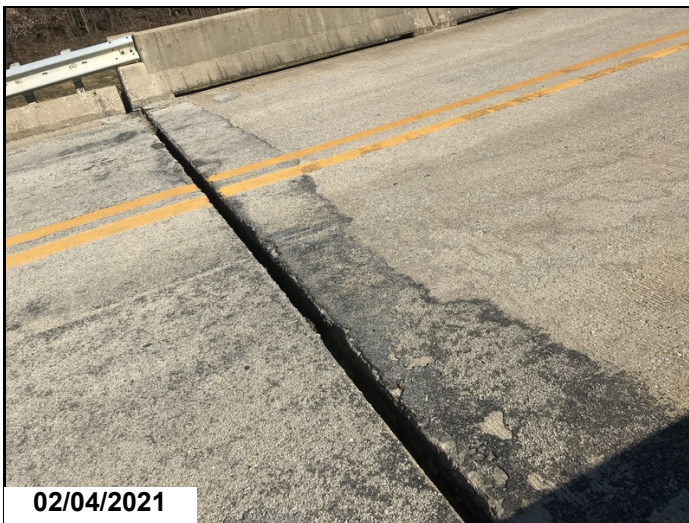
Approach slabs have settled and pulled away from bridge at each approach. Bent 1 approach slab has settled approximately 1"

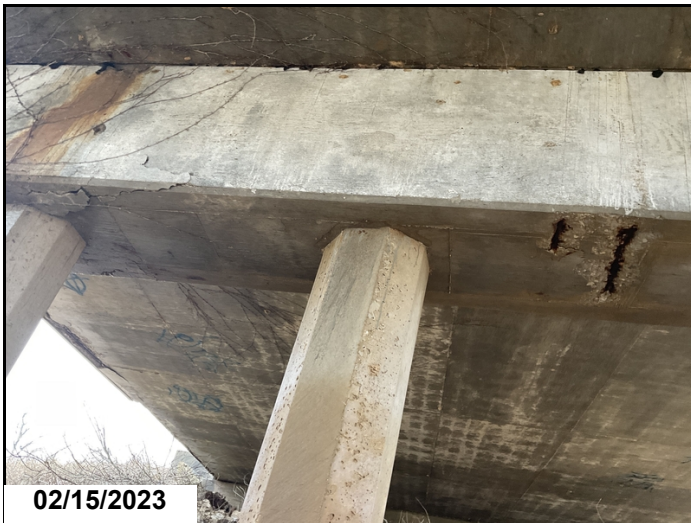
Bent 14

Caps have several minor cracks, spalls, and delaminated areas. Some spalls have exposed rebar.

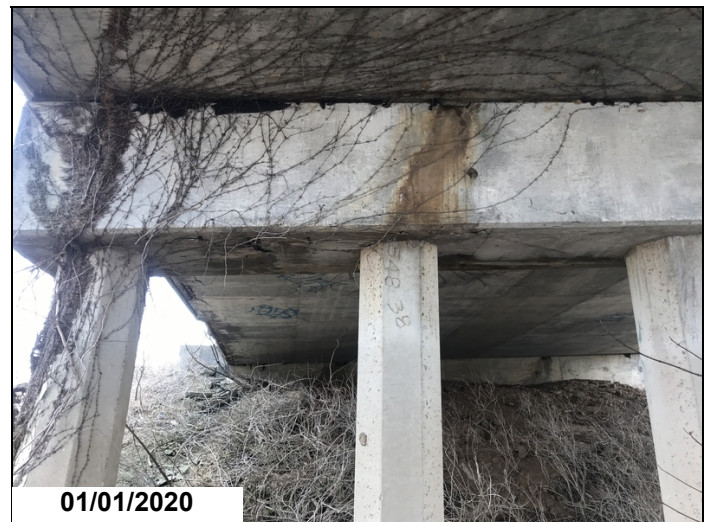
Bent 14 delam

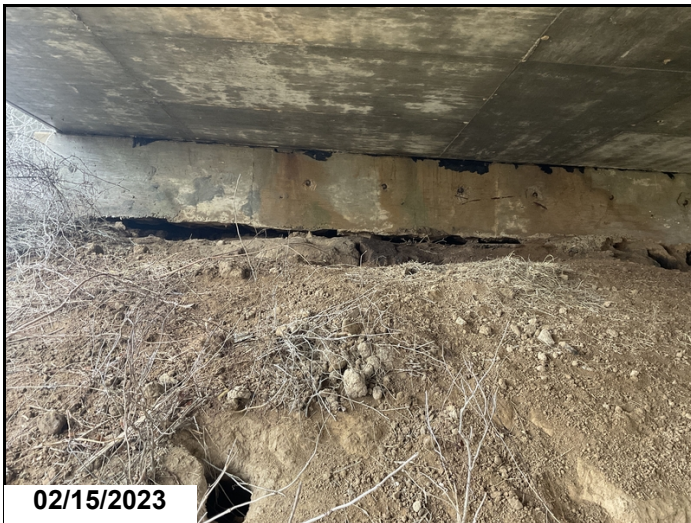
Bent 1 abutment has some minor undermining with 2 piles exposed.
