## Bridge 00734 Inspection Report

Asset #00734(Routine, Underwater type 2)

SH 1-15- LM 6.31 over ENGLAND CR

Team Lead: Cory Shaw Inspection Date: 05/06/2025

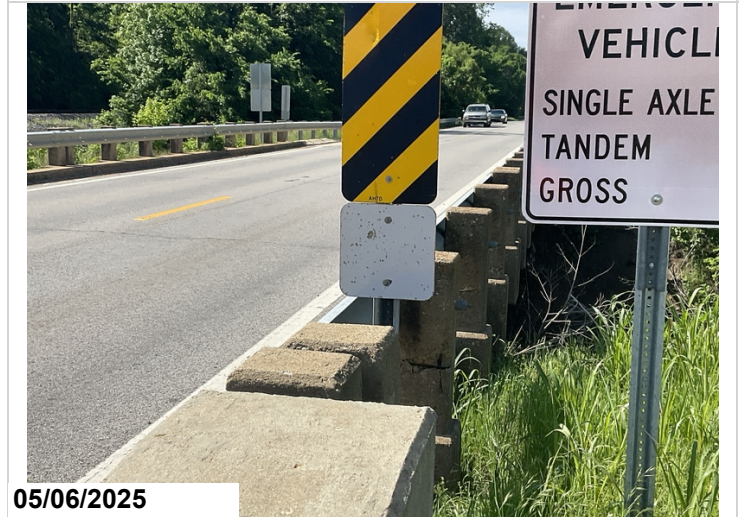
North end Log mile posting faded.

North end Log mile posting faded

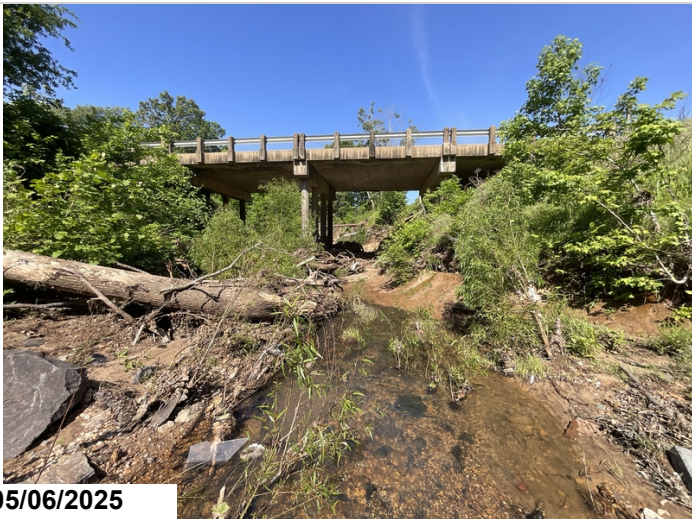
Vegetation adjacent to bridge.

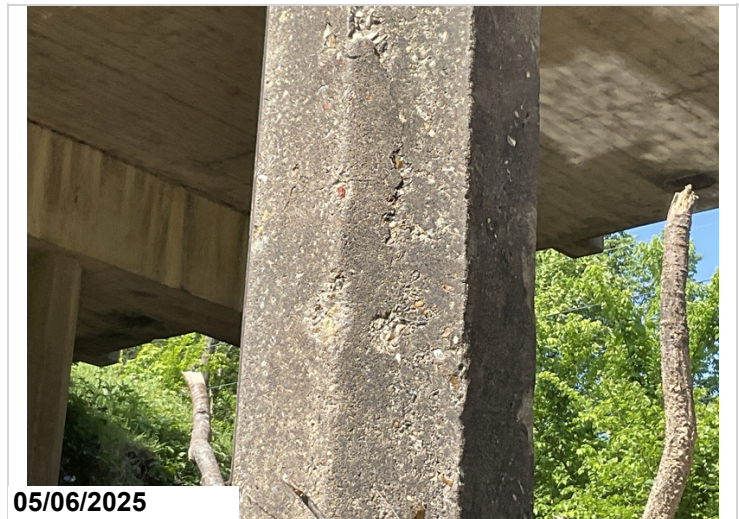
Bent 3 pile 4 horizontal and vertical cracks

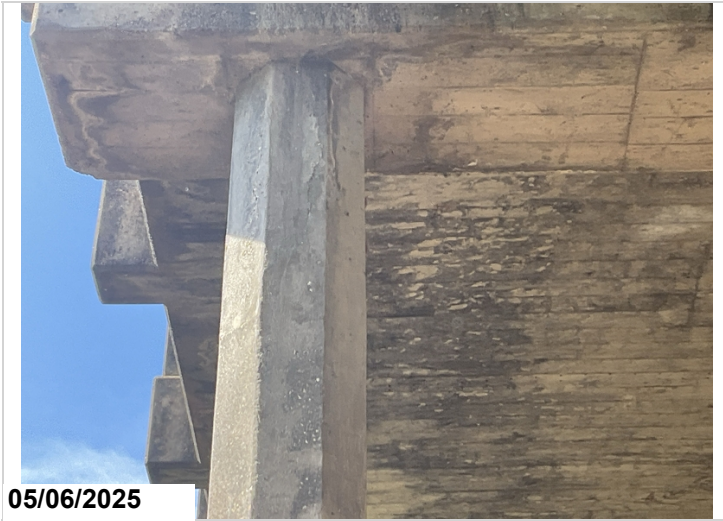
Bent 3 pile 4 vertical crack at top of pile

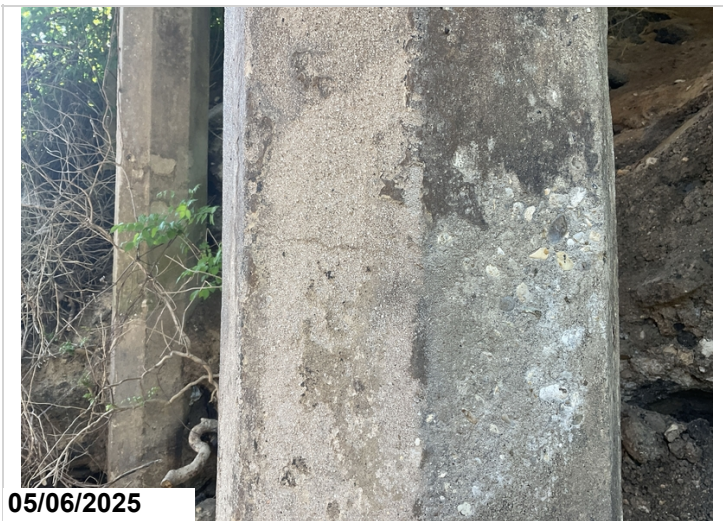
Bent 2 pile 2 cracks

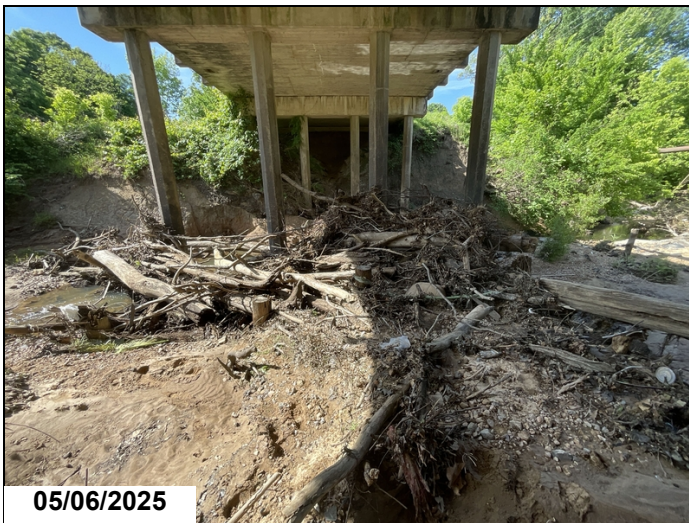
Drift is built up at Bent 3 causing flow to reroute towards Bents 2 and 4.

Span 2&3 drift

**Type of Work:** Channel Work/Drift Removal

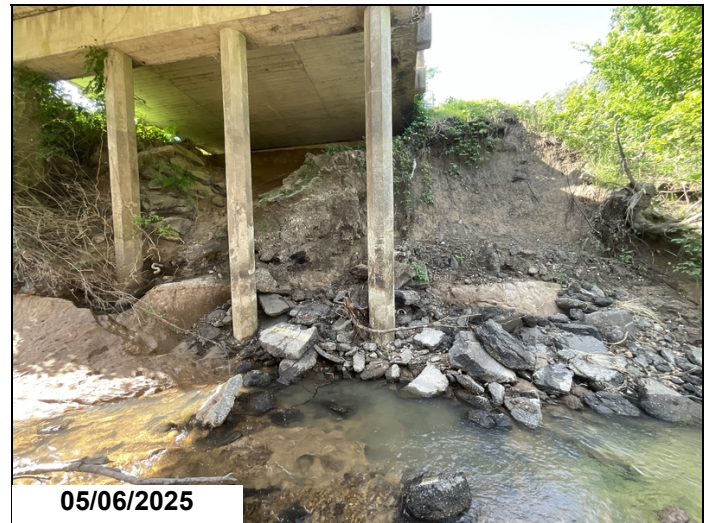
Embankment under Span 1 has some erosion. 3' of berm remains at Bent 1.

Span 1 slope (South end of structure)

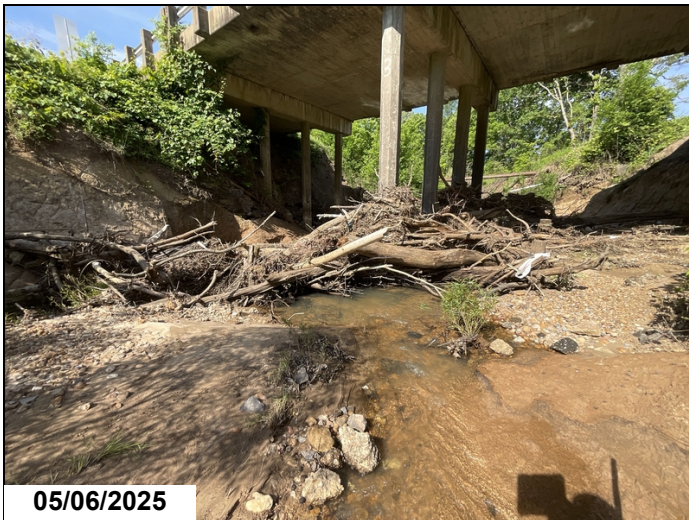
Span 2&3 drift

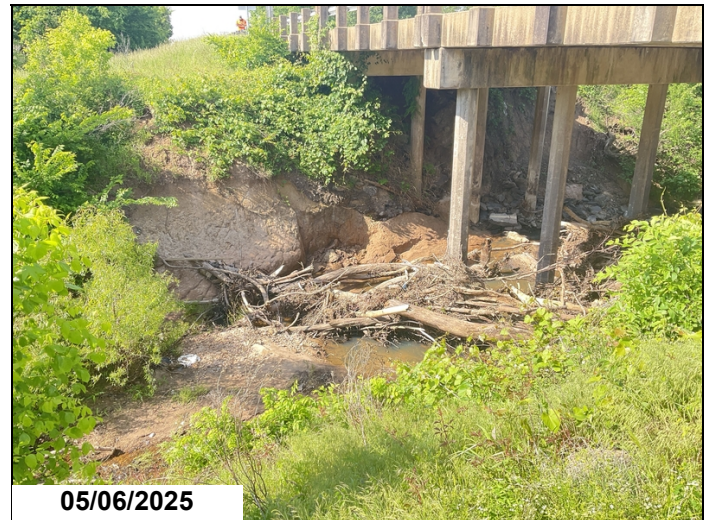
Span 1 slope (South end of structure)

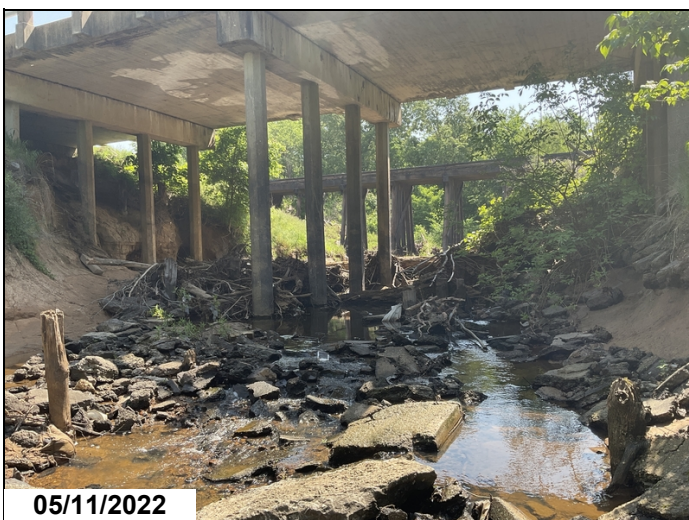
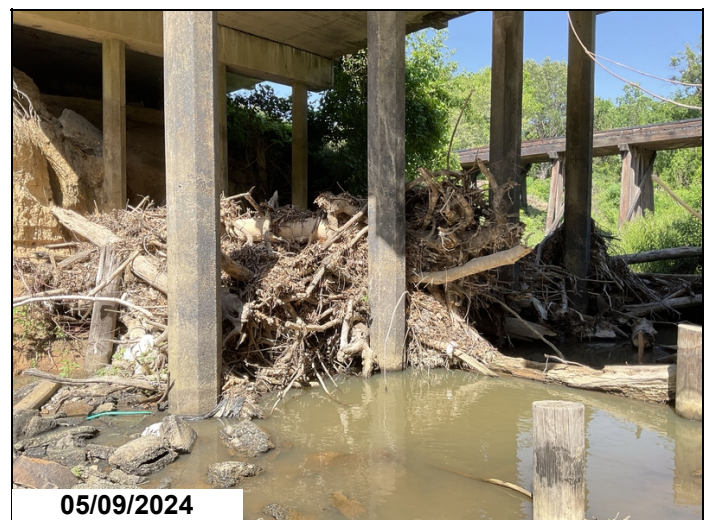
Bent 3 piles have approximately 19.7' exposed from bottom of cap to ground line.

Bent 3 drift 19.5' of pile exposed from bottom of cap to ground line

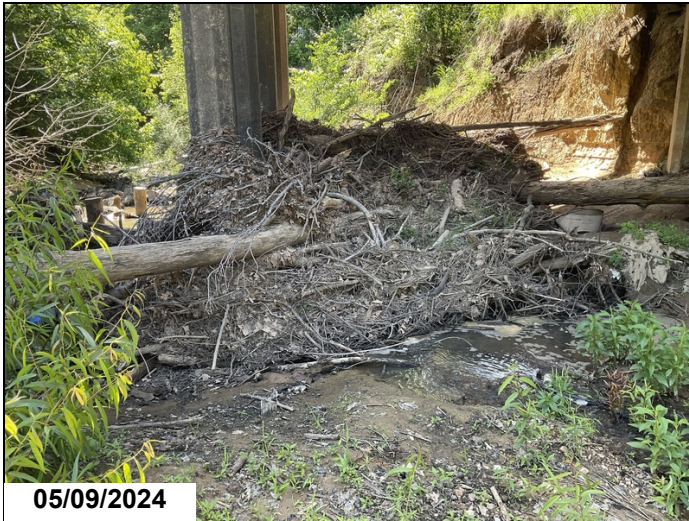
Bent 3 drift

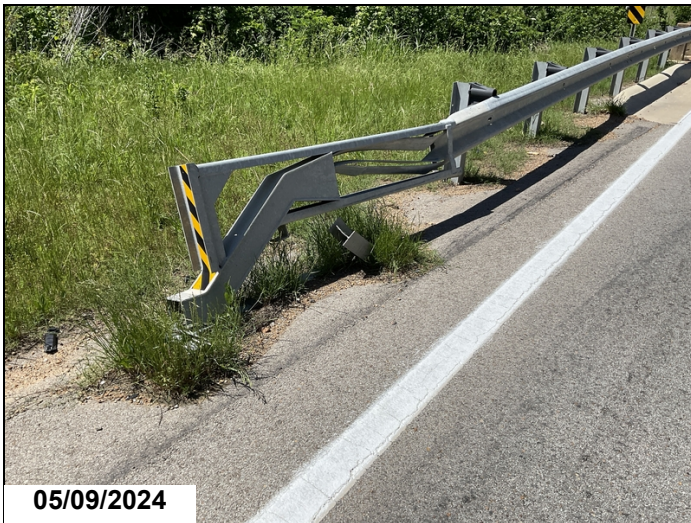
Approach rail at Bent 1 Left has impact damage.

Bent 1 Lt approach rail

**Type of Work:** Approach Leveling/Maintenance

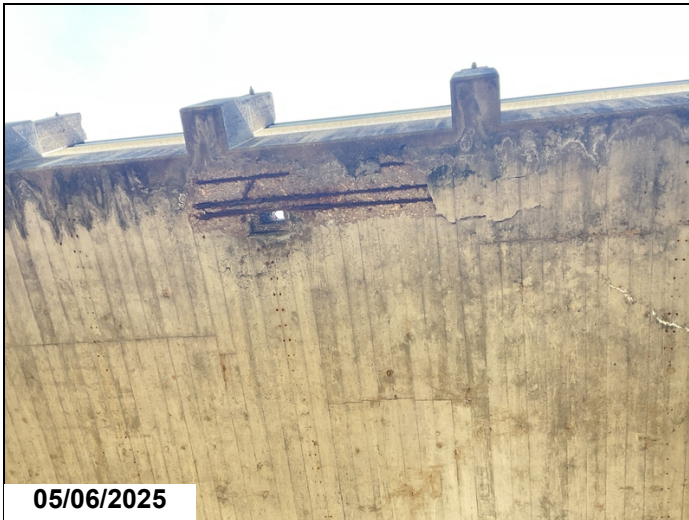
Span 3 undersurface left edge has a 2' x 10' spall with exposed rebar.

**Type of Work:** Repair (General)

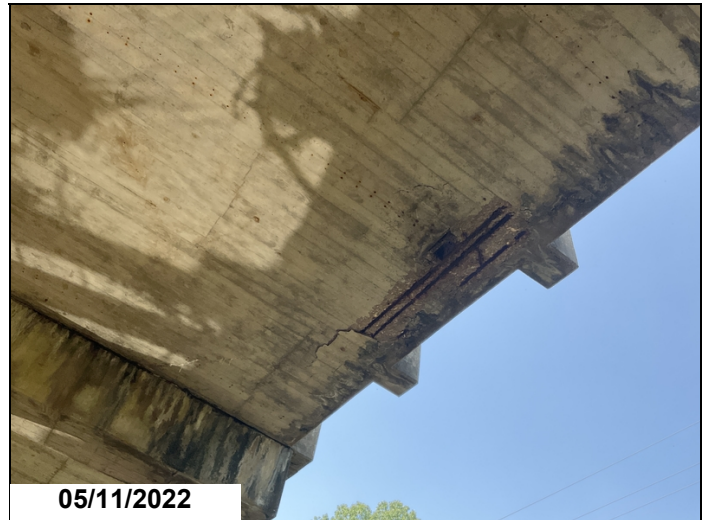
Span 3 left

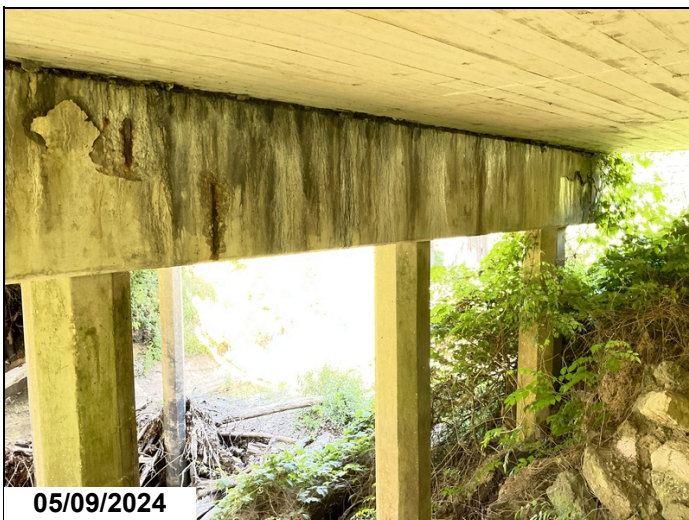
Bent 2 back side spalls and rebar CS3

**Type of Work:** Substructure Repair

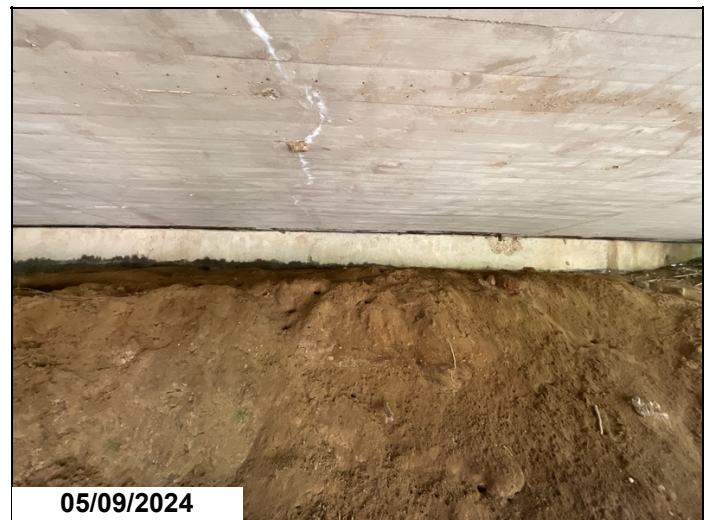
Bent 1 delam and minor chip/spall CS2 and 3

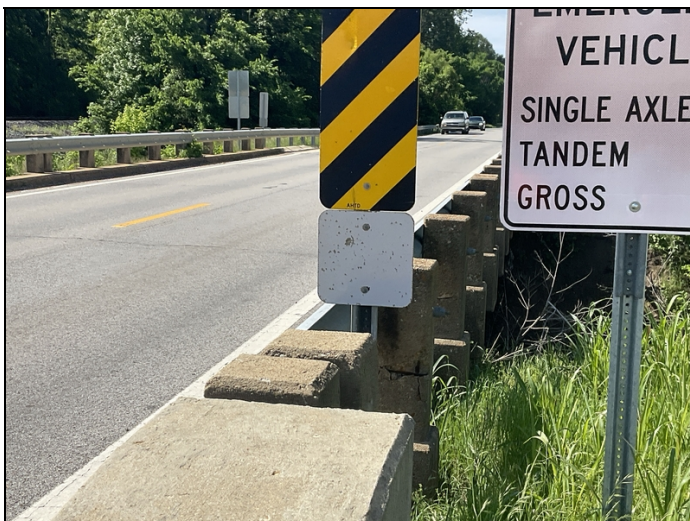
North end Log mile posting faded.

North end Log mile posting faded

**A-63 - Missing/Incorrect Log Mile Signage (Yes)**

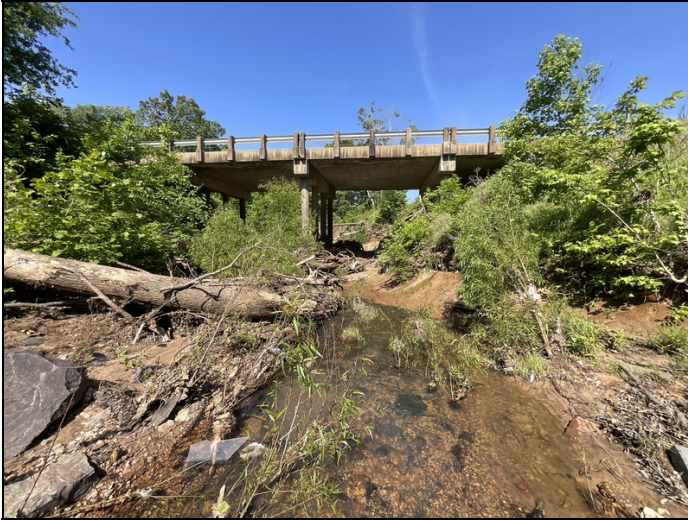
Vegetation adjacent to bridge.

**A-64 - Vegetation Removal Requested (Yes)**

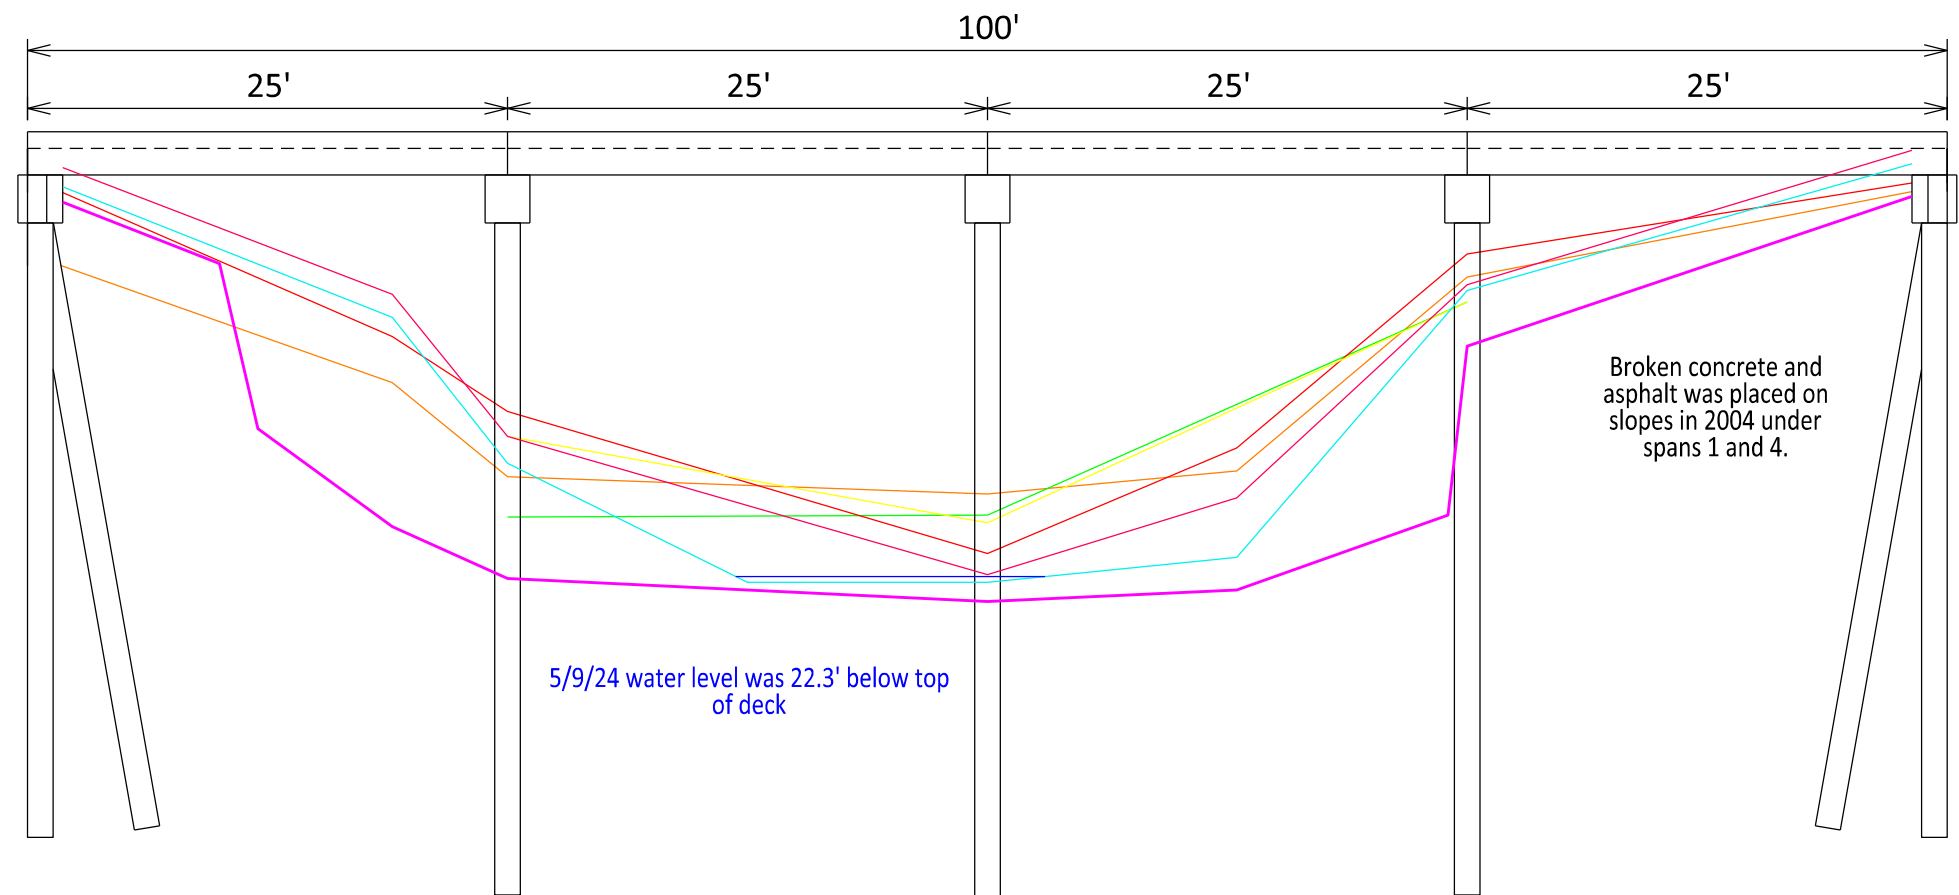
Bent 2 pile 1 has 18.5' exposed from bottom of cap to ground line.

Bent 3 piles have approximately 19.7' exposed from bottom of cap to ground line.

Bent 4 piles 2 and 3 have approximately 15.2' exposed from bottom of cap to ground line.

Channel soundings taken from top of deck Lt side (Downstream)
