Bridge X0296 Inspection Report

Asset #X0296(Routine)

SH 1-16- LM 7.08 over DRAINAGE DITCH

Team Lead: Cory Shaw Inspection Date: 05/02/2025

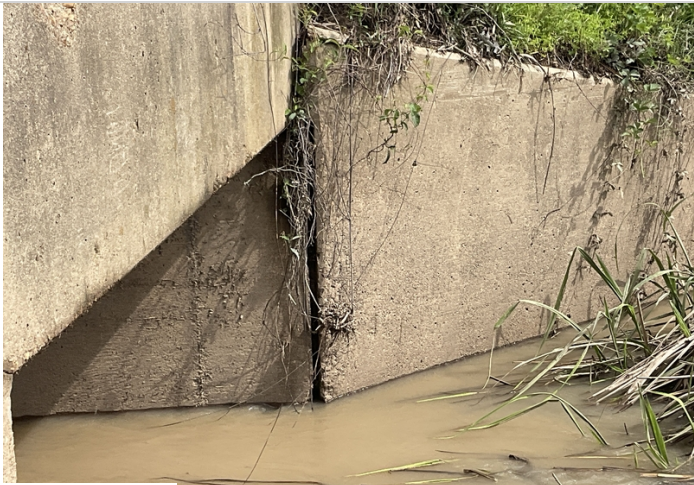
Barrel 3 right wing separated up to 2" inches

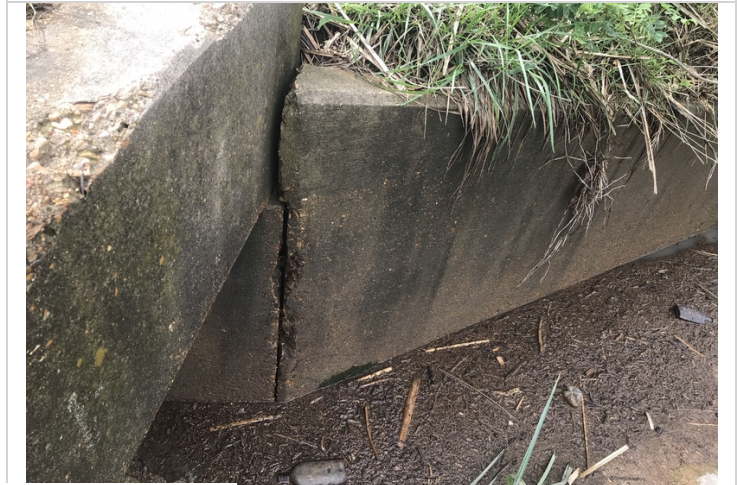
Barrel 1 left wing separated up to 1" inch

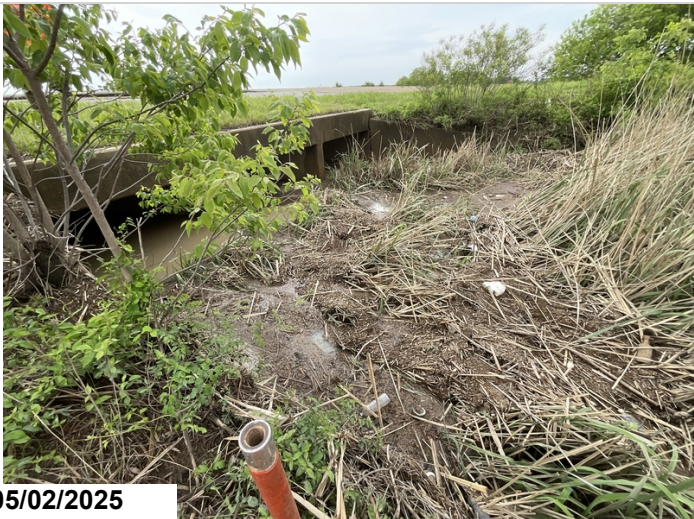
A-64 - Vegetation Removal Requested (Y)
Vegetation on left end partially blocking channel flow.

Vegetation on left end

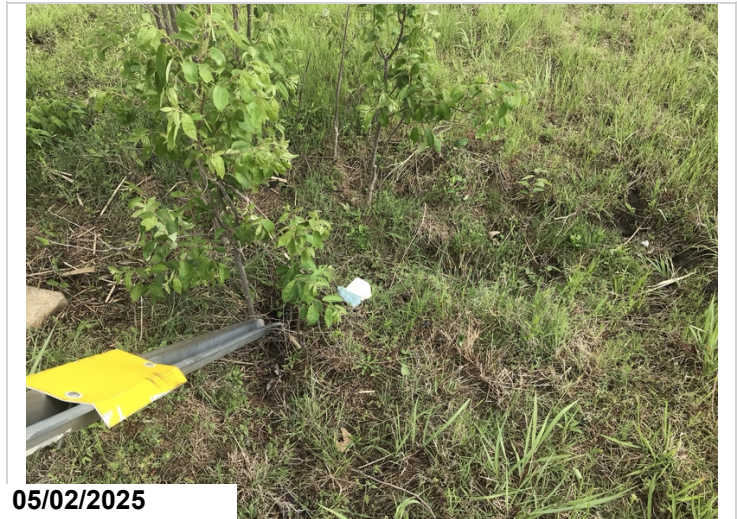
Minor settlement at NW corner from roadway runoff

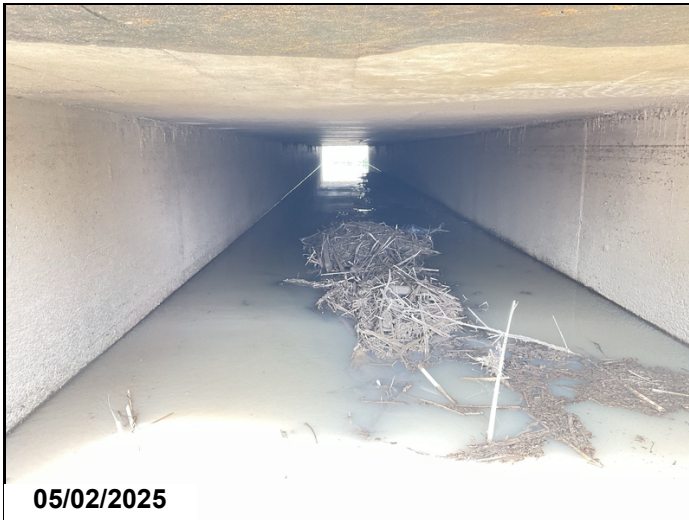
Barrel 1 has 1' of sediment buildup.

Barrel 1 sediment buildup

Type of Work: Channel Work/Drift Removal

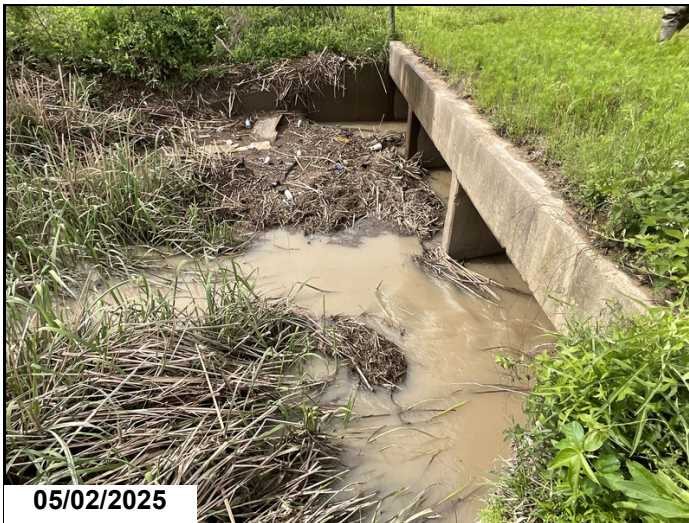
Drift built up at inlet end of box culvert.

Drift at inlet end

Type of Work: Channel Work/Drift Removal

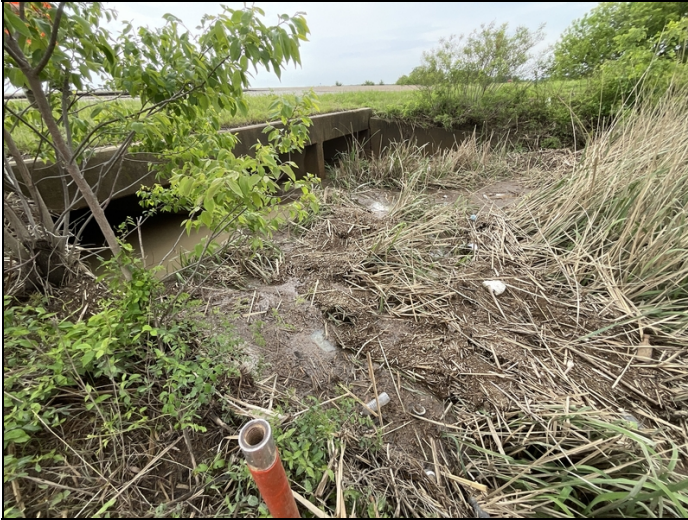
Vegetation on left end partially blocking channel flow.

Vegetation on left end

A-64 - Vegetation Removal Requested (Yes)
