Bridge X0297 Inspection Report

Asset #X0297(Routine)

SH 1-16- LM 9.10 over DRAINAGE DITCH

Team Lead: Cory Shaw Inspection Date: 12/02/2025

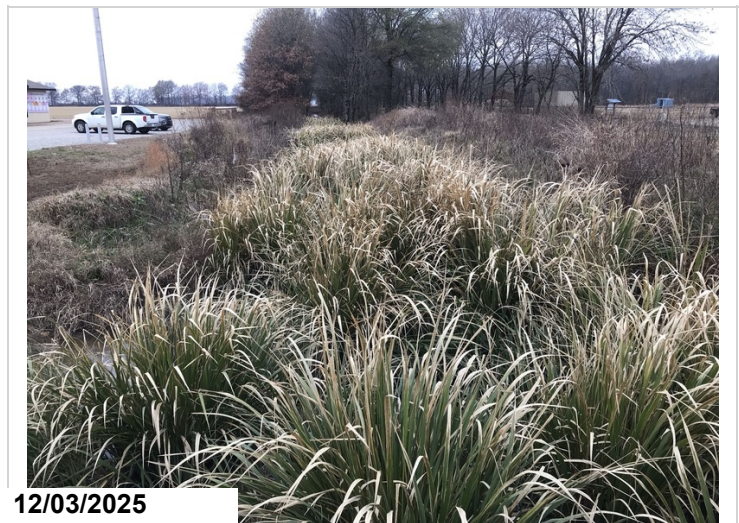
Dense vegetation growing in channel.

Channel on the Left.

A-64 - Vegetation Removal Requested (Y)

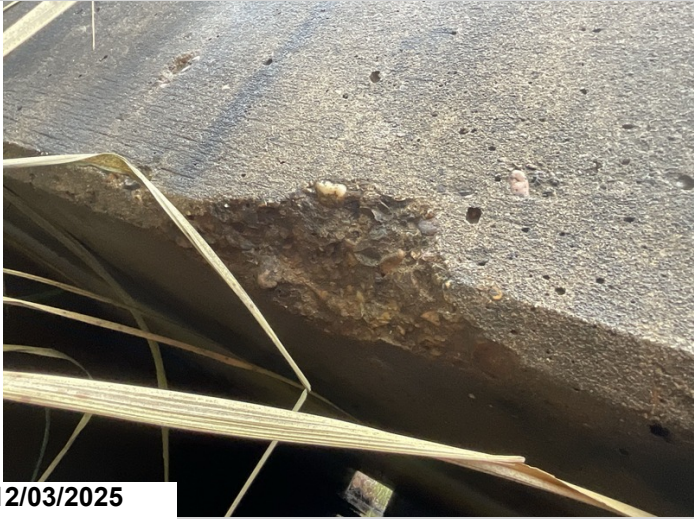
Barrel 3 Left end has a minor spill.

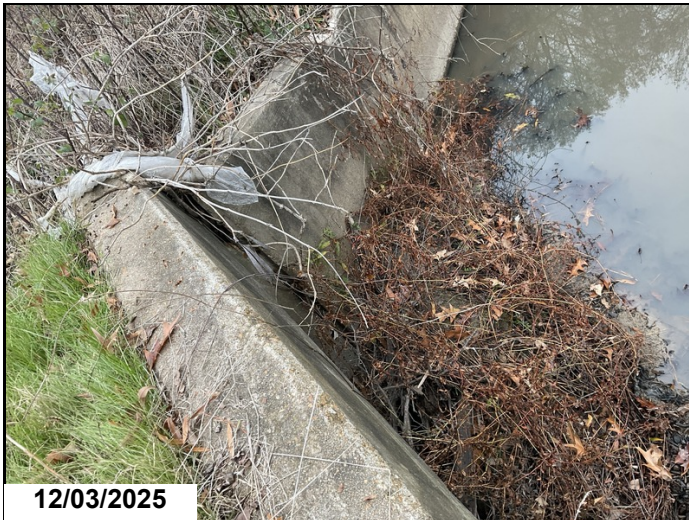
2025 - Barrel 3 Right Wing

Barrel 1 Left wing is separated 3" from culvert and rotated towards channel 1.5".
Barrel 3 Right wing is separated up to 2" from culvert.

Type of Work: Repair (General)

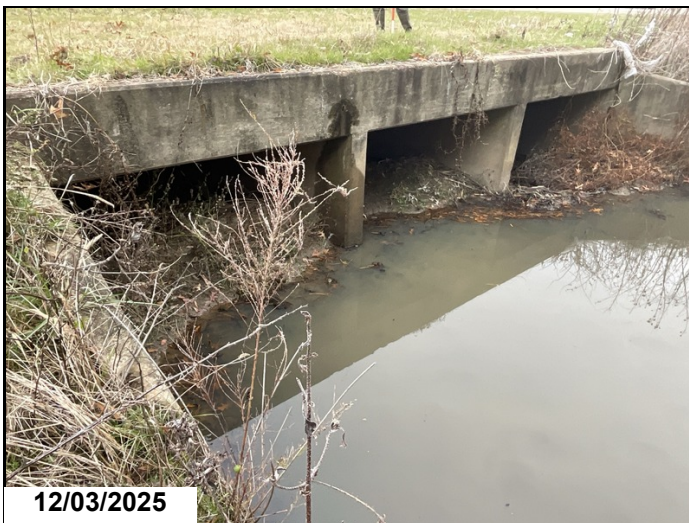
Barrels have up to 1' of sediment buildup.

2025 - Sediment buildup in barrels.

Type of Work: Channel Work/Drift Removal

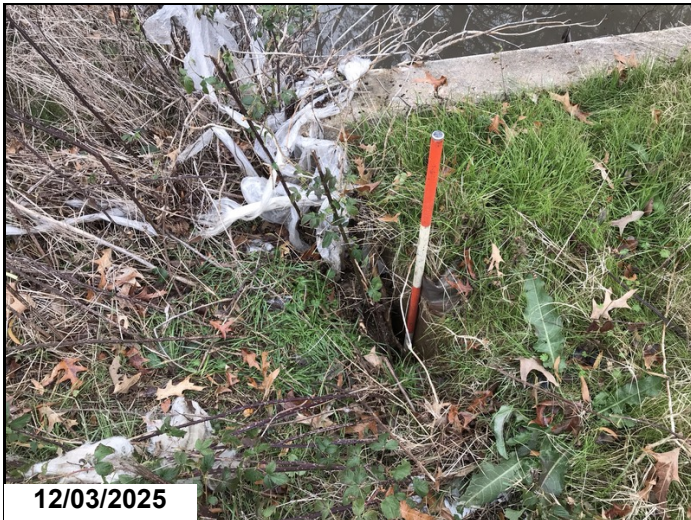
Roadway embankment has some erosion behind wing walls. Barrel 3 Right Wing has up to 2' deep erosion behind the wing.

Barrel 3 Right Wing has up to 2' deep erosion behind the wing.

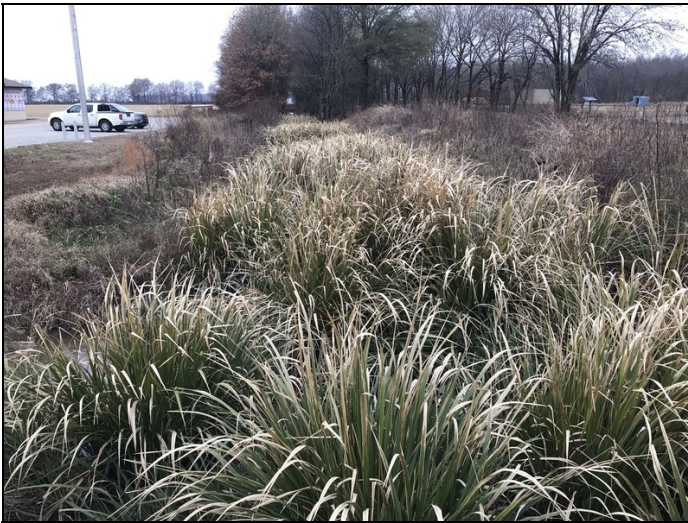
Dense vegetation growing in channel.

Channel on the Left.

A-64 - Vegetation Removal Requested (Yes)
